# Ticknall *Conservation Area* Character Statement

**2013**  
***CONSULTATION DRAFT***

**SOUTH DERBYSHIRE  
DISTRICT COUNCIL**

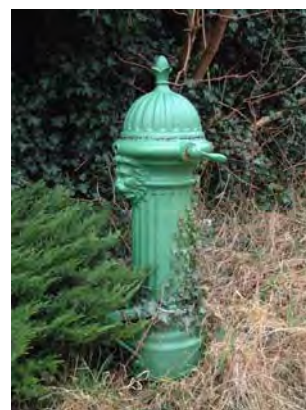
*Cast-iron pillar fountain*

- a variety of boundary walls fronting the street, predominantly of rubble limestone
- lions-head, cast-iron pillar fountains throughout the village are a constant reminder of the Harpur Crewe estate's influence there, having been installed by Sir Vauncey Harpur Crewe in 1914

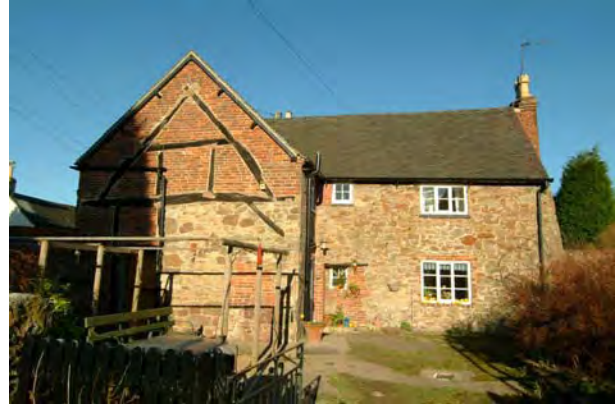
*Fragment of timber frame exposed in the gable of Springfield House Farm*

The earliest surviving vernacular buildings appear to have been of timber-framing on rubblestone plinths. Although a number of houses contain evidence of timber-framing, only Springfield House Farm has an exposed frame in the gable end. The incorporation of a plinth at low level continued through the centuries. At the Chequers and nos. 36-40 Main Street the stone plinth has a chamfered stone cap and is probably late 17<sup>th</sup> century in origin. The use of high plinths in rubblestone, ashlar or brickwork continued to be a common building detail for a long time and was also adopted in the 19<sup>th</sup> century for a number of brick buildings in the village (e.g. Sheffield House and Victoria House).

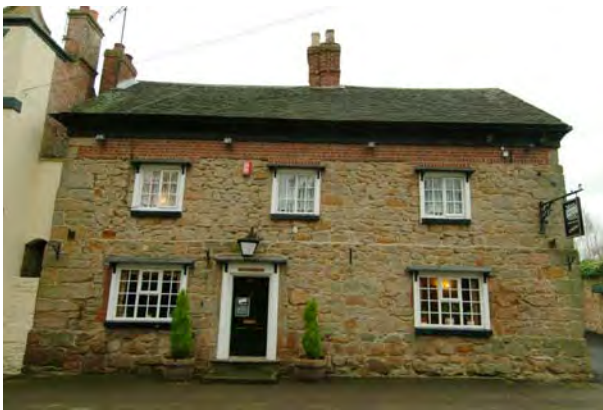
*The Chequers Inn built from rubble sandstone and rubble limestone and later raised in brick*

Two substantial stone buildings survive, probably dating from the 17<sup>th</sup> century, built from both rubble sandstone and rubble limestone (namely The Chequers and Royal Oak House).

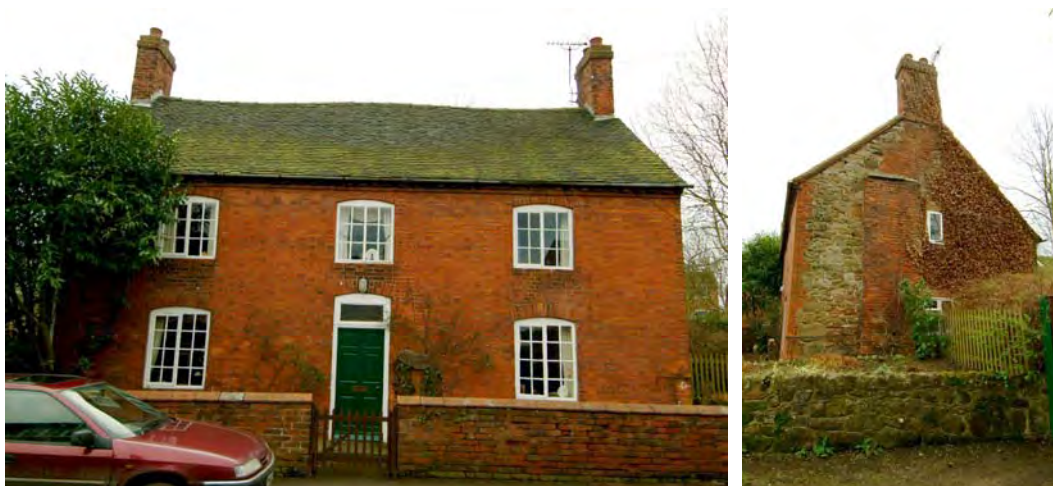
*Laurels Cottage: Red brick front, rubblestone side*

was often a choice reflecting the polite taste of the times, not building evolution (e.g. Laurels Cottage, Main Street).

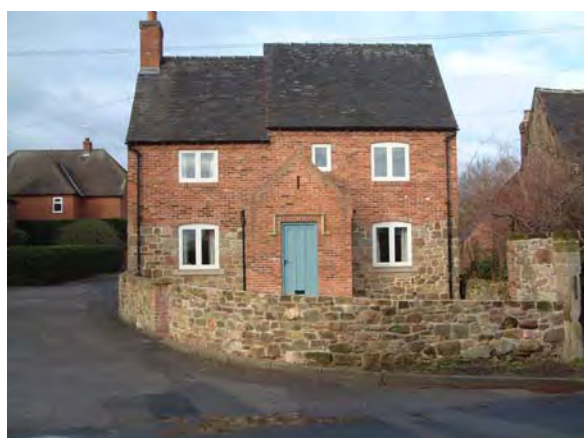
*Modern housing on High Street, designed to fit*

Today, sections of random stonework are being included in new development purely on aesthetic grounds, aping the visually interesting historic examples. In these cases the inclusion of stonework does not, of course, represent phases of building evolution.

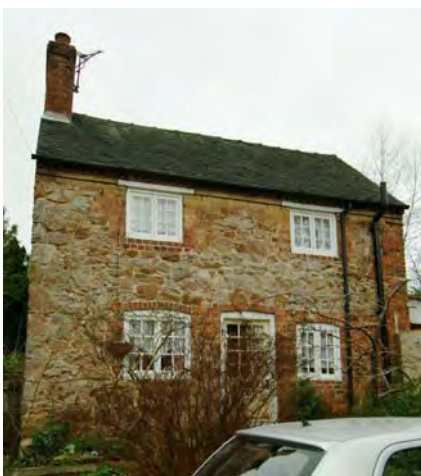
*Left - Pennfold Cottage, 8 High Street: Simple segmental arches to ground floor windows, timber lintels at first floor, no cills*  
*Right - 124 Main Street: gauged brick arches and stone cills*

- the segmental brick arch, used on the majority of cottages and the simplest and easiest to construct as the taper was accommodated wholly in the mortar joints,

without the need to cut the bricks. In some cases the bricks have a “false” incised line in the bricks to create the illusion of a joint

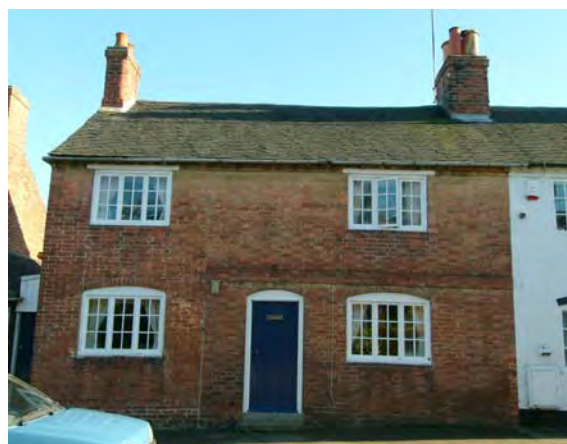
*41 High Street - traces of limewash can still be seen under the gutters*

In a number of instances brickwork was limewashed, e.g. nos. 36-40 Main Street, no. 173 Main Street and the terrace nos. 41-45 High Street, to provide a “sacrificial” weatherproof coating. Small traces of limewash are still visible on no. 41, although the others in the row have been painted in modern emulsions. Traces of limewash can still be seen elsewhere in sheltered places, such as under eaves. The practice of limewashing has now died out.

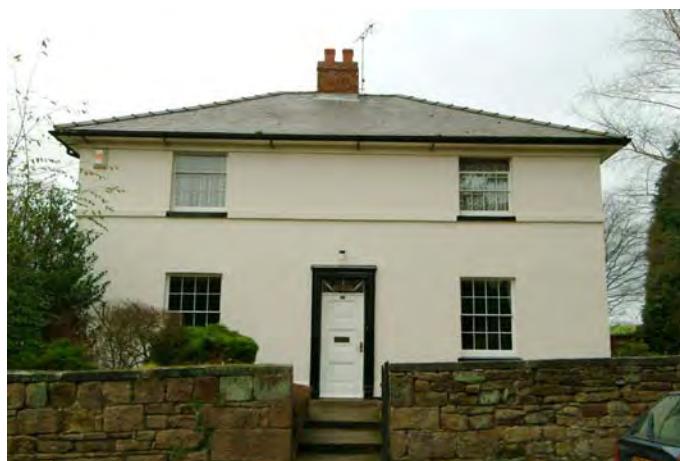
*The Firs, High Street:  
Hipped slate roof and broad overhanging eaves*

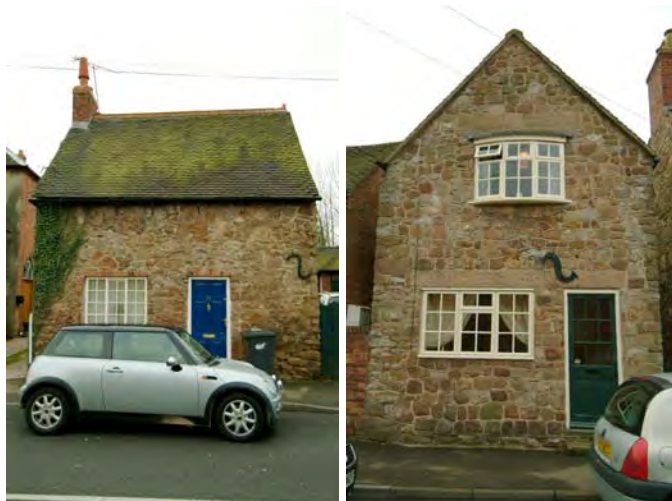
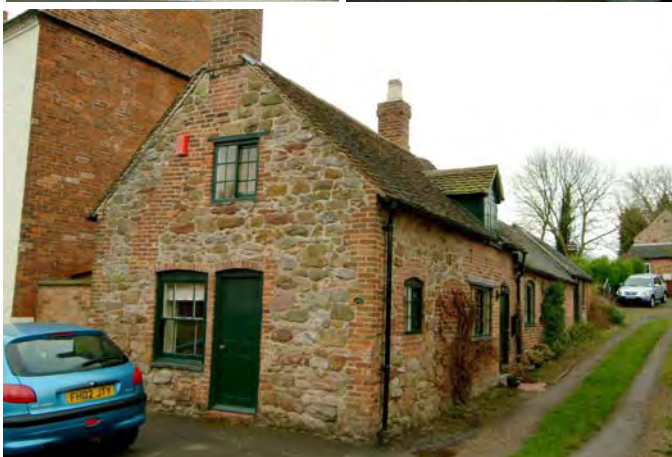
*Narrow frontages of 34a, 42 (top) and 48 Main Street*

Amongst the standing buildings on the south side of the street are clues to the medieval form of the village. Stone-built, narrow frontages are occasionally seen. These and the brick cottages are interwoven with narrow access paths and more substantial cart tracks serving outbuildings and other

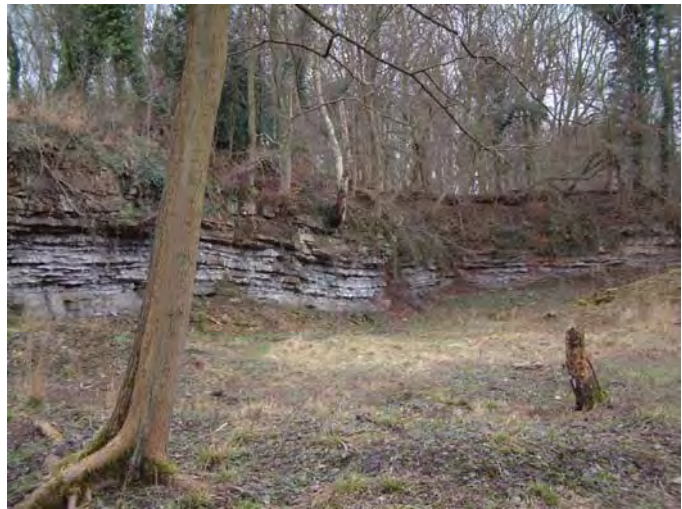
*The historic Limeyards*

The Limeyards are an unusual survival of an early type of quarrying. Documentary evidence suggests that the limestone was being worked in the 15<sup>th</sup> century. The area of the quarry workings is quite vast, and compares with many quarries that are being worked today using modern methods of extraction. However, there is no sense of this scale once inside the tranquil Limeyards. This is partly because of the amount of unchecked tree growth and partly because the area was split into individual small quarries during a private enclosure in 1765, which were eventually amalgamated into one ownership (that of the Harpur-Crewe family) by the mid 19<sup>th</sup> century. Boundaries between quarries largely follow the pattern of this mid 18<sup>th</sup> century ownership. This in turn reflects the direction of the previous boundaries running north-south, probably related to the medieval open field system. The limestone outcrops separating these quarries survive, some with raised high-level cart tracks between them. The horizontal bedding planes of the limestone are clearly evident in the quarry faces.

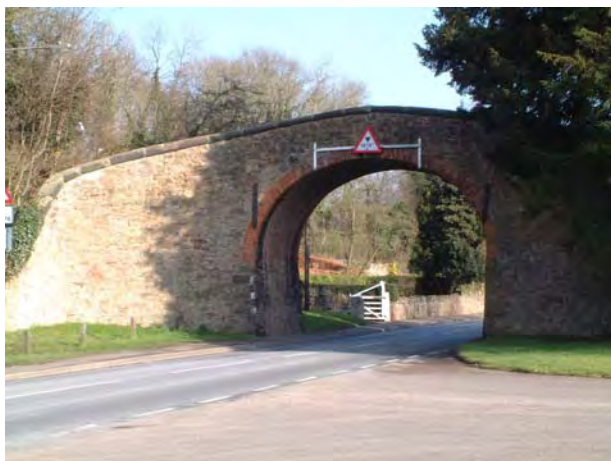
*The Ticknall Arch*

The Tramway Arch is a focal point in views looking both east and west along Main Street, dense tree cover on either side enhancing pin-hole views through the arch. Looking eastwards through the Arch, only greenery and roadside walls are seen; the houses are invisible.

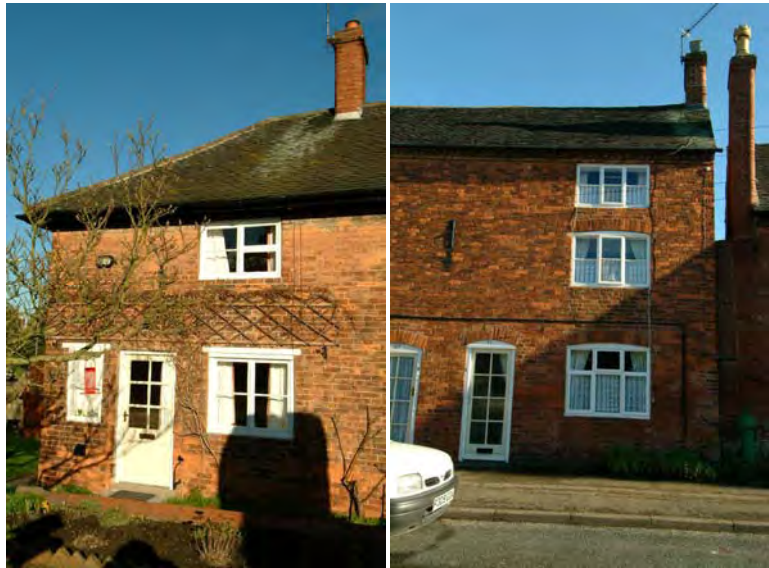
*Modern glazed doors*

There are relatively few historic doors surviving. Of those that survive, a large proportion are 6-panel doors with a simple “bead and butt” moulding. One particular door distinctive within Ticknall is the Gothic-headed door, where the heads of the inset panels are finished with pointed arches. This is an estate design found also at Calke Abbey. There are only a few examples left in the village. Many traditional doors have been replaced with modern glazed doors.

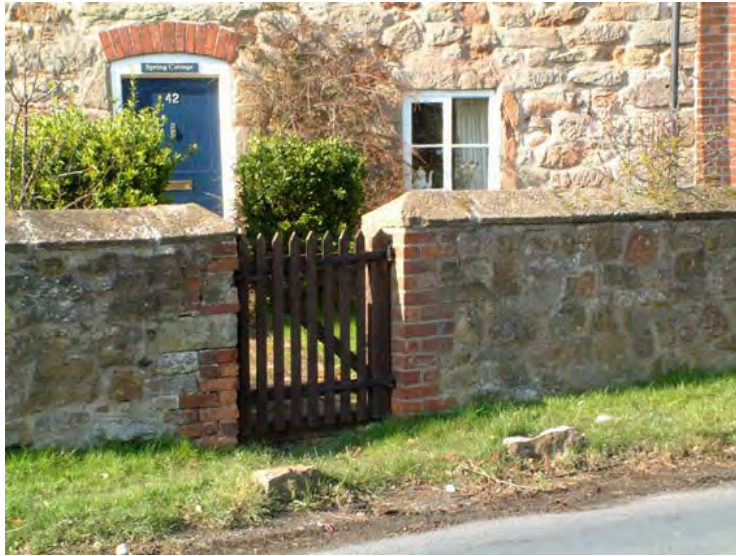
Random rubble was commonly used for the construction of the local walls, finished with triangular ashlar copings.

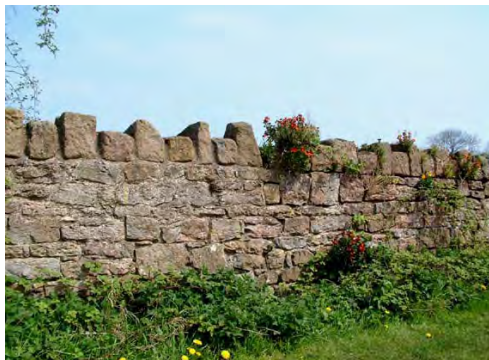
Above - rubblestone boundaries edging the fields are roughly mortared and often finished with "cock and hen" copings.

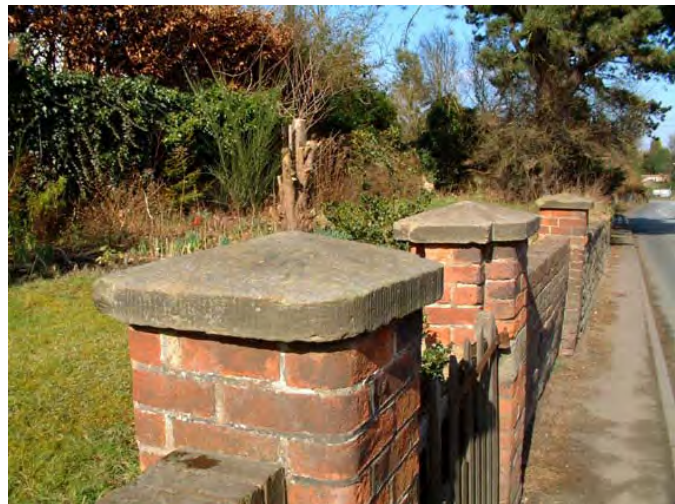
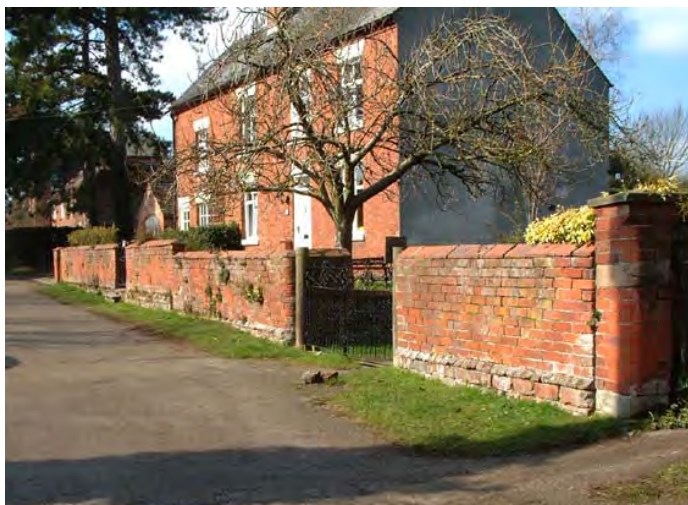
Above left - brick boundary wall of the C19 with triangular red clay coping. Above right - tall walls of rubblestone heightened in brick to serve the former kitchen garden at the old Vicarage.

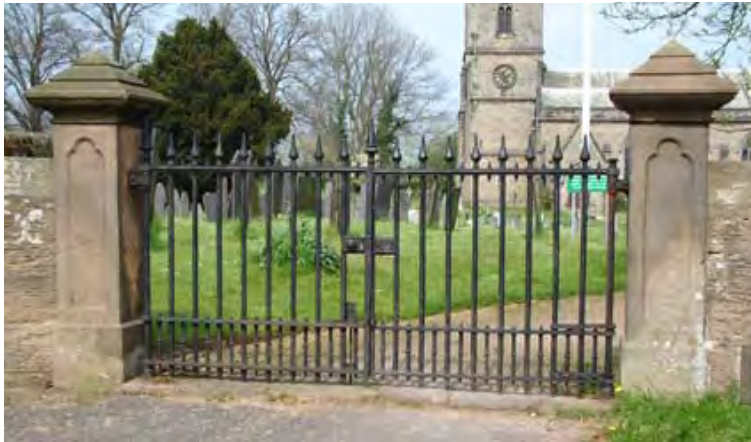
Left - heavy cast iron gates serve the churchyard.

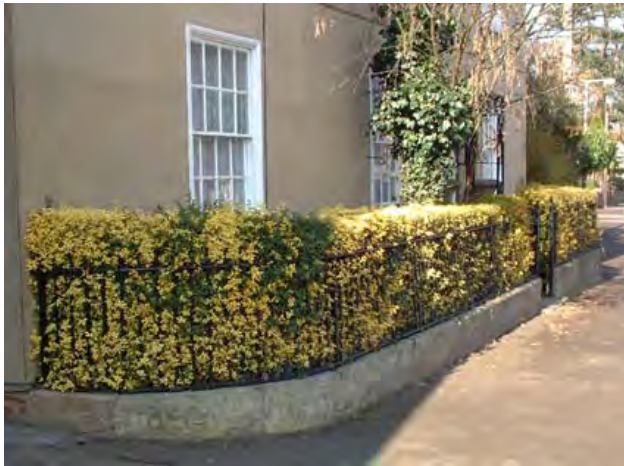
Above and right - iron round bar railings with cast iron urn finials partially concealed by a privet hedge at Pennwyche, 32 High Street.

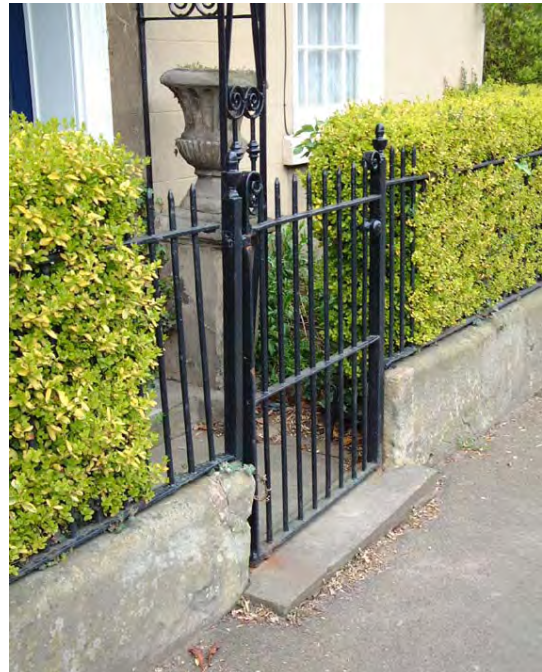
Below - cast iron round balusters with cast-iron fleur-de-lys finials and cast horizontal rails at 35 Chapel Street.

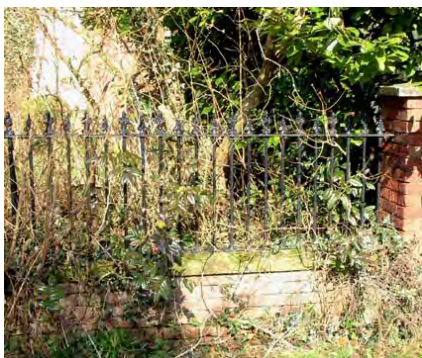
Right - in some instances wrought iron railings were combined with cast iron finials, which could be ordered by the local blacksmith from a catalogue. Here fleur-de-lys finials are combined

with square section wrought iron railings set straight into a stone plinth.

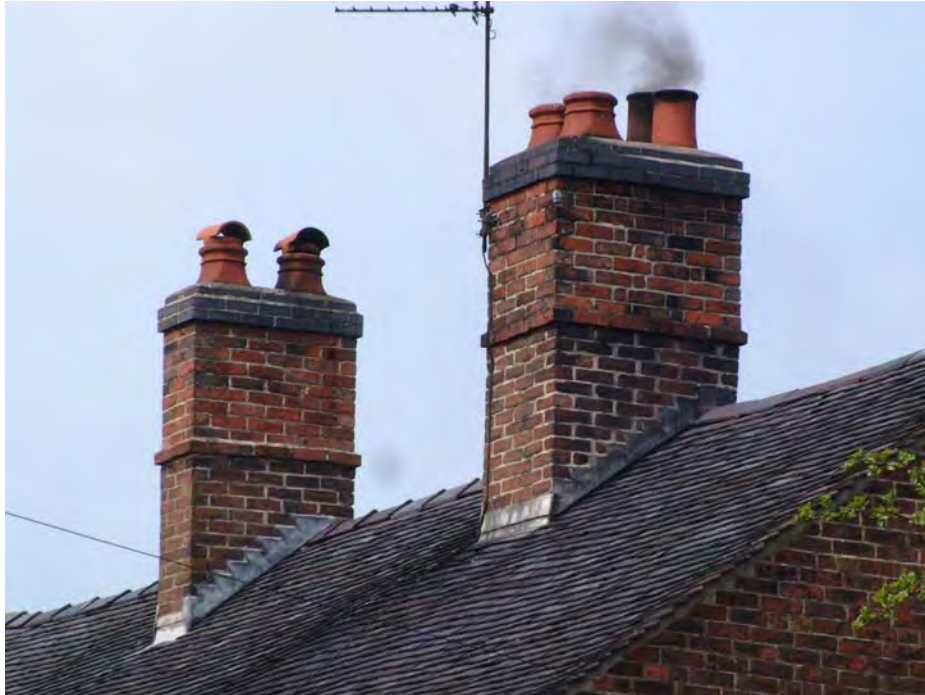
Common patterns of chimney stacks and pots were made feasible by the extensive estate ownership at the end of the 19th century. Blue brick oversailing courses (above) and rounded and moulded bricks (right) are particularly characteristic of Ticknall.

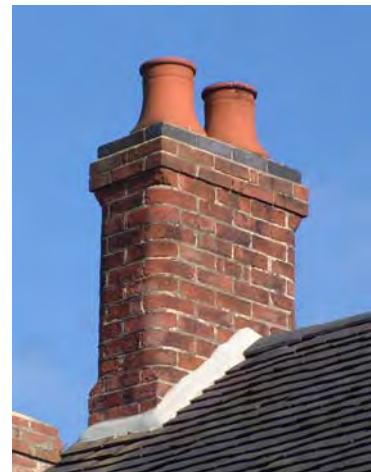
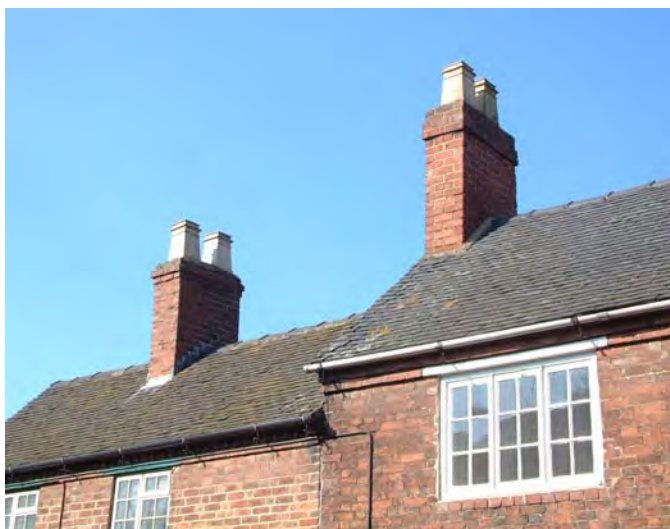
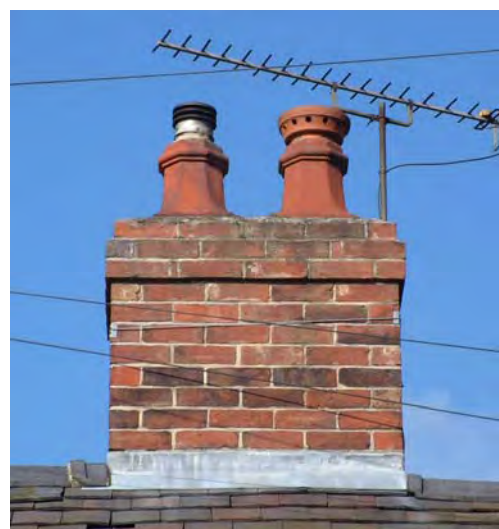
Chimney pots are mainly a 19th century phenomenon. Local manufacturers provided an array of styles from which to choose, such as the square buff pots (below) and chamfered red pots (bottom right).

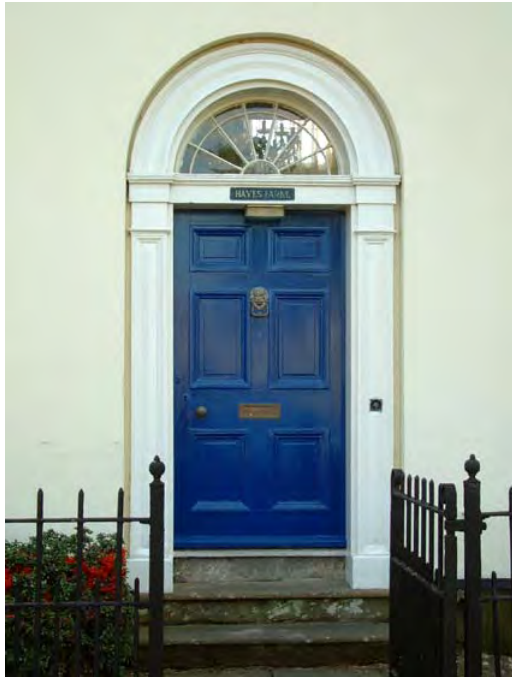
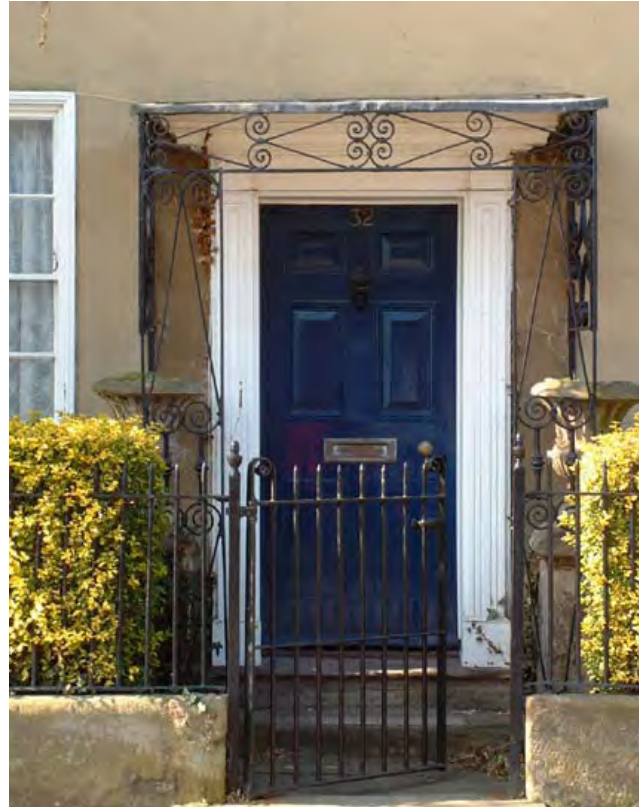
Above - Georgian panelled doors and traditional doorcases, pilasters and cornice. Hayes Farmhouse (above left) has a Regency style doorcase with a semi-circular “sunburst” fanlight, six-panel door with “raised and fielded” and “bolection” mouldings, very rich details. 32 High Street (Pennwyh) - (above right) - has similar features with plainer “scratch” mouldings for the bottom door panels.

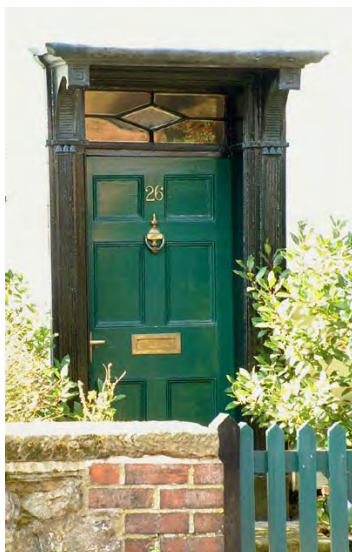
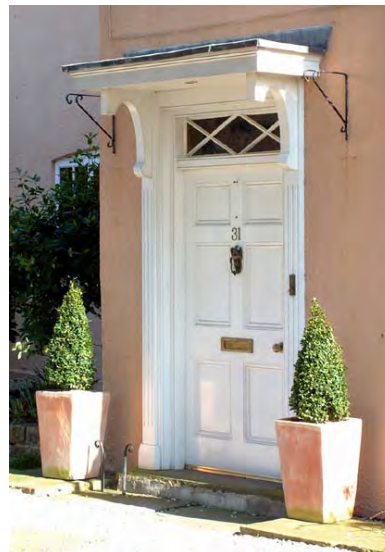
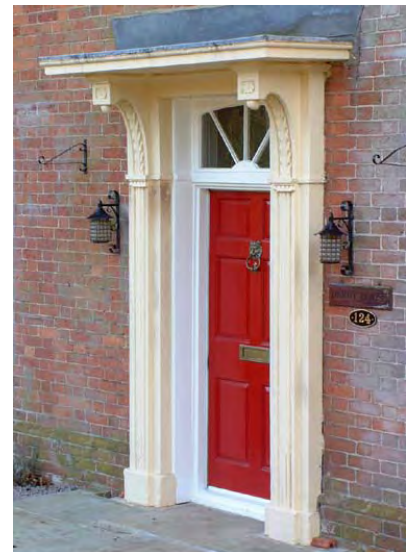
Several doorcases conform to a regular pattern (below). The cornice is extended so that it forms a canopy which is supported by attenuated, curved brackets. This elegant detail can be seen below in combination with fanlights. From the left - (1) doorcase of circa 1820 with reeded pilasters, Greek key and guttae and fanlight with central diamond, (2) lattice fanlight and simplified doorcase, (3) the same formula within a stone surround with carved acanthus leaf moulding.

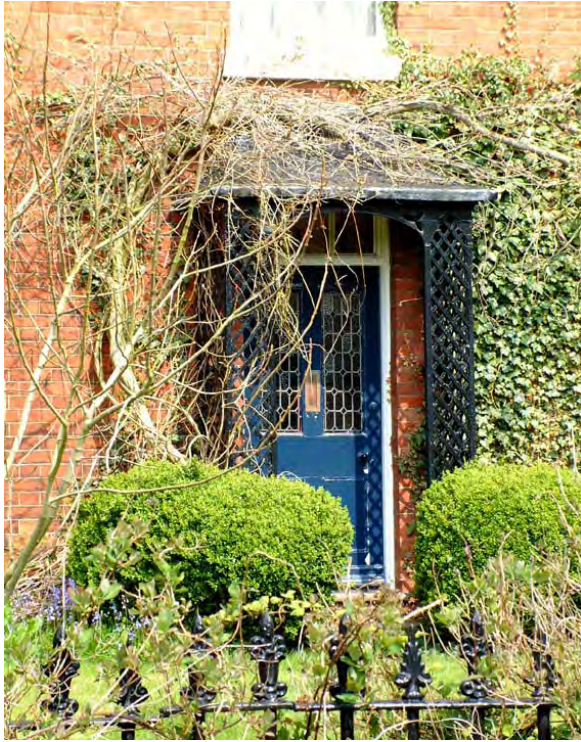
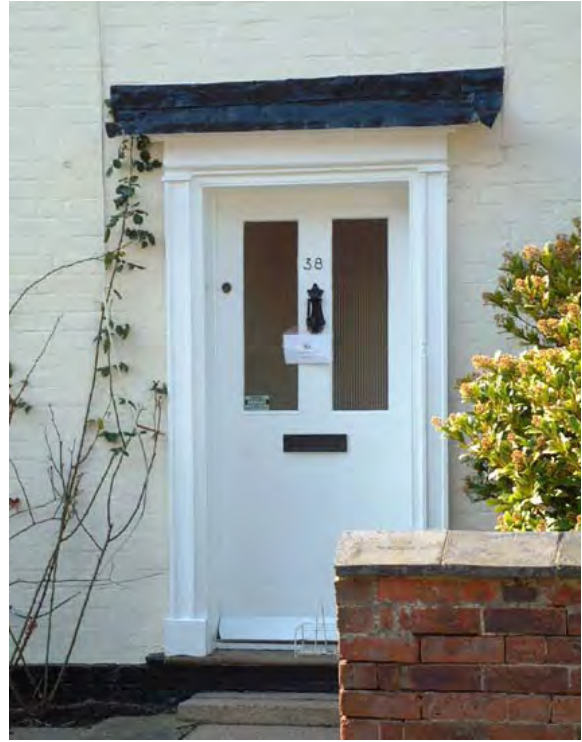
Above left - porch; a simple ornamental timber trellis with lead canopy at 35 Chapel Street.  
Above right - four-panel door at 38 High Street, incorporating simple “scratch” mouldings and simple doorcase with cornice.

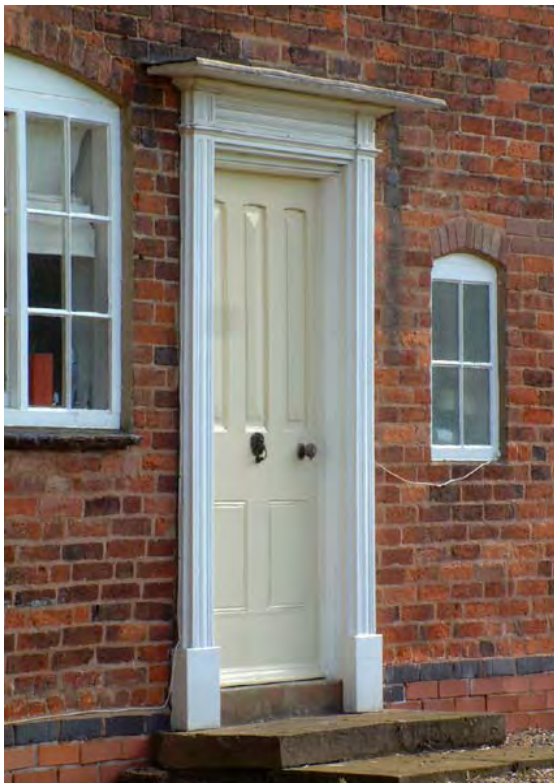
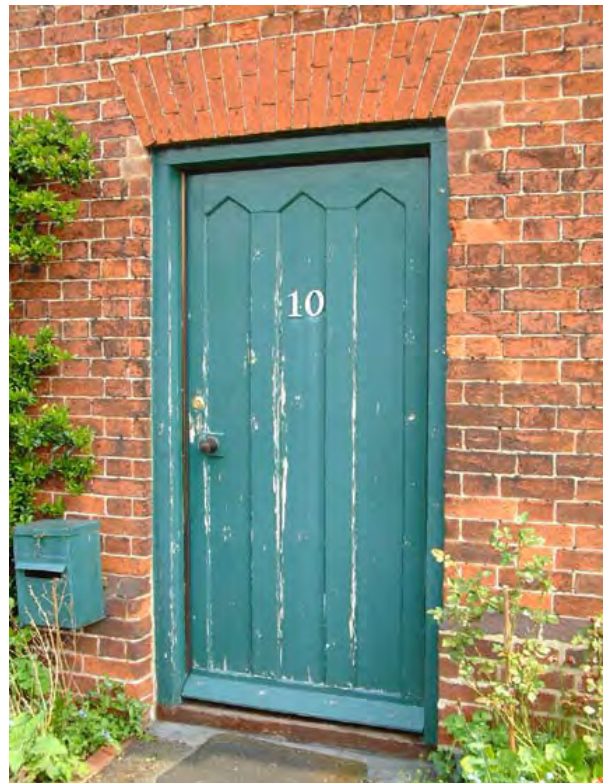
Below left - five-panel Victorian door, the bottom two pales have “scratch” mouldings, whilst the upper panels have “chamfer-stop” mouldings and “raised and fielded” panels. Slender pilastered timber doorcase with mouldings. Below right - gothic style boarded door at 10 Church Lane, with pointed arched top rail, one of only a handful surviving that were adopted by the estate.

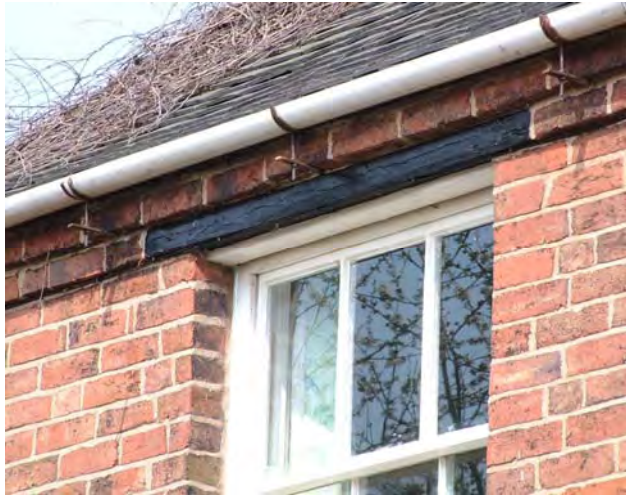
Timber lintels were often used for the first floor window under the eaves (left and below), where there was insufficient depth for a stone lintel.

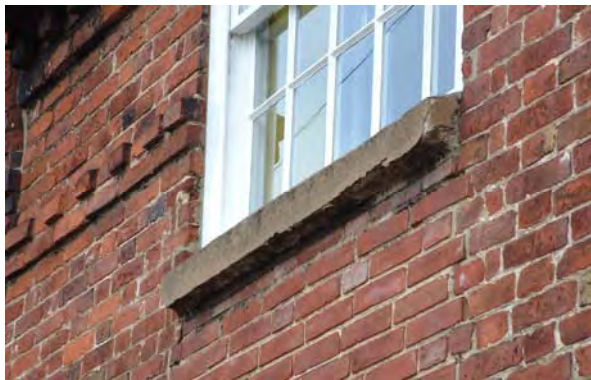
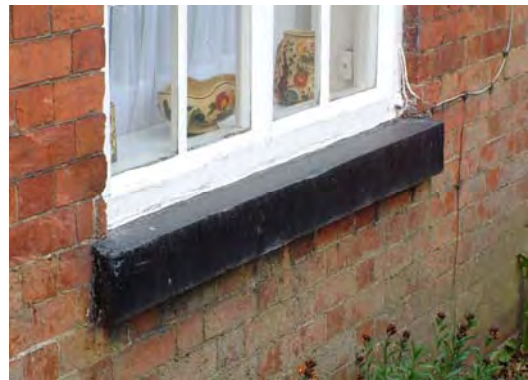
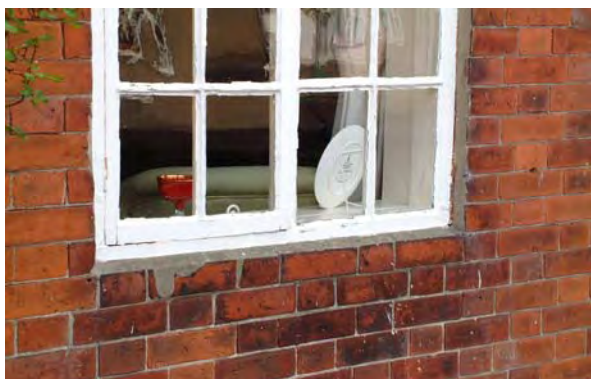
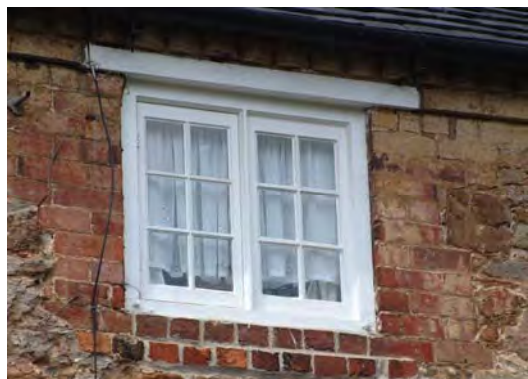
Most of the larger properties have stone cills (below), whilst the smaller cottages were originally built without proper cills (bottom).

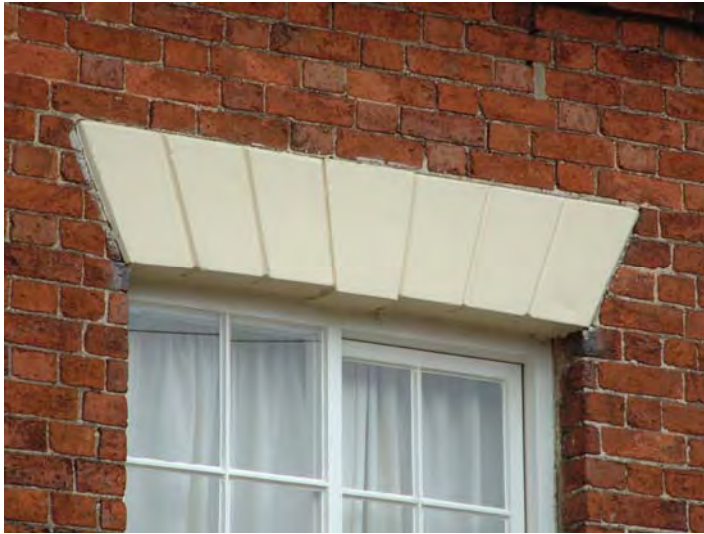
Wedge lintels are a common form throughout Ticknall. Most are now painted. Many were incised to look like individual blocks of stone ashlar.

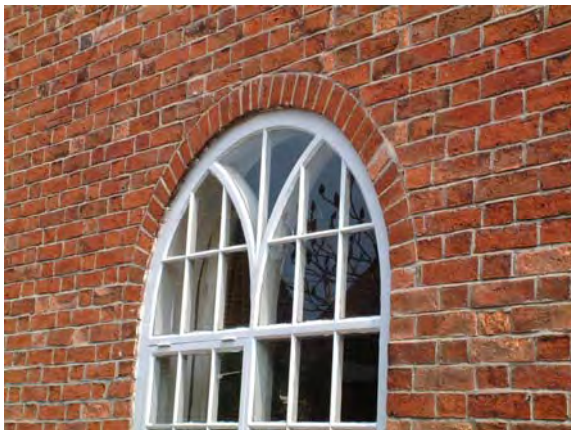
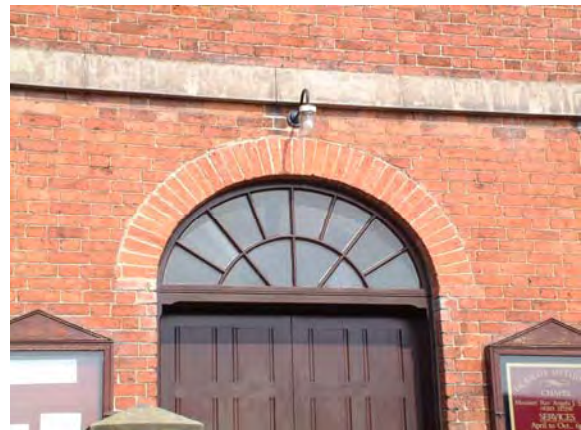
The semi-circular arch lintel was reserved for the chapels (below).

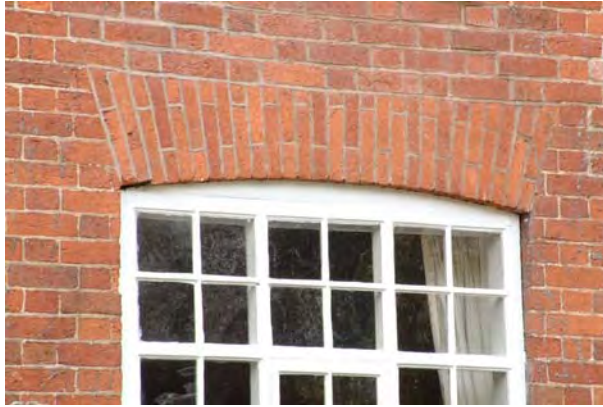
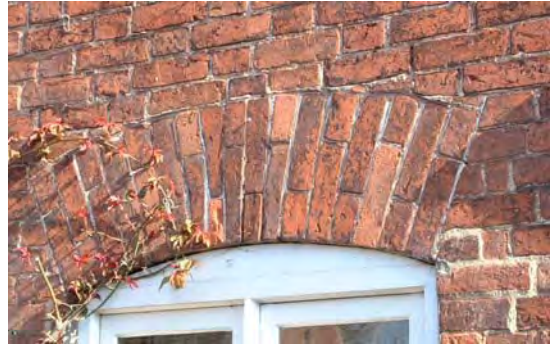
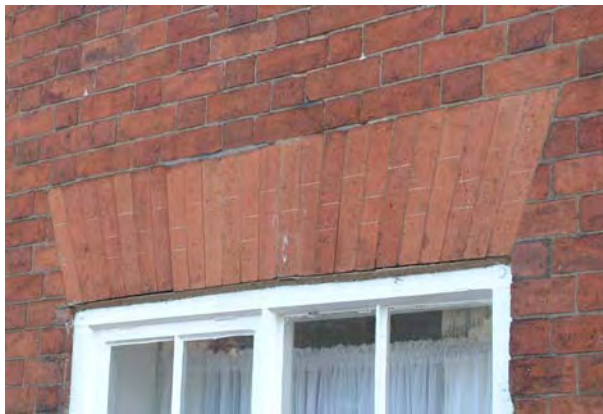
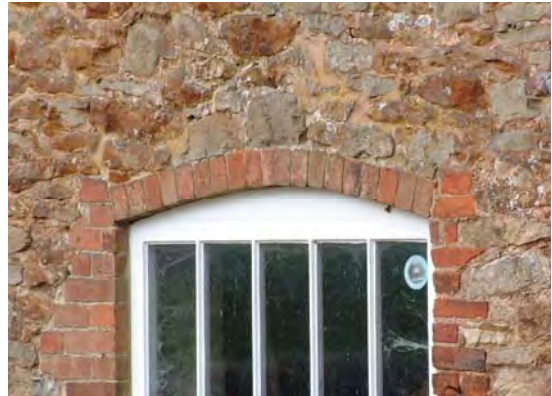
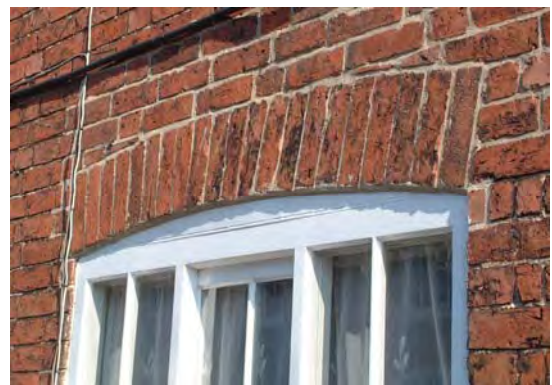
In Ticknall, brick lintels incorporate the full range of techniques available to the bricklayer, from the most complex and expensive to fabricate - the cambered arch (top) and the gauged arch (above) - to the cheapest type of construction - the segmental arch (right and below).

Segmental arches could be a single course of "headers", a full brick deep, or a brick-and-a-half deep. In some cases these were made from special hand-made rubbed bricks incorporating incised lines to simulate lime putty joints (below).

In some instances the distinctive segmental brick arches of the late 18<sup>th</sup> and early 19<sup>th</sup> century buildings have been replaced in recent years with flat soldier courses of brickwork hiding steel and concrete lintels. The vast majority of these are along Main Street; 11, 15, 18, 34, 36, 38, 141, 145, 179 and 181 Main Street.

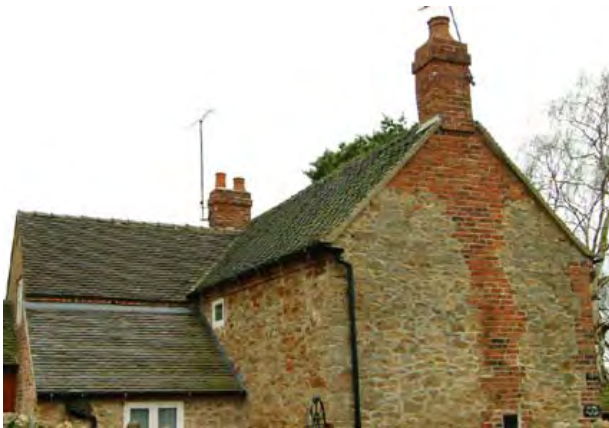
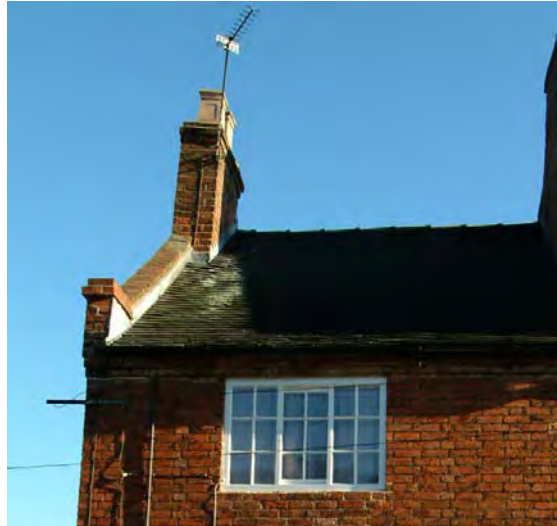
The majority of roofs are pitched with a simple plain close verge or corbelled verge (above left) but there are some more unusual roof types.

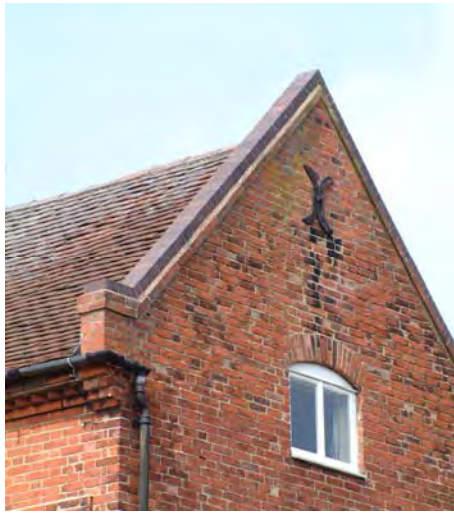
Raised coped gables in brick (above) and raised coped gable with a modern brick-on-edge coping (left).

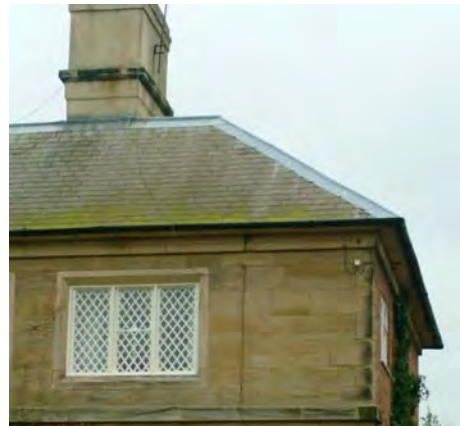
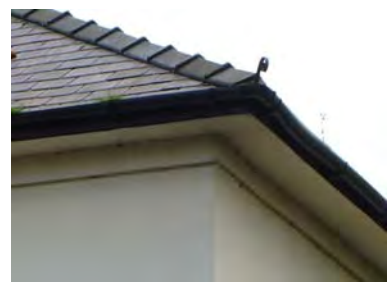
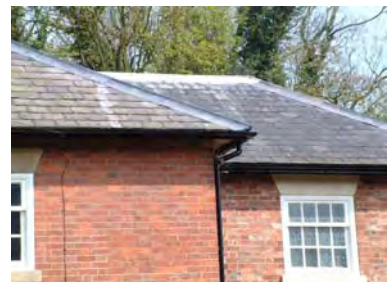
Below and right - hipped Welsh slate roofs with pronounced overhanging eaves, hips cloaked with blue clay tiles and a wrought iron scroll at the eaves (below) or lead flashings covering timber rolls (right and bottom right).

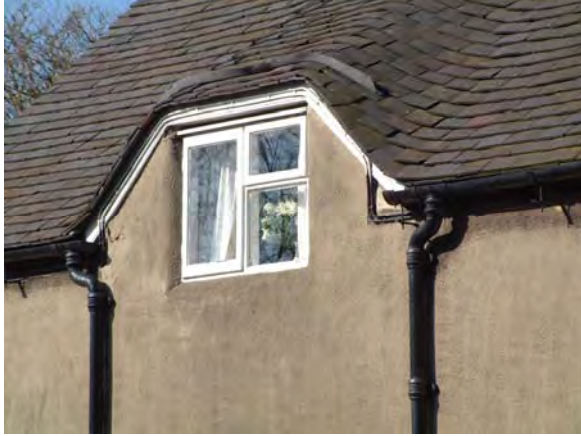
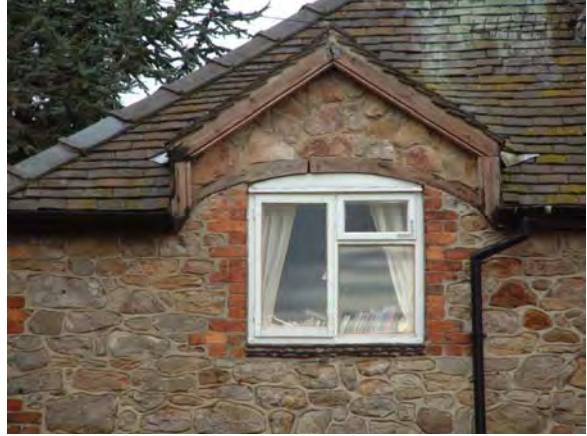
Eyebrow dormers may reflect the presence of a former thatched roof (above and below right) or a gablet may reflect a Victorian interpretation of this local tradition (below left).

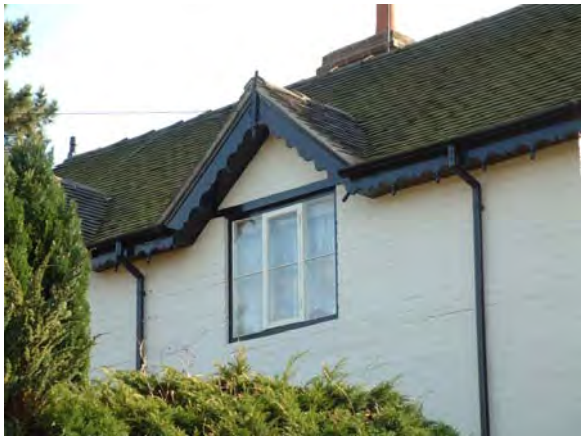
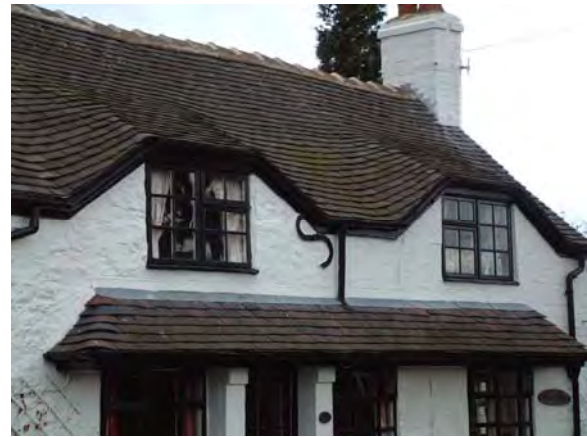
Occasionally, handmade, red clay tiles survive (right and below). They have a characteristic undulating form.

There are two early roofing materials, for which there is evidence in Ticknall. One of these, thatch, no longer exists. The other, handmade red clay plain tiles, is rare and has dwindled to a few examples. This is because they were relatively soft and the nib fixings were prone to break when damaged by frost. They were replaced throughout Derbyshire on a large scale by Staffordshire blue clay tiles from the “Pottery” towns, a more durable alternative that was available from the late 18<sup>th</sup> century. The old red tiles were often more uneven and rounded than new handmade plain clay tiles (available today) and the two materials do not

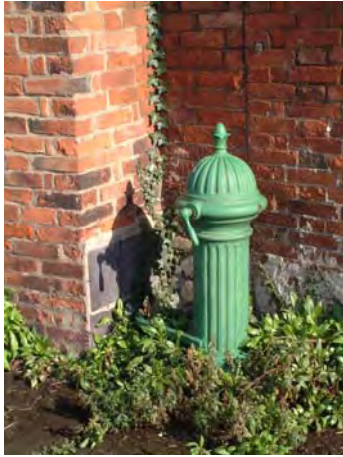
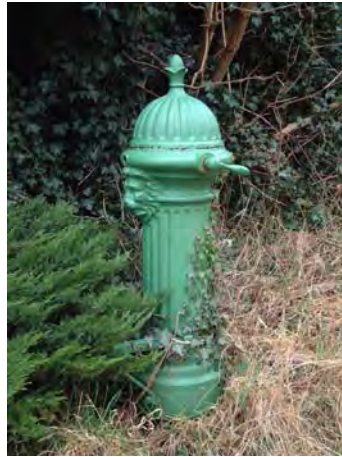
Left: Cast iron pillar fountains manufactured by Glenfield and Kennedy Ltd of Kilmarnock, erected 1914, incorporating lion mask to tap outlet. (2 of 15, all Grade II listed buildings).

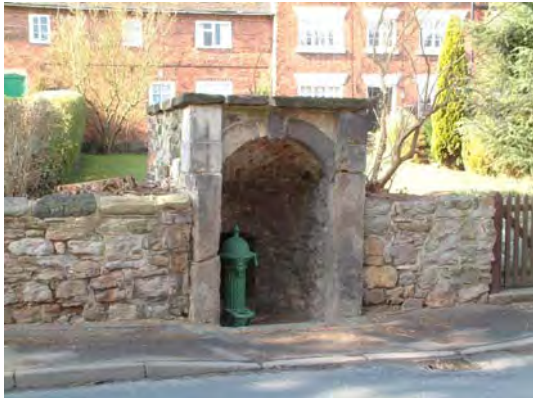
Left top: Alcove and remains of early 19th century well containing cast iron pillar fountain of 1914 (Grade II listed building).

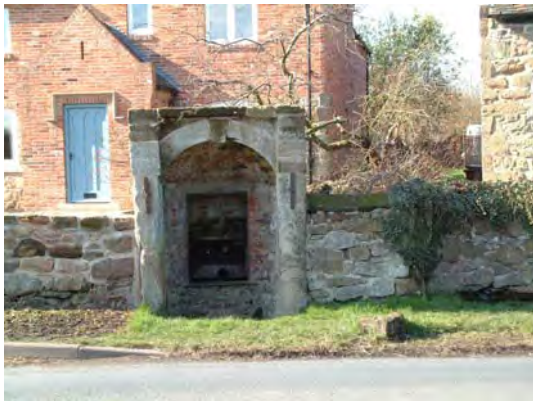
Left bottom: Spring house, incorporating water trough and early 19th century well (Grade II listed building).

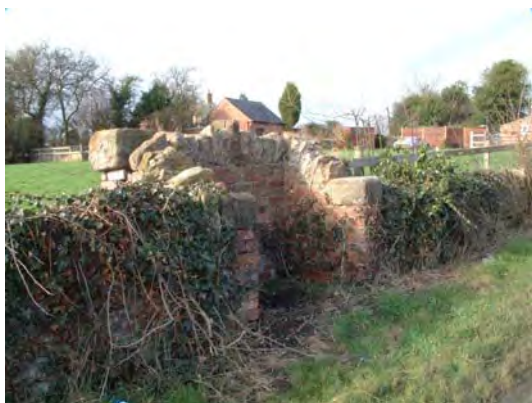
Below left: Remains of well, built in brick and contained within wall of paddock, probably designed to protect a cast iron tap (removed)  
Below right: Brick alcove containing spring-fed well, early-mid 19th century.

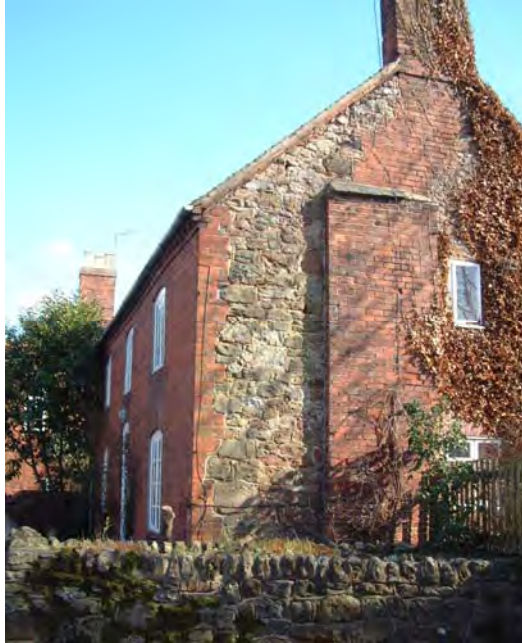
Above - the remains of a truss and timber frame exposed in the gable end of 53 High Street. The building was adapted and heightened in brick. This is the only visible remains of a timber-frame building in the village.

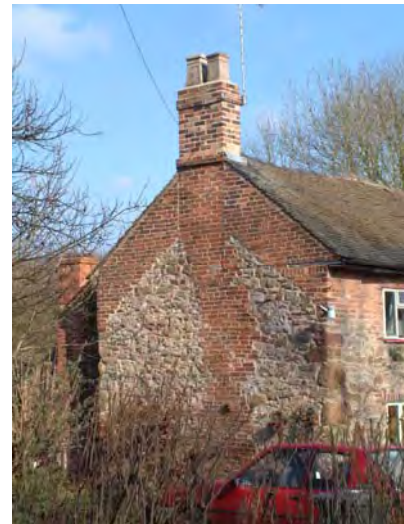
Above - purpose-built house (28 Main Street) with fine quality Flemish bond brickwork for front elevation and rubblestone for side and rear walls.

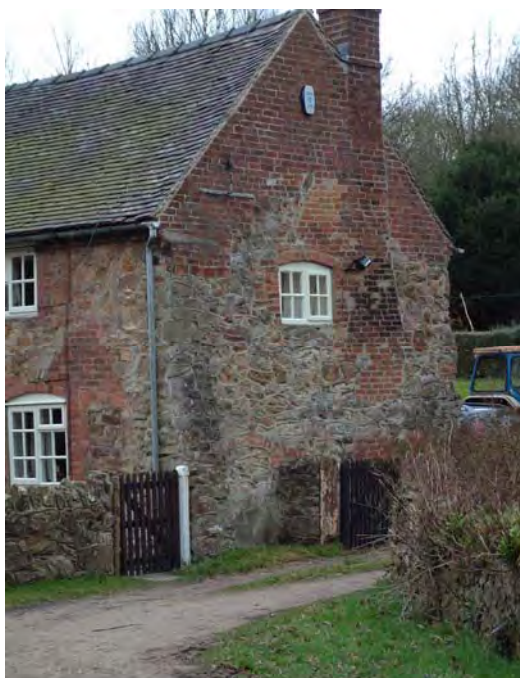
Left and above - examples of rubblestone used in combination with brick reveals and brick or timber lintels, common local details.

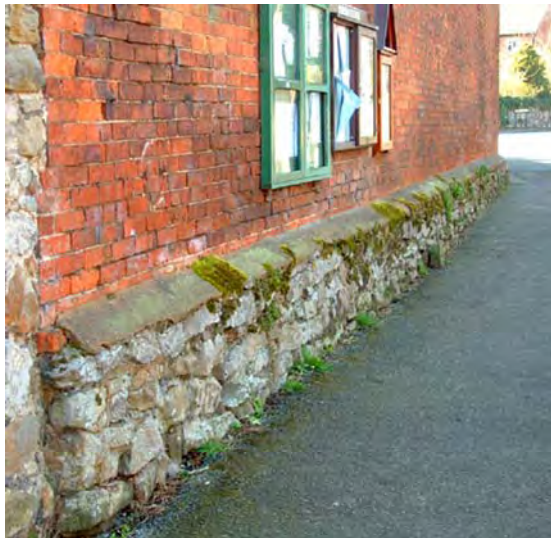
Right - rubblestone plinth, roughly coursed and dressed, with chamfered stone weathering and quoins at 40 Main Street

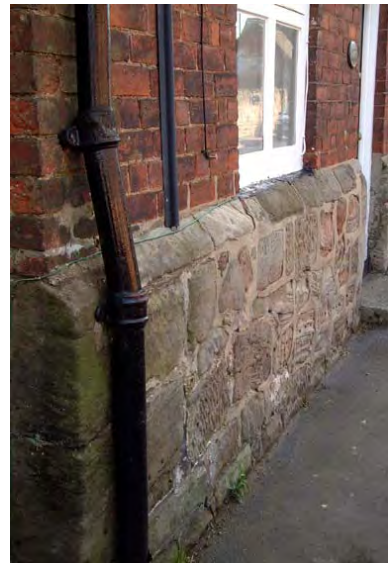
Above - barn with rubblestone plinth and mortared fillet providing a weathering.
