# Ticknall *Conservation Area* Character Statement

**2013**  
***CONSULTATION DRAFT***

**SOUTH DERBYSHIRE  
DISTRICT COUNCIL**

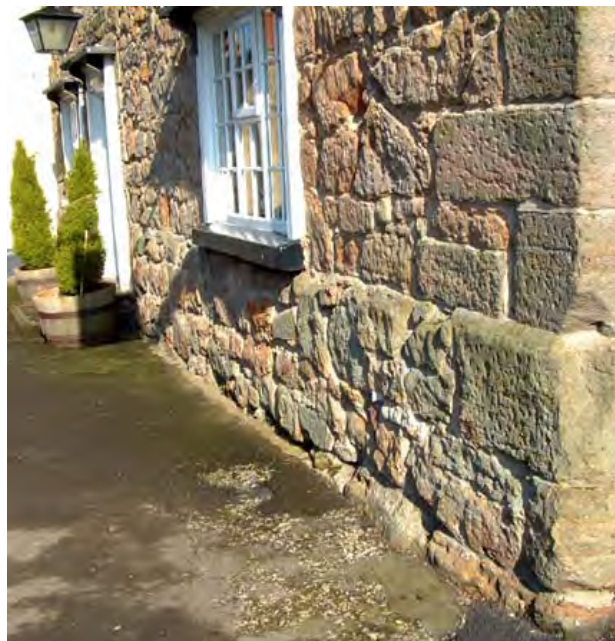
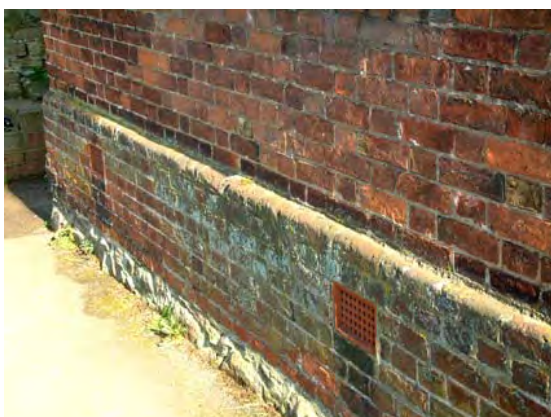
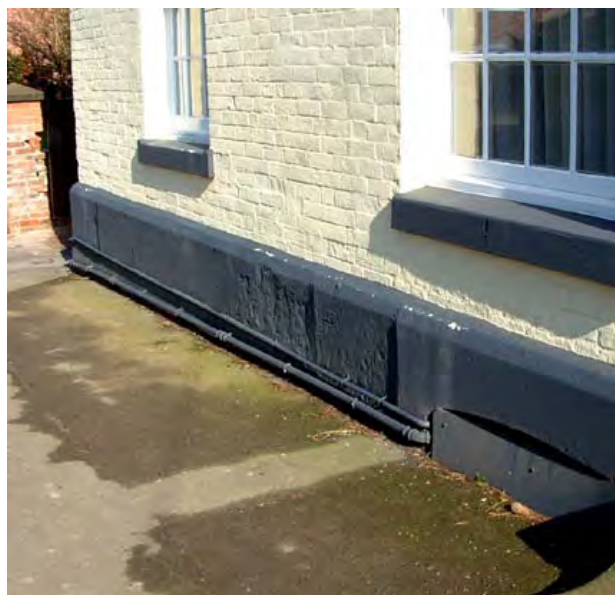
Below - brick plinth with handmade rounded bricks forming a softly finished weathering.

Bottom right - brickwork with fine dressed ashlar plinth (Sheffield House, 25 High Street).

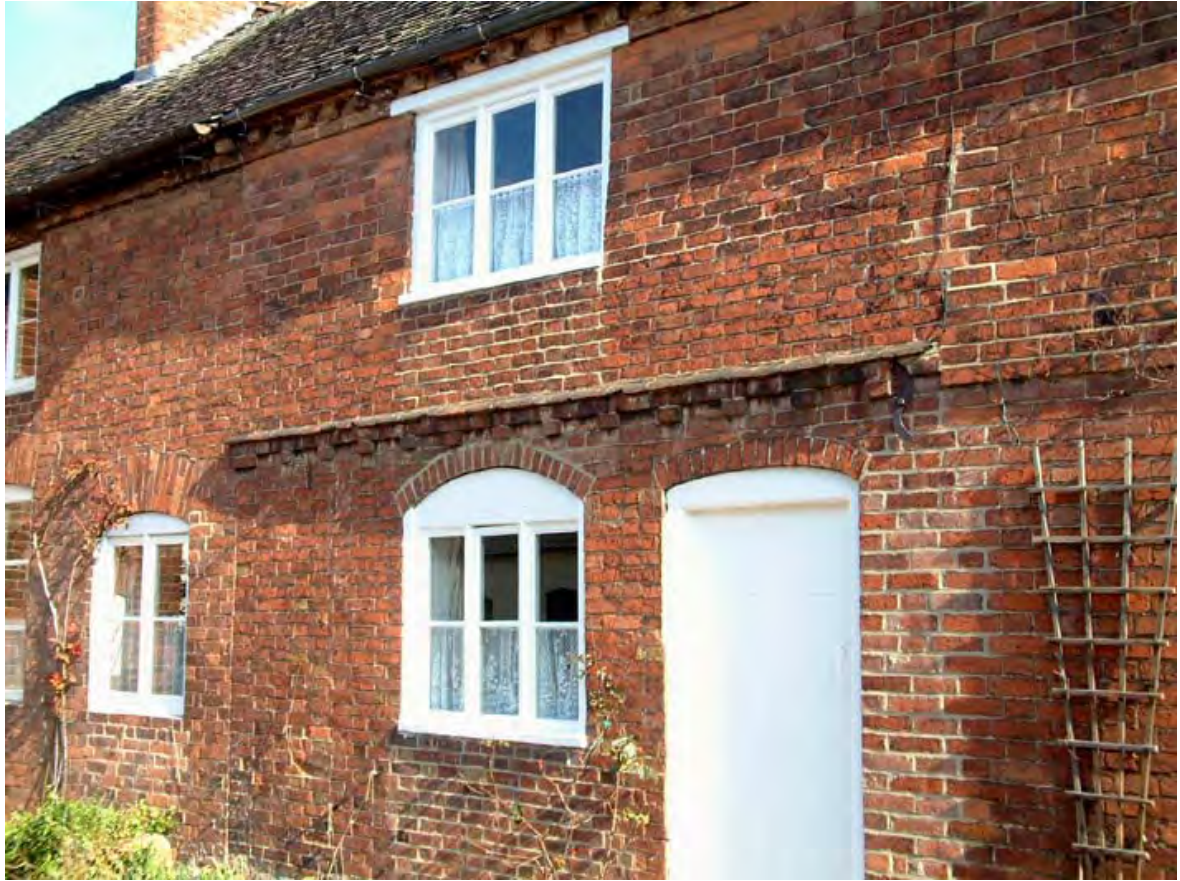
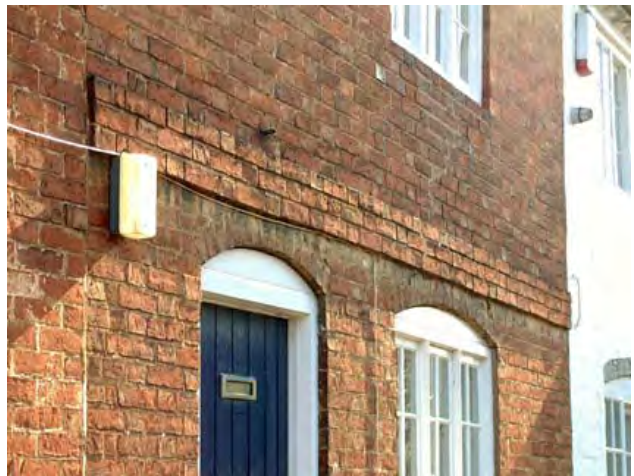
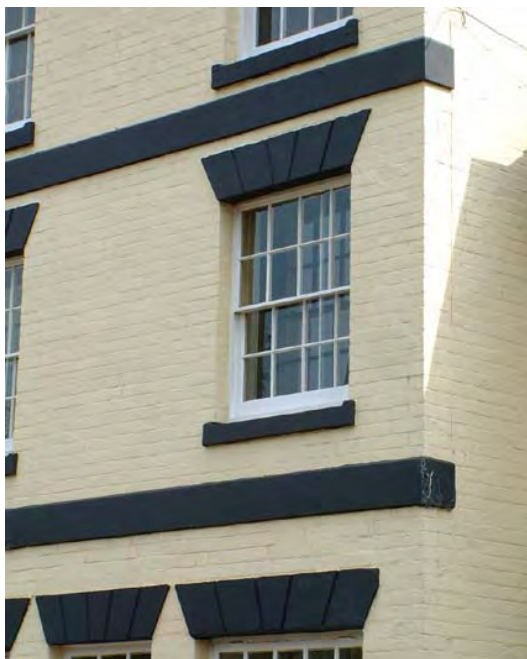
**Brick and stone bands**

Above - dentilled brick band  
Right - plain brick band of three courses

Below - painted stone bands of ashlar  
Bottom right - stone band of ashlar

A detail that is commonly found in Ticknall is the use of a raised brick band on the gable end of brick houses. This follows the verge, to provide a drip moulding, and continues level with the base of the chimney stack. This detail is most frequently found along Main Street.

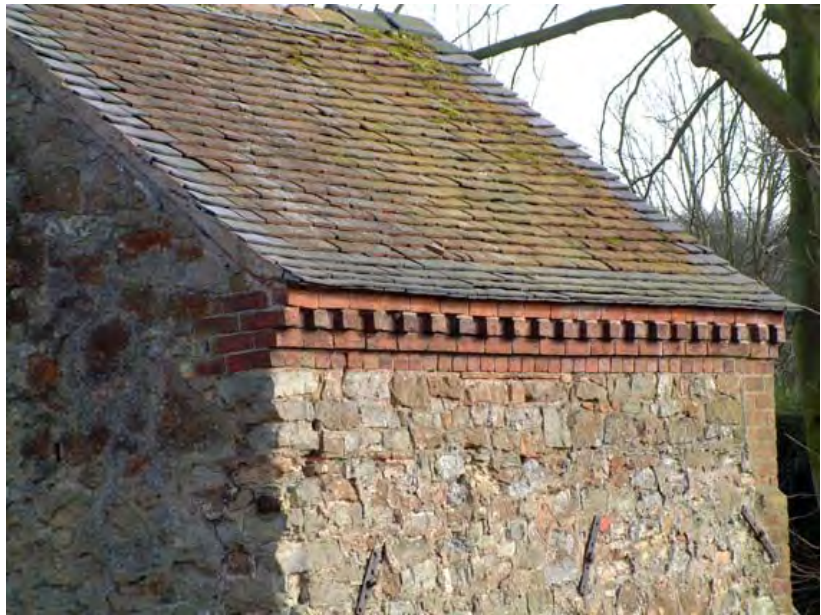
Below right - dentilled brick eaves

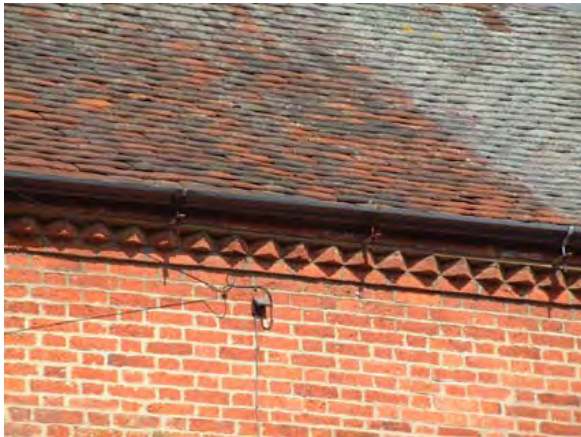
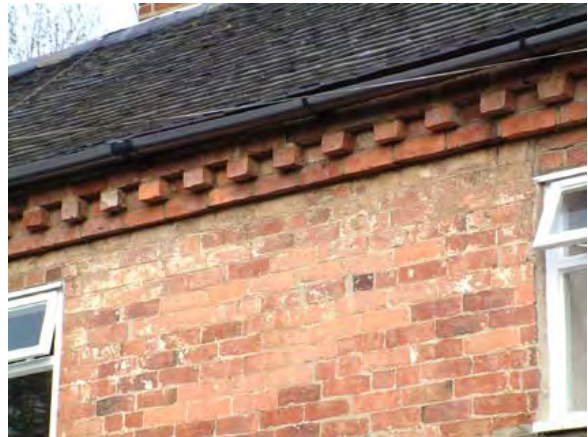
**Brick eaves details**

Below left - "sawtooth" brick eaves

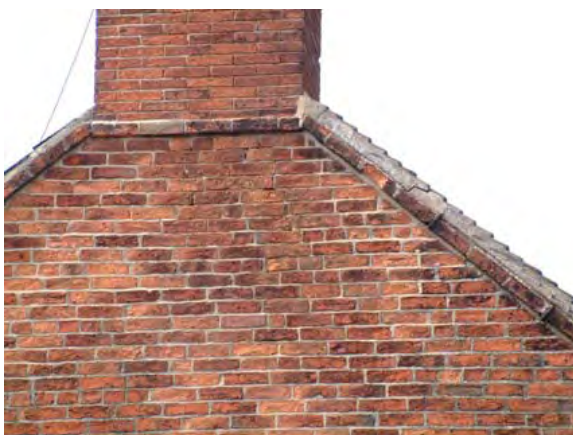
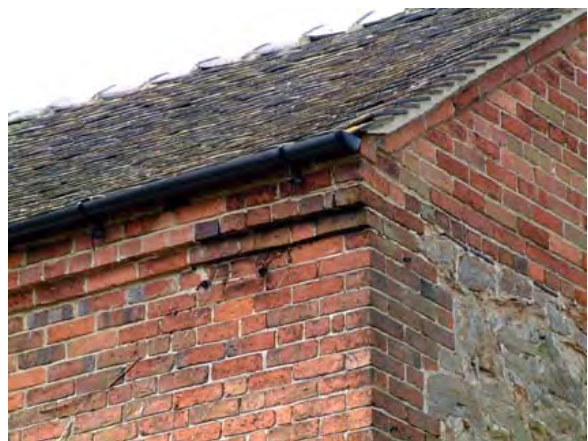
Right - plain corbelled brick eaves

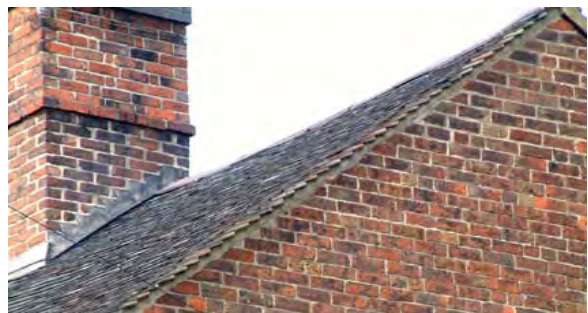
**Brick verge details**

Above - corbelled brick verge

Right - plain close verge

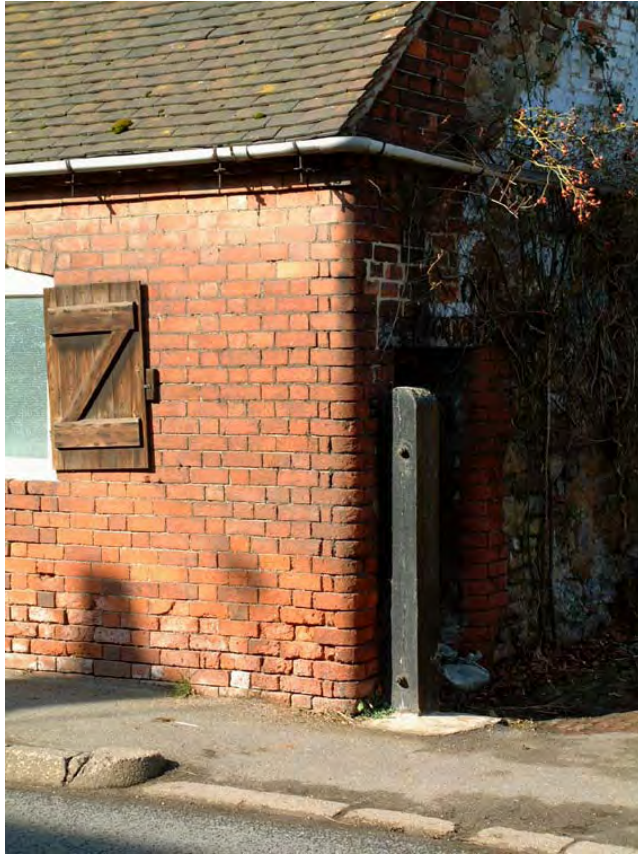
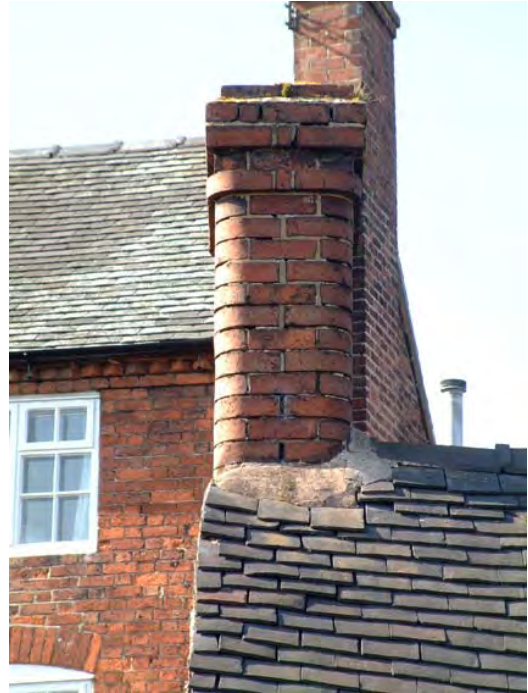
Above and left - a number of buildings and features, such as chimney stacks, were built by the estate with rounded, moulded bricks. These were handmade in special moulds.

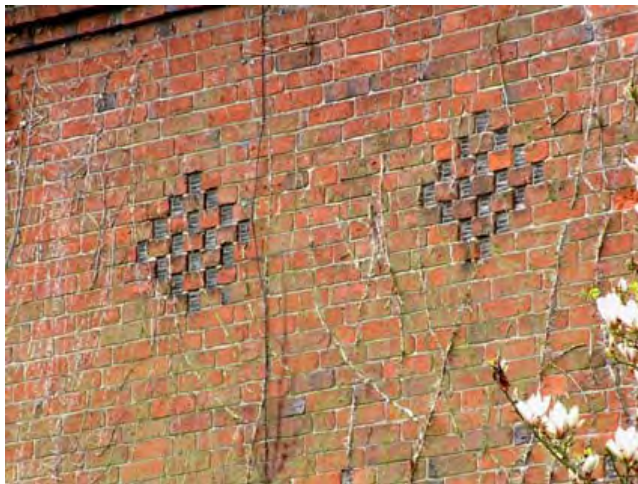
Above - barns often incorporate “breathers” - gaps in the walls to provide cross ventilation. These are often treated decoratively, such as the diaper pattern above. Most examples have been blocked up (as above) with a contrasting material.

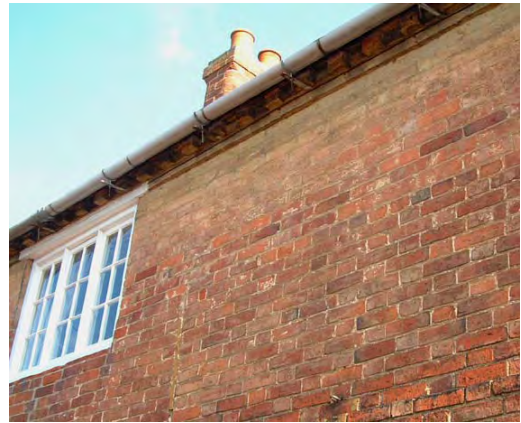
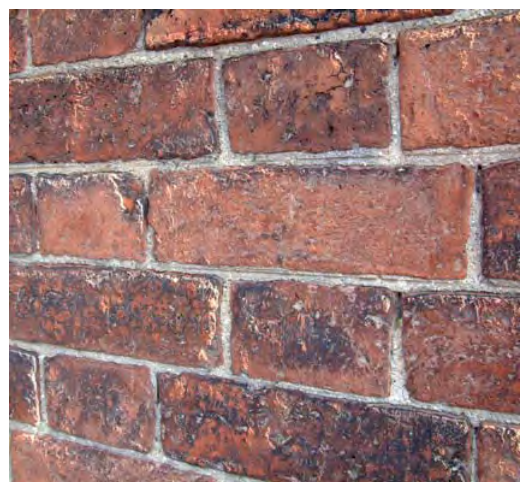
Above right - the remains of ochre-coloured limewash can often be found near the eaves.

Right - “penny-struck pointing”. The fresh lime mortar joints are incised with a penny, rolled in the surface to create a crisp appearance.

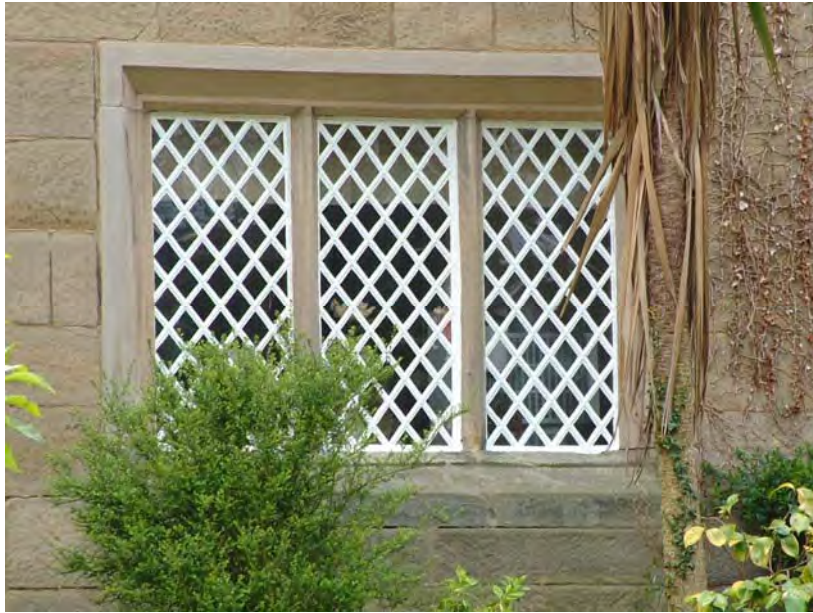
**Casement windows** - within Ticknall there are many varieties of traditional side-hinged casement, including some unusual examples, such as the lattice cast-iron casement (above).

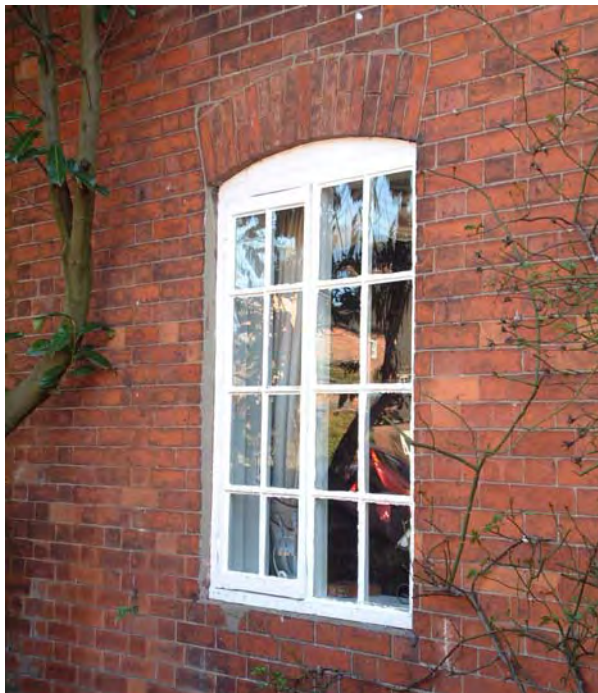
Below - eight-by-eight paned casement window. The fixed light is direct-glazed. Note the quality of the reflections from the original cylinder glass.

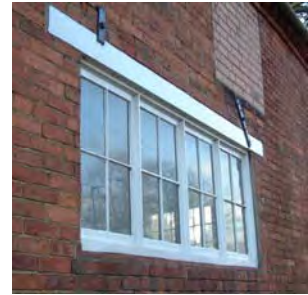
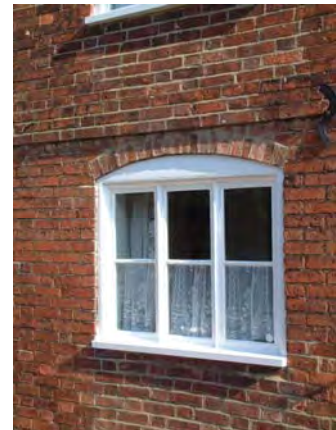
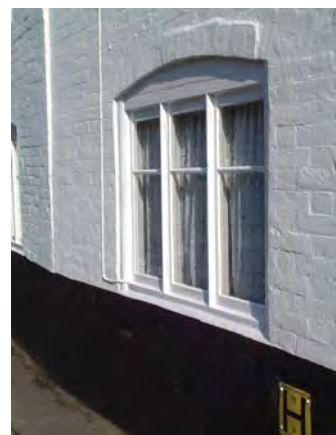
Chamfered frames in timber, with recessed opening lights, are a particular feature (right). Note that many of these examples have no projecting cill, of any kind.

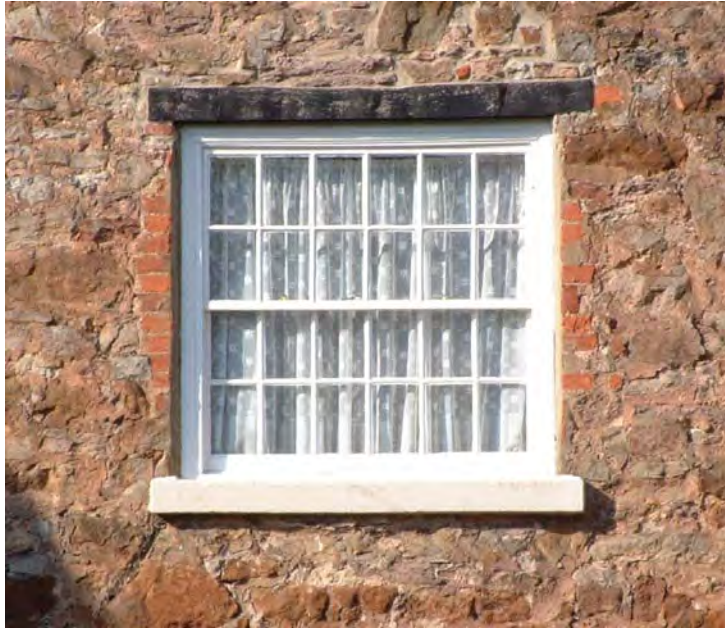
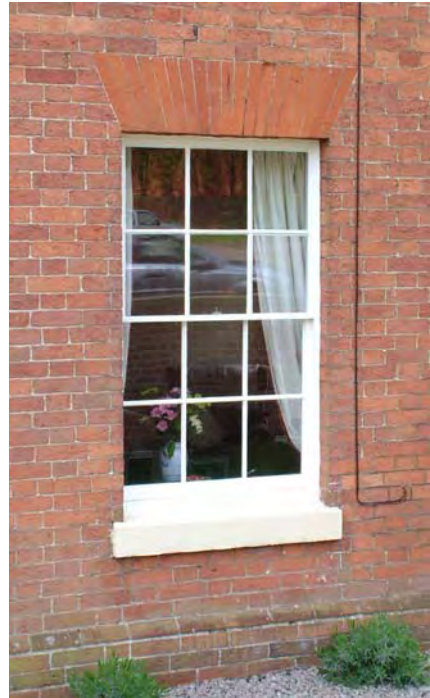
## Sash windows

Vertically sliding sashes (above) - 12 over 12 pane sashes with exposed sash boxes. Top right - six-over-six sashes without horns. As glass production evolved, the size of panels of glass increased, and the small-paned sash windows of Georgian England gave way to larger panes of glass, separated by single vertical glazing bars. Many of these had "horns" added to increase the strength and rigidity of the sash frame (below left).

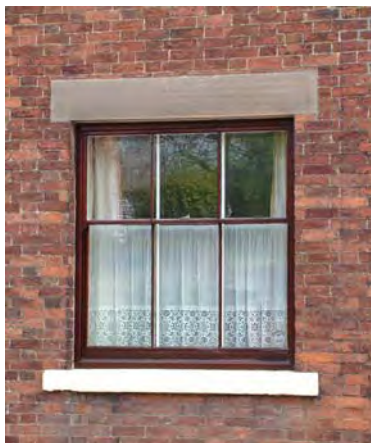
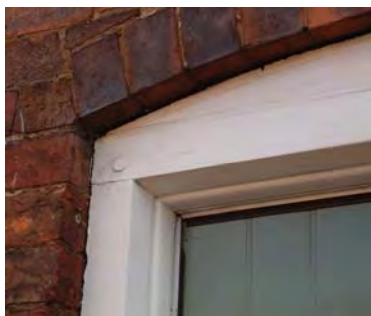
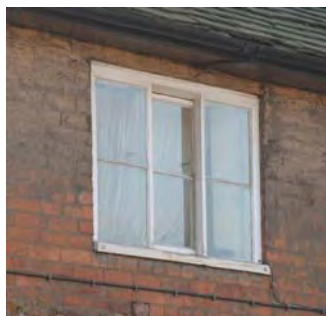
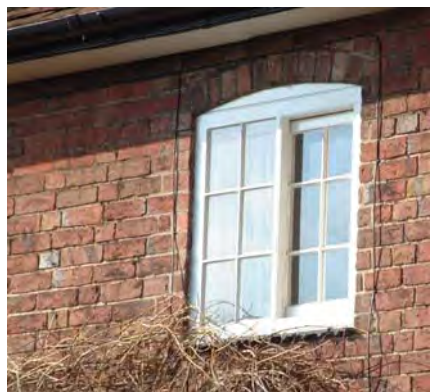
Horizontal sashes (right and bottom row) also known as "Yorkshire sashes". Unlike the vertical sashes, very few of the smaller Yorkshire sashes had a proper cill, and they had a pegged frame construction (bottom left).
