# Walton on Trent *Conservation Area* Character Statement

**2014**

**SOUTH DERBYSHIRE  
DISTRICT COUNCIL**

## Introduction

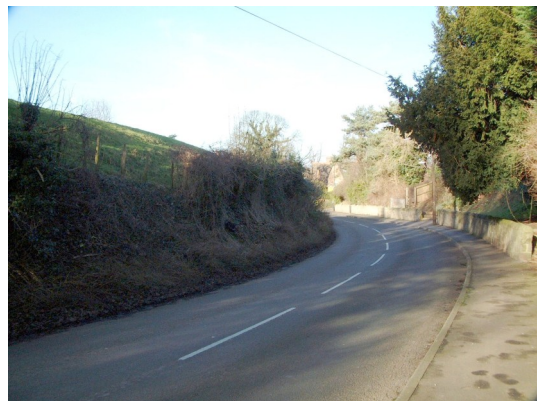
*Coton Road within deep cutting*

Coton Road may have formed the main thoroughfare from the high ground down to the ford crossing on the River Trent. The sunken character of Coton Road suggests an early route or holloway, cutting across Rosliston Road and dropping from the higher ground to the river at a junction or crossroads opposite the church. It is possible that this was heavily used in association with the main cart access to the local windmill,

The current depth of Coton Road may be the result of more recent excavation to make a smooth transition down to the junction, which has left a mound in the field to the west of the road. The road may also have been originally wider than at present, particularly at the junction with Main Street. With encroachment, houses have reduced the width of the road where it meets Main Street. The large, raised, embanked earthwork within the field to the west of Coton Road follows the route of this deep cutting. It is interesting, as it appears to contain an exaggerated, man-made mound, rather than be part of the natural contours. Was this an enhanced mound, designed to provide a vantage point or does it represent another earlier archaeological feature?

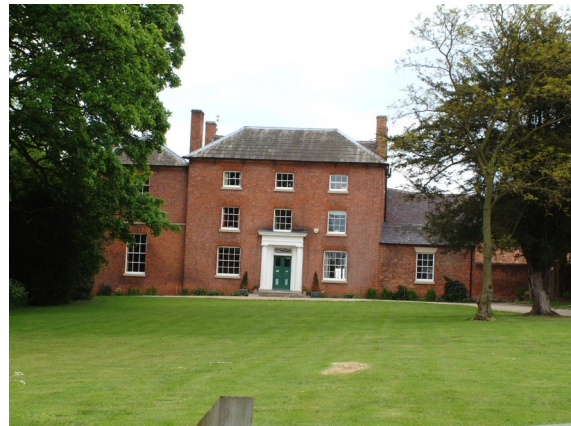
*The handsome frontage of Barr Hall Farm*

There was a burst of agricultural growth in the mid 18<sup>th</sup> century evident in the creation of some large independent farms – e.g. Barr Hall Farm - that may have followed private enclosure agreements.

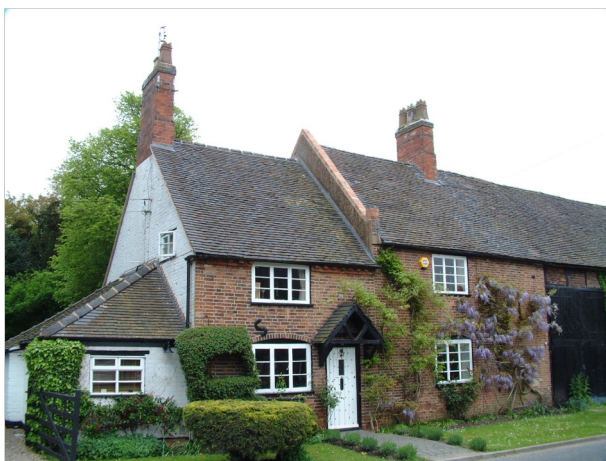
*Barn Farm Cottage*

Barn Farm Cottage had been turned into a separate small house by 1841. It was created out of the pre-existing barn, to which was added a small extension, an unusual arrangement at this time.

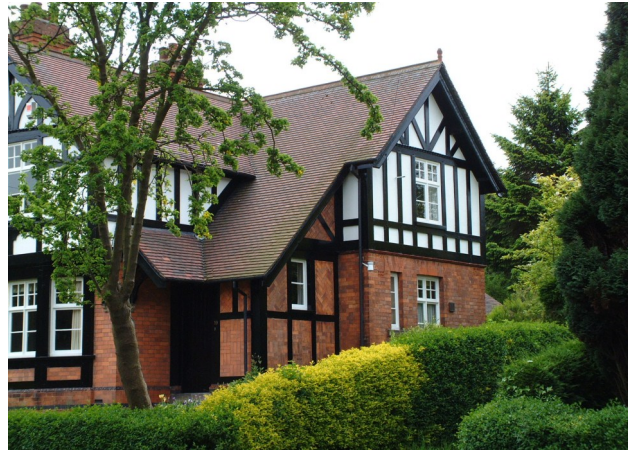
*19 Main Street*

Whilst under the ownership of Richard Ratcliff it appears that the estate style cottages, 17-19 Main Street and 7-11 Bells End Road, were built. The choice of moulded and decorative brickwork and half-timbering was not unusual. In the fashion of the time, Ratcliff chose to build in the Gothic Revival style and thus imbued the village with a late 19<sup>th</sup> century estate character that had not existed until this time. This character was completely unrelated to the Walton Hall estate. The former school and schoolhouse have strong similarities with Borough Hill Farm, and were probably designed by the same architect (in 1841 they were part of Marquis Townshend's estate).

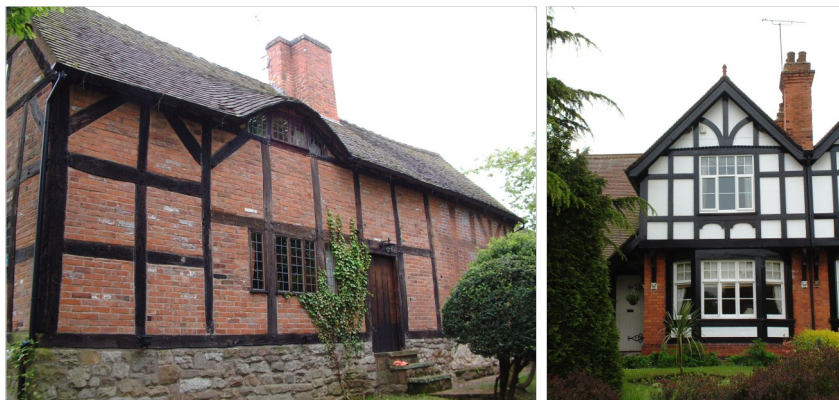
*Timber framing of three different eras  
Above left - 35 Main Street, 17th century. Above right - 17 Main Street, late 19th century. Below - Walton Village Hall, 1920*

Remnants of timber-framing survive in several buildings, of which there are examples visible at 35 Main Street and 3 Bells End Road. The latter was in fact erected in the 1960s from a demolished building in the West Midlands. The local example incorporates box-framing, a type of construction associated with this region. There are remnants of 16<sup>th</sup>

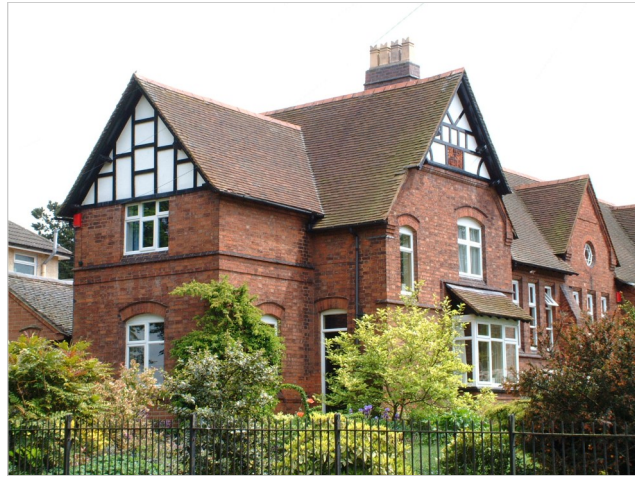
*11 Main Street, the former school house*

By 1878 moulded bricks had become fashionable, as at 11 Main Street (the former school house) and 17-19 Main Street (also ca.1878). Decoration was achieved with moulded, carved and rubbed bricks laid with lime-putty joints and the use of tumbling courses of brickwork (as can be seen on the chimney stacks at the old school) and panels laid in patterns, such as herringbone (as used at The Village Hall and 19 Main Street). By this time, achieving a contrast between plain brick walls and white-painted joinery had become the norm.

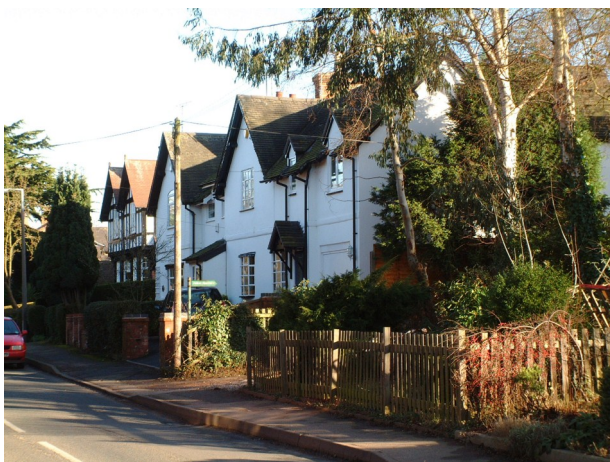
*17-25 Main Street create an estate character*

There are three distinct groups of late 19<sup>th</sup>/early 20<sup>th</sup> century buildings on the south side of the Main Street that give the street an estate character – The Shoulder of Mutton, The Former School and Schoolhouse, 17-19 Main Street and the heavily altered row Nos. 21-25. As has been explained in assessing the historic development of the village, the Walton Hall estate owned none of these. Despite being few in number, the village nevertheless has an estate character, largely because these buildings are integrated amongst earlier and later properties, with spacious and generous green settings.

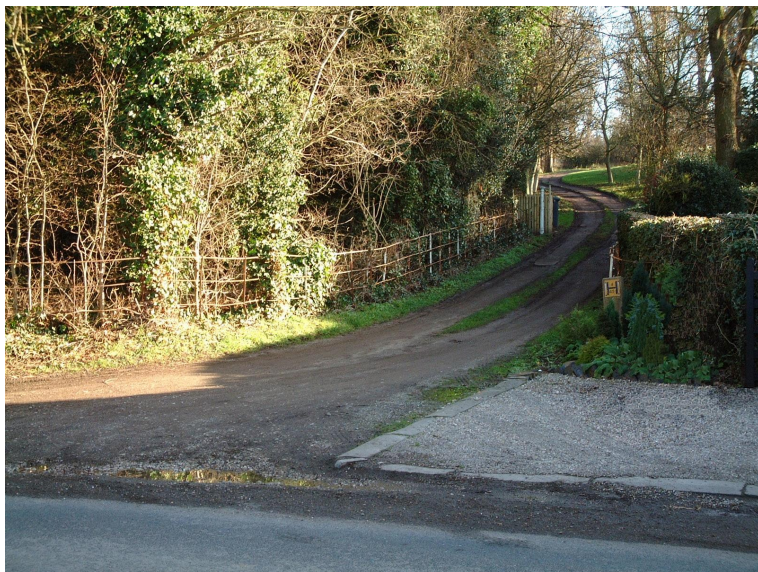
*Entrance to Walton Hall*

The entrance to Walton Hall is very understated, and falls between Barn Farm Cottage and a small wooded copse. It has a simple metal estate fence lining the entrance drive with a wrought iron gate and cast-iron posts. The parkland occupies a long, tranche of land stretching from Catton Road to Coton Road. The landscape parkland to Walton Hall is quite small and self-contained. Another informal entrance appears to have existed onto Coton Road, but this was probably just designed for access and ease of maintenance. The lack of

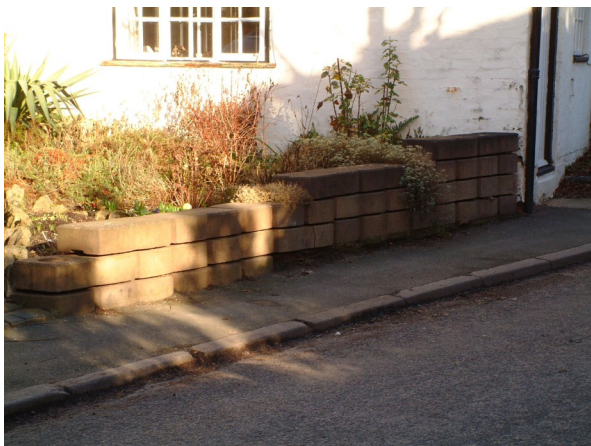
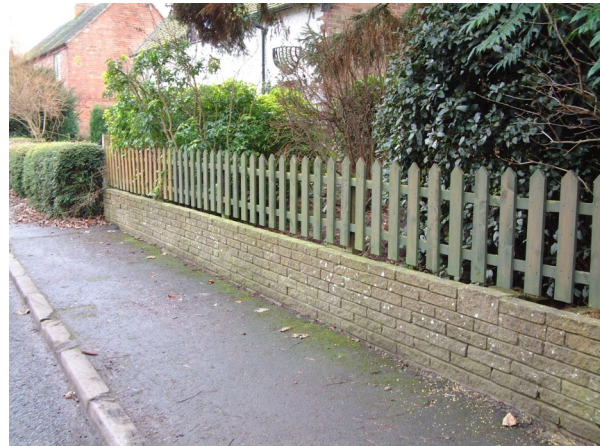
*Concrete blocks and artificial stone are alien to the character of Walton*

In the absence of a local natural walling stone, a number of property owners have

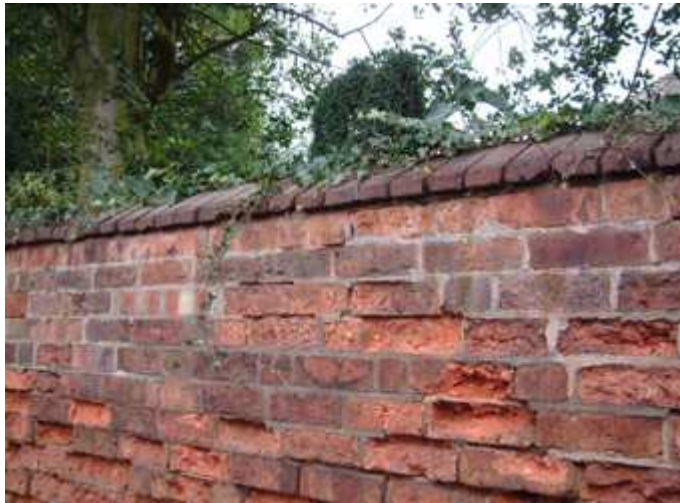
Walls were generally built from red/orange brick, with a clay coping. Copings varied a great deal from the moulded red clay triangular copings at the former rectory (above left) to the blue clay triangular copings at the churchyard (top right). Elsewhere copings are bull-nosed blue brick (below left), triangular moulded red clay (painted off-white - below right), moulded red clay at the churchyard (bottom left), and half-round blue brick on Coton Road (bottom right).

Bull-nosed blue bricks reappear as a shallow plinth on Main Street (above right). Blue brick was introduced widely in the late 19th century for its semi-engineering properties.

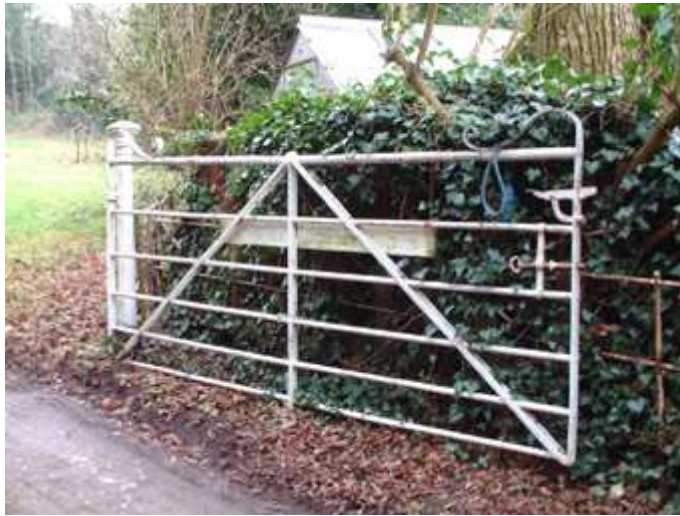
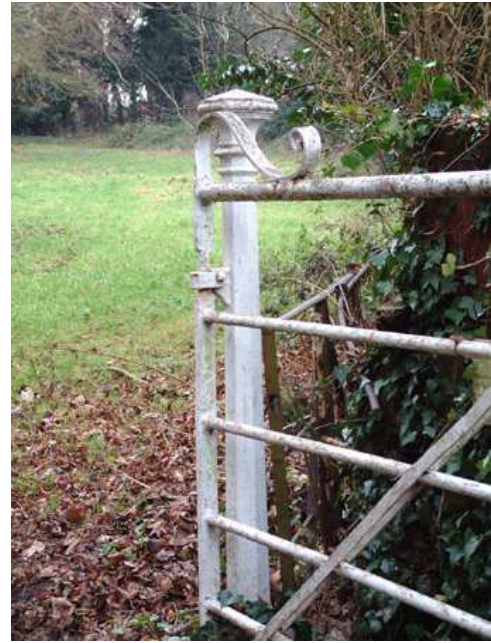
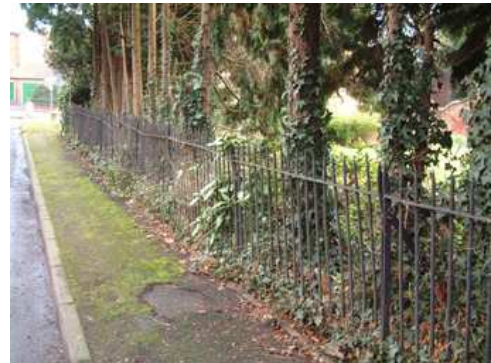
### Gates and railings

In Walton on Trent railings were reserved for certain key buildings.

Estate-type fencing and gates were generally erected by the Walton Hall estate. They were simple to fabricate, and could be produced by a local blacksmith, although the cast-iron gateposts (top right) would have been ordered from a catalogue of stock items.

The railings surrounding the former rectory (right - second from top) are simple spiked wrought iron.

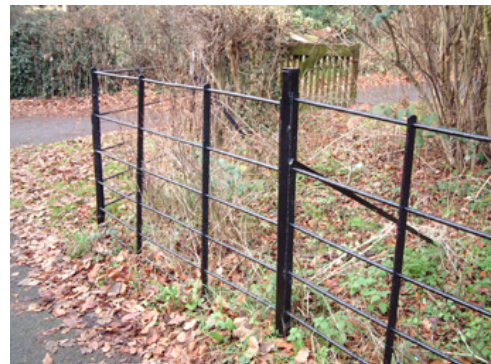
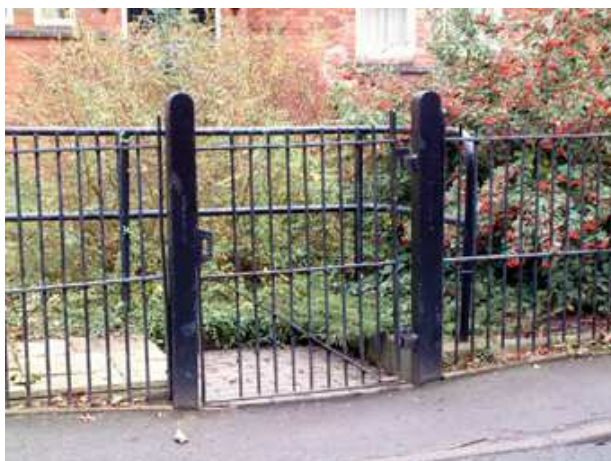
By the late 19th century, steel railings could be fabricated in thinner sections with similar properties to wrought iron (the former school - below).

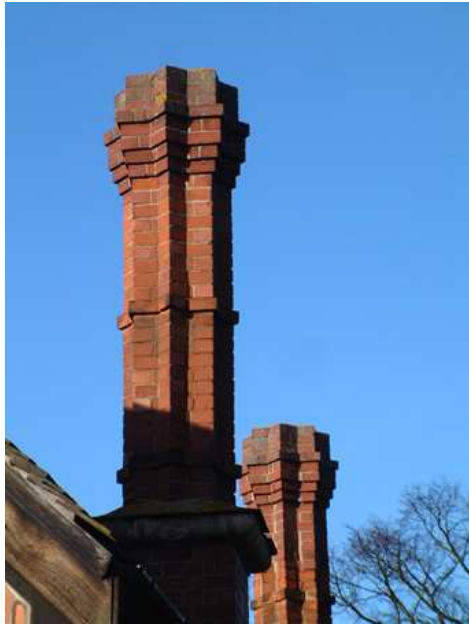
Left - decorative brick chimney stacks of the early 20th century Arts & Crafts movement emulate Tudor chimneys (the Village Hall). The distinctive star shape is created from rubbed bricks.

Right - plain rendered chimney stack, lined out to imitate ashlar, with single oversailing course of stone ashlar and buff square spiked pots.

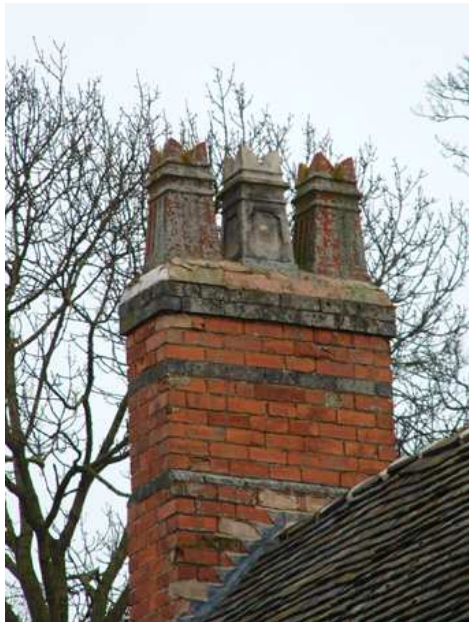
Below left - red brick stack with bands of blue brick and square spiked pots. Blue bricks were occasionally used as an oversailing course, where a stronger brick was required, sometimes also used decoratively, but this was generally a mid-late 19th century replacement.

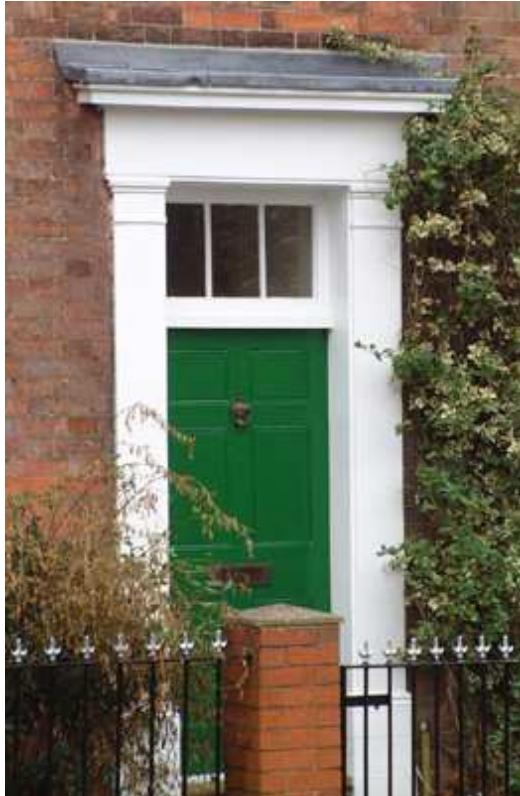
Six-panel door with simple “bead” mouldings (above), incorporating fanlight and Georgian style classical doorcase with cornice, frieze rail and plain pilasters.

Four-panel door with simple “bead” mouldings (right).

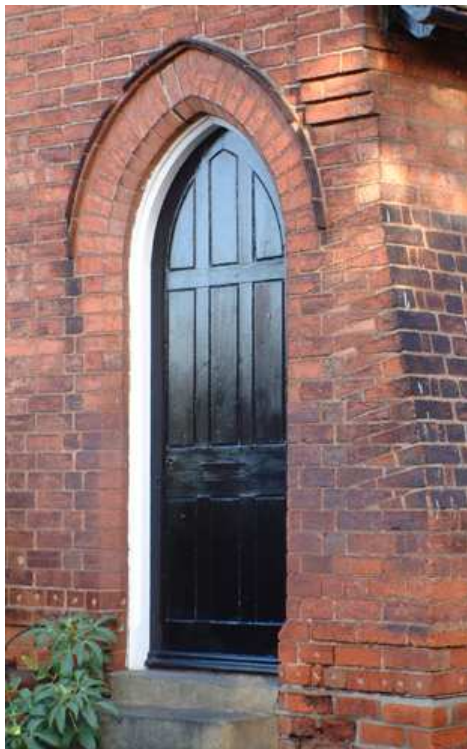
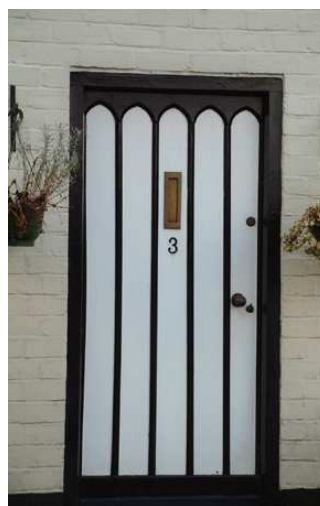
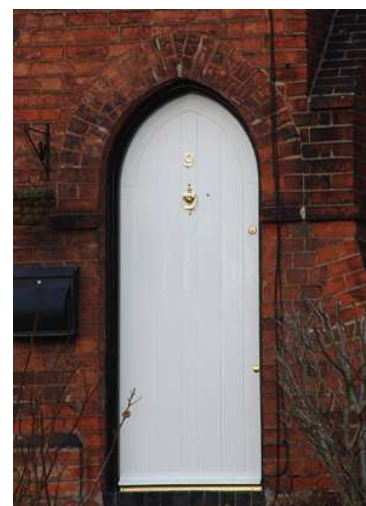
The Gothic Revival introduced a range of doors - nine-panel within a pointed arch (left), plank door with applied fillets and pointed Gothic arches (above centre) and boarded within a pointed arch (above right).

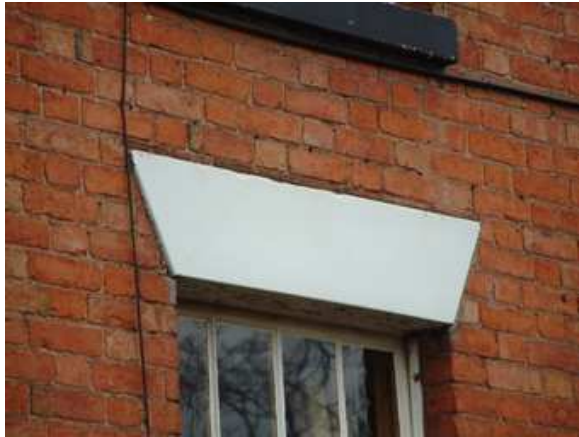
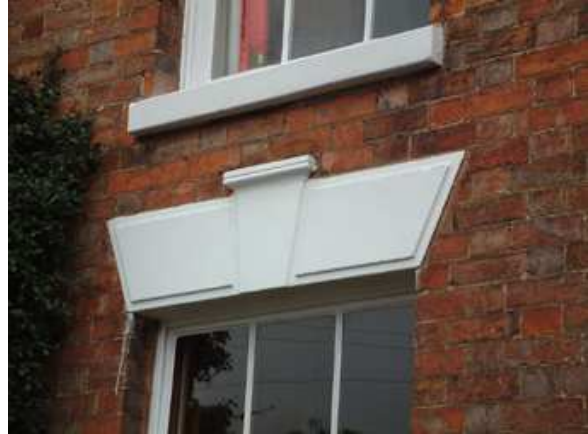
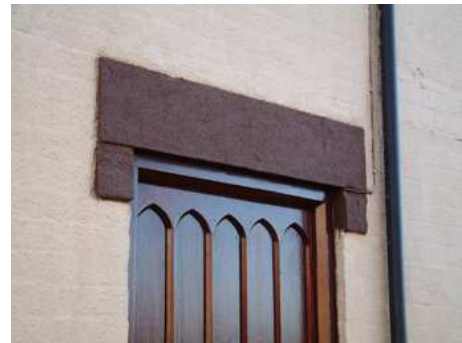
## LINTELS AND CILLS

During the 17th and 18th centuries in Walton on Trent lintels were mainly brick or timber. By the first half of the 19<sup>th</sup> century, the use of stone was much more widespread, partly due

to improvements in the transportation of heavy goods (by canal and later rail). Wedge-shaped stone lintels were common, sometimes plain (as at The Swan Inn - above) and sometimes incised and carved (as at 2 Coton Road - above right). The squared stone lintel with stone lugs (right) emulates the hood mould of Gothic architecture and was introduced in the mid 19<sup>th</sup> century.

- the stone wedge lintel, generally found from 1800 and through the first half of the 19<sup>th</sup> century (e.g. The White Swan, 2 Coton Road, 44 Main Street). Although the lintels at The White Swan are plain, the slightly earlier examples at 44 Main Street are rusticated and combined with exaggerated rusticated stone quoins.

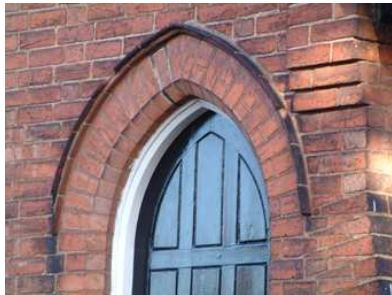
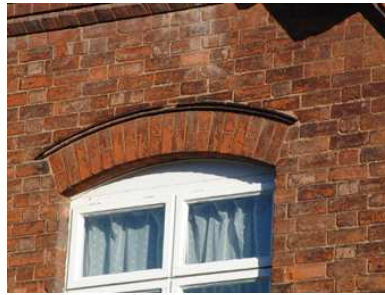
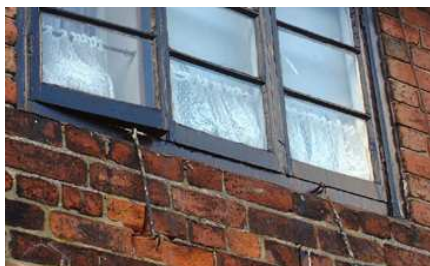
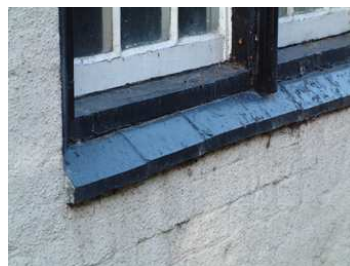
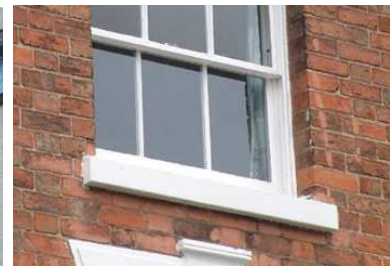
Later in the 19<sup>th</sup> century, brick lintels returned. They were often made from moulded bricks and clay details; pointed Gothic arch (below left) and segmental arch (below right).

Many of the smaller cottages had no cill (above left). Elsewhere, some of the cottages had a blue brick cill added at a later date in the 19<sup>th</sup> century (above centre). The larger, grander buildings generally had stone cills (above right).

In combination with the brick arches, stone cills were not normally used, relying on the simple weathering properties of the brickwork. Unfortunately, this detail has been replaced in most cases by a modern window with a projecting timber cill. In a few instances moulded bricks or tiles have been added at a later date. On the later 19<sup>th</sup> century properties, blue and red moulded clay cills were incorporated as original details, as a more effective weathering (e.g. 7-11 Bells End Road, 21 Main Street and the former school and schoolhouse, Coton Road). The more substantial houses and farmhouses have stone lintels combined with dressed stone cills (e.g. Warren Farm, The White Swan, 2 Coton Road).

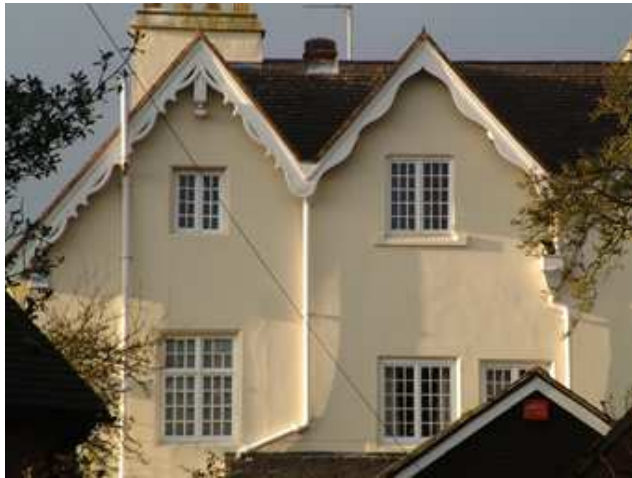
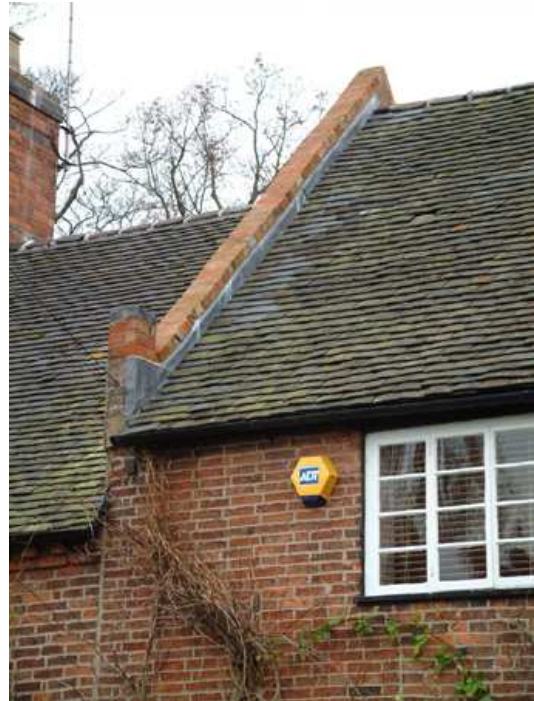
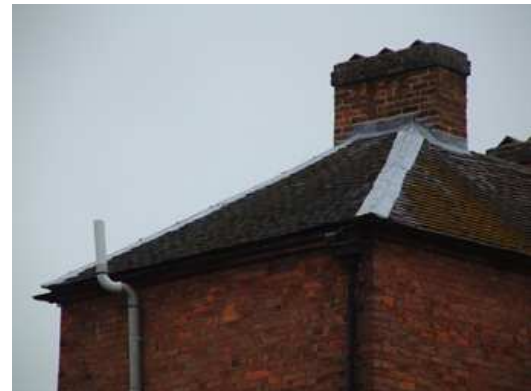
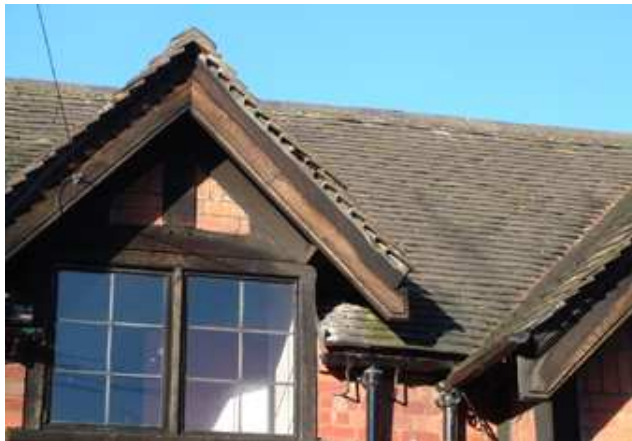
### Local roof details

Top right - raised coped brick gable with tiled roof of Staffordshire blue clay tiles

Right - hipped clay tiled roof with lead flashings

Above and below - pitched clay tiled roofs with decorative bargeboards

A variation of the pitched roof can also be found in the 18<sup>th</sup> century when a parapet was often added at each gable-end, as at 56 Main Street and Barn Farm, commonly referred to

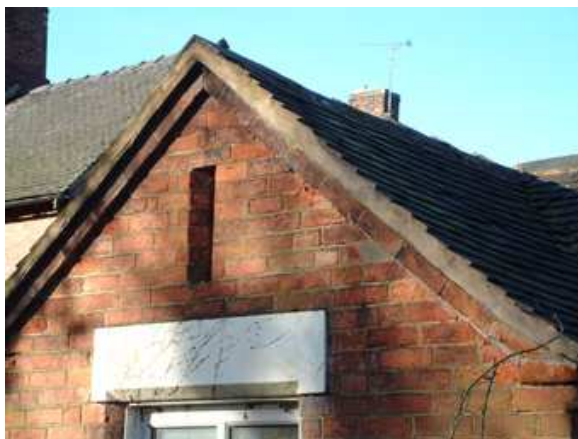
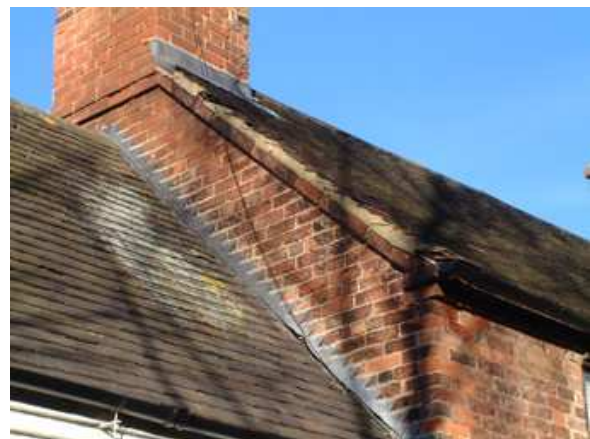
**Brick verge details below** - corbelled with several courses of bricks (below left) and corbelled with a single course (below right)

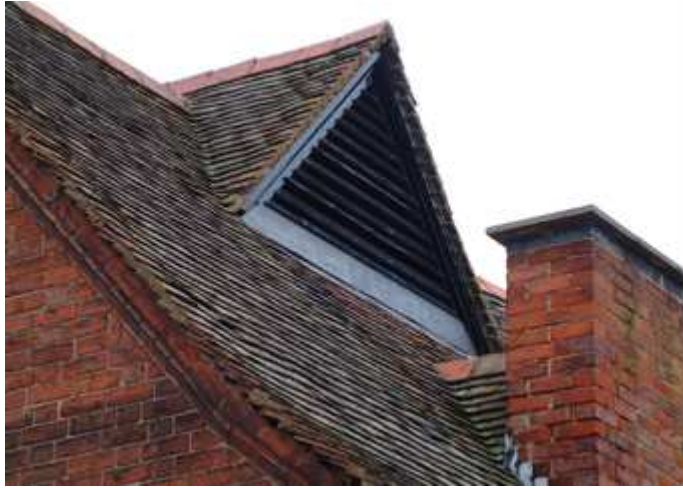
Left - timber ventilator at the old school. This distinctive feature of the late 19th century is combined in the red clay tiled roof with swept valleys.

Timber gable (right) with timber dentil moulding, timber console bracket and roughcast render. After about 1910, roughcast render became fashionable throughout the country, largely influenced by the architecture of Charles Voysey and the Arts & Crafts movement.

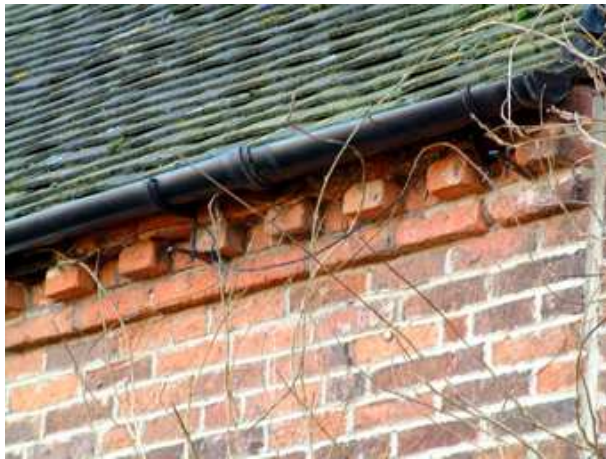
During the 18th century, brickwork was often embellished with a corbelled and dentilled eaves (above). Elsewhere, brickwork was made decorative purely by the treatment of openings, such as ventilation slots in the hay barn (top right).

Flemish bond brickwork (bottom left), although associated mainly with Georgian architecture, continued to be used in the 19th century for its decorative effect by incorporating coloured “headers” picked out in a subtle contrasting shade.

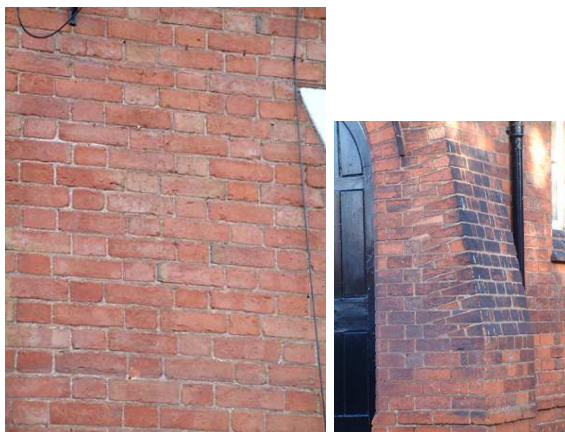
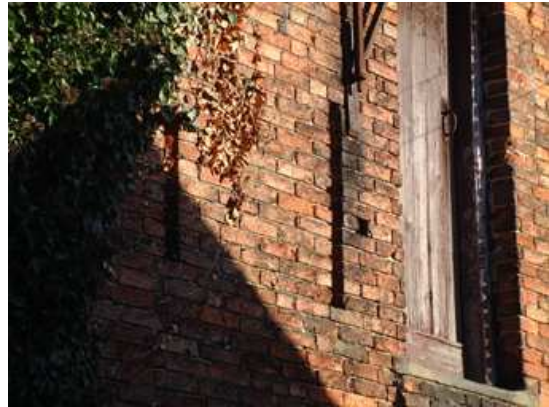
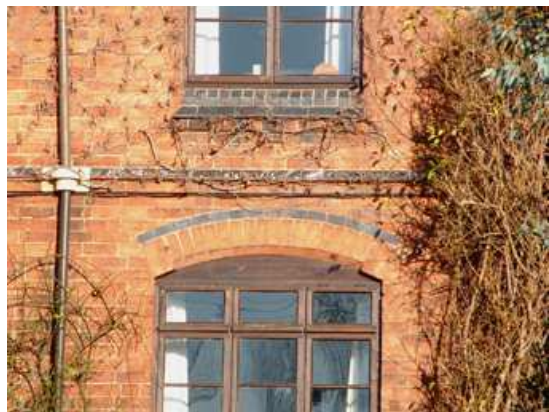
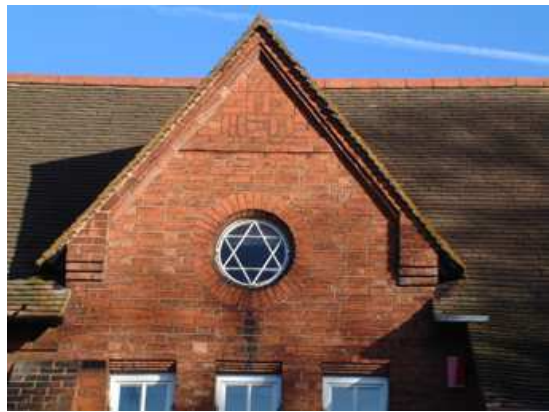
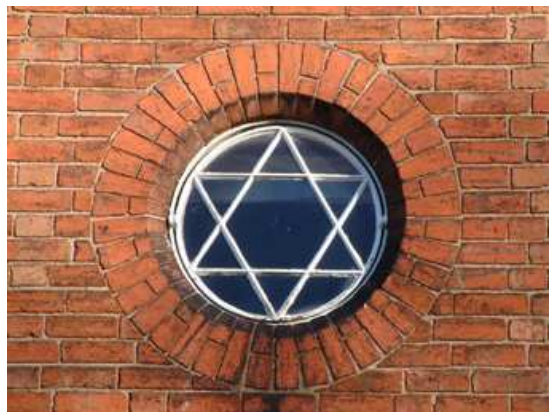
## WALLS - Brickwork details

An influx of late 19th century picturesque estate-type buildings within the village has left a legacy of intricate brickwork details. During the last decades of the 19<sup>th</sup> century, there was a new interest in the craft of the bricklayer. By 1878 moulded bricks had become fashionable, as at 11 Main Street and 17-19 Main Street (right). Decoration was achieved with moulded, carved and rubbed bricks and the use of tumbling courses of brickwork (below right) and panels laid in patterns, such as herringbone (gable end - right, and see next page).

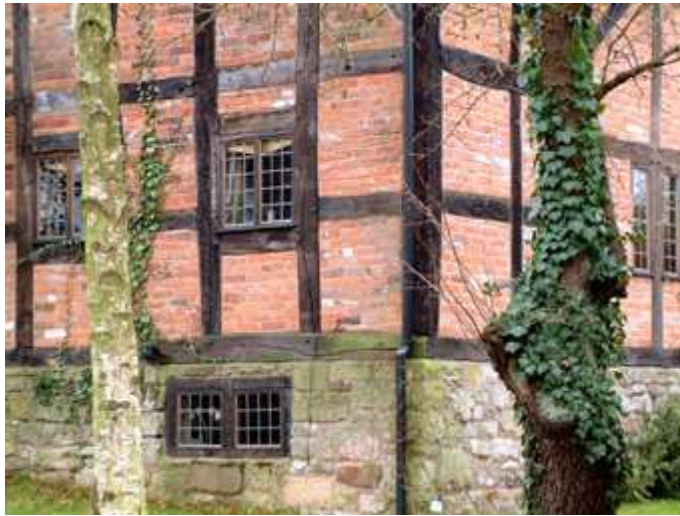
Up until the 18<sup>th</sup> century, the principal building material for the smaller houses was timber, with panels of wattle-and-daub. The type of timber-frame used in Walton is known as small box-framing - squared panels made up of posts and short horizontal rails. The example at 35 Main Street (left) is the principal surviving 17<sup>th</sup> century building in the village. The wattle and daub was replaced with bricks, known as “nogging”.

conjunction with other materials. It is found used in combination with brick & render in Walton-on-Trent (below). The early 20<sup>th</sup> century Village Hall (below left) incorporates close-studding and decorative herringbone brickwork, not the local small box-framing tradition. Other late 19<sup>th</sup> century buildings (below right and bottom left) also adopted timber-frame for its appealing surface decoration, and used it in conjunction with rendered panels and brickwork.

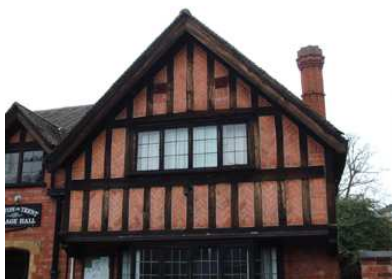
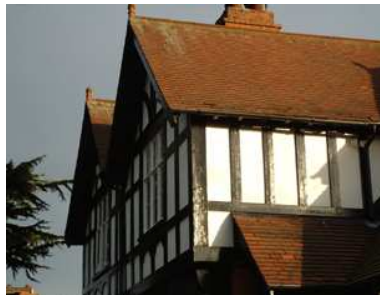
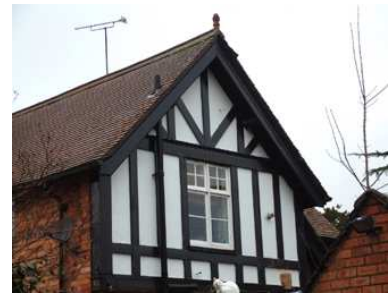
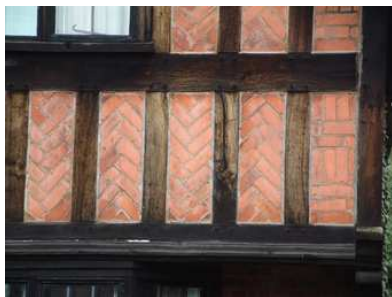
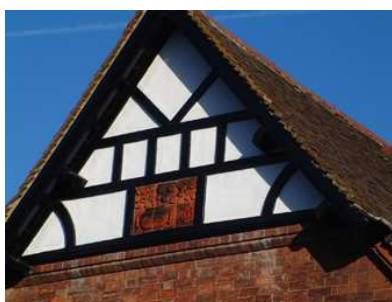
## WALLS - Timber-frame and stone details

In the mid to late 19<sup>th</sup> century, there was a revival of interest in vernacular materials. Timber-frame was valued particularly for its picturesque qualities. The Arts & Crafts movement reintroduced timber-frame in

The earliest surviving buildings were built from timber-frame with panels of wattle-and-daub. These panels have over the years been generally replaced with brickwork. In fact the original Old Hall, which was partially demolished in 1840, was a highly decorative timber-framed building, although it had been extended in brick at some time.

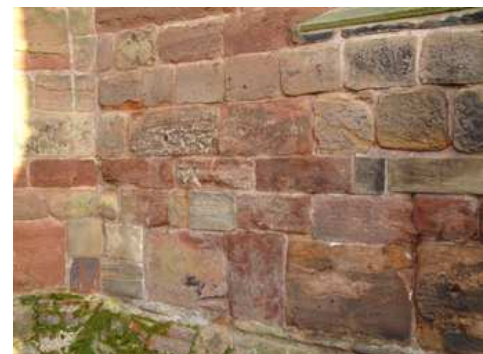
**Stone** - the use of stone within the village is limited to the occasional stone plinth (right), using shaly blue-grey limestone, known as “skerry”, or quarried, imported, reddish/pink sandstone from Staffordshire, as at the church (bottom right).

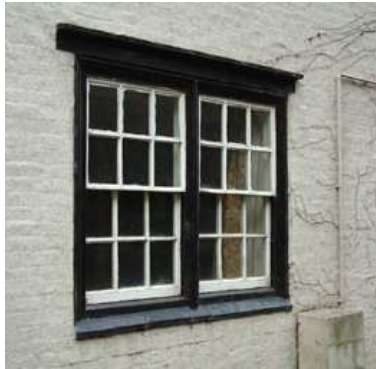
## WINDOWS - Joinery

Left - vertically sliding sash windows. As glass production evolved and the size of panels of glass increased, the small-paned sash windows of Georgian England gave way to larger panes of glass, separated by single vertical glazing bars. The examples in Walton-on-Trent date from the very early 19th century (top left) up to the mid 19th century (left).

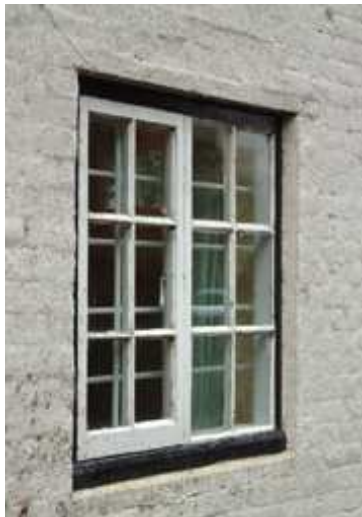
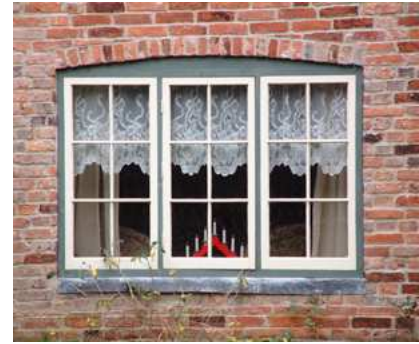
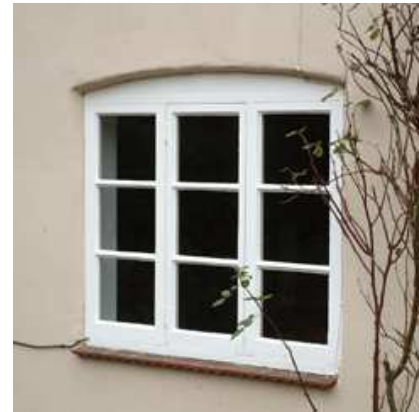
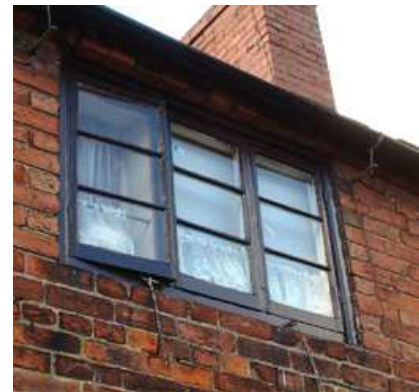
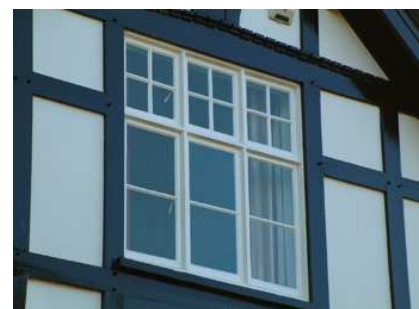
The simple casements with two of three horizontal glazing bars were introduced by the Walton Hall estate, probably in the second half of the 19th century (right -second and third from top).

Below - examples of six paned casements survive at Trent House.

Above - casements were often favoured over sashes by late 19th century architects for their more authentic vernacular origins and were most commonly used on Gothic Revival buildings.

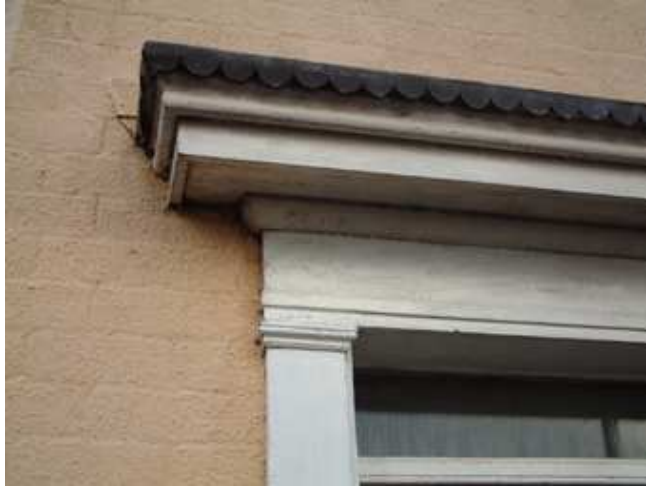
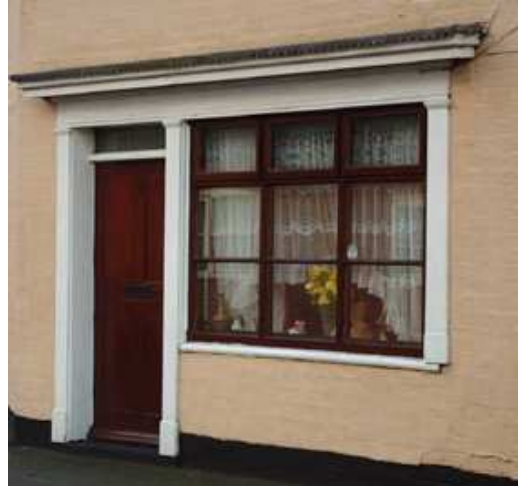
There are few traditional shopfronts left in the village. The 19th century shopfront had several important elements, illustrated in the photographs above - a stall riser under the shop window, a fascia, where the name of the shop or owner would have appeared, the cornice, which helped to shed water from the whole shop window and door, and the pilasters, which framed the window and door. All of these elements together are based on principles of composition from classical architecture. The stained timber is, however, a modern alteration.

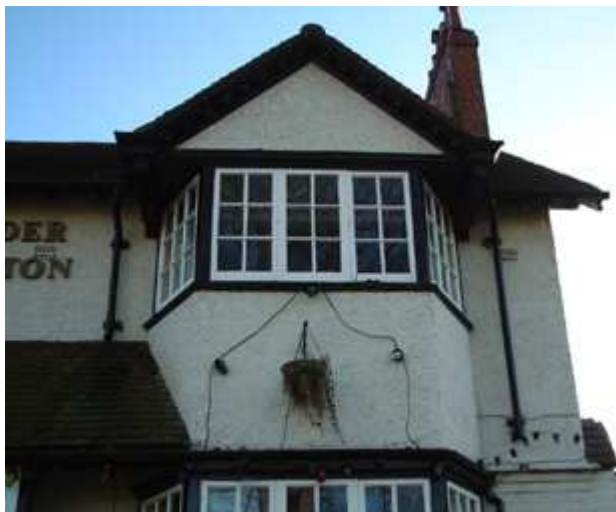
The two-storey canted bay window found at The Shoulder of Mutton (left) is very typical of the early 20th century and was introduced by architects following a style called "vernacular revival". Roughcast render used in combination with small-paned casements windows is also typical of this architecture. By 1900 panes of glass were being made smaller again in timber or lead to emulate the older styles.
