Trusley
Conservation Area
Character Statement

**SOUTH DERBYSHIRE
DISTRICT COUNCIL**

Trusley *Conservation Area*

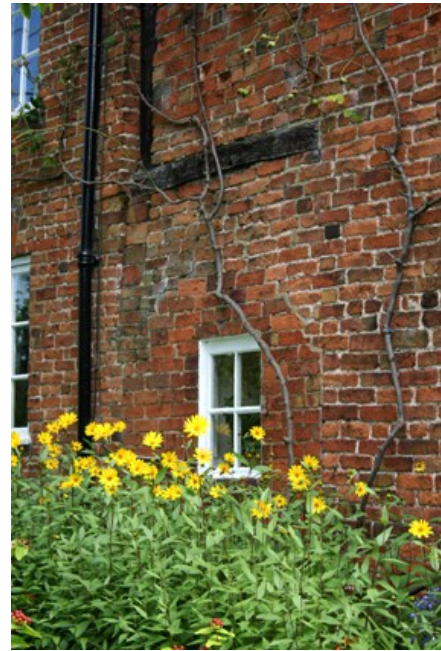
Tatlow's Cottage - the remains of a former bread oven and the timber frame are still evident

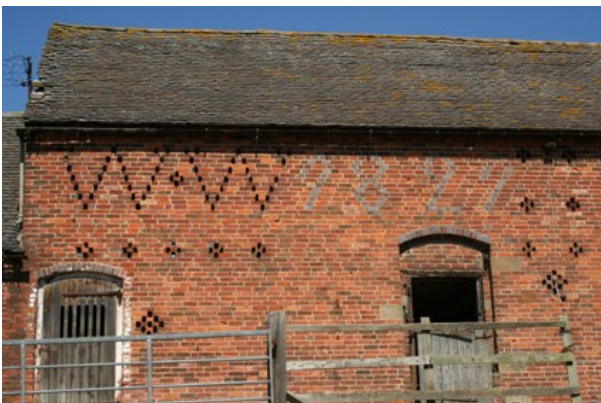
Initials “W W” for William Woodward incorporated as a ventilation pattern and blue bricks laid in a pattern that marks out 1821 at Ivy Close Farm

The Woodward family, who still occupied Ivy Close Farm in 1840, had ensured that the initials “W W” appeared in the south-facing wall of the barn, when it was built in 1821, where they still survive. Both Ivy Close Farm and Home Farm were redeveloped in 1821.

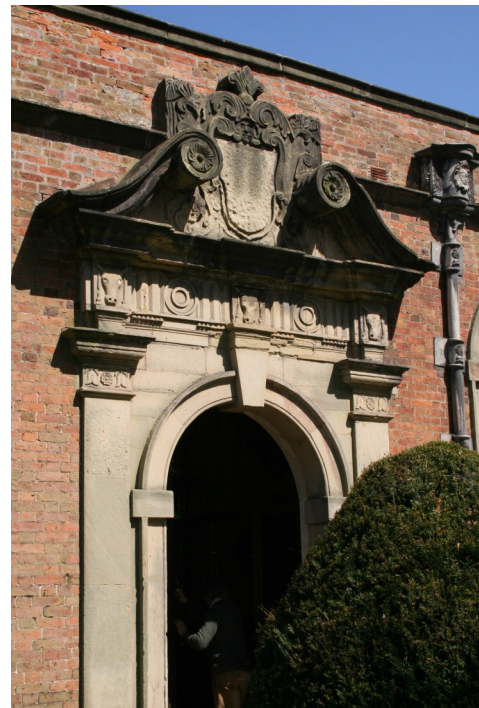
Ornamental Baroque doorway to All Saints Church - one of the few local instances where stone was used

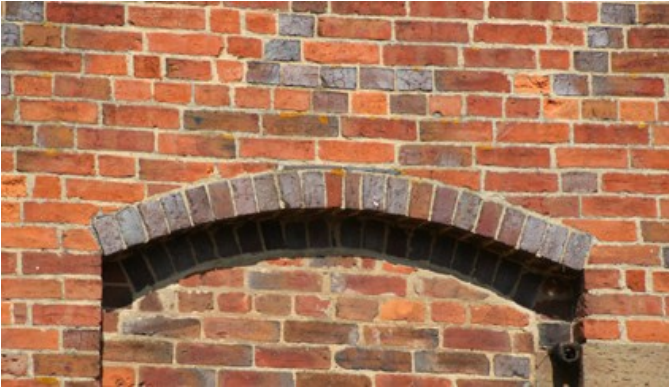
Blue “flared” (or burnt) bricks were used decoratively for their contrasting effect, such as this segmental arch lintel at Ivy Close Farm

to Home Farm). Blue “flared” headers were introduced into the village in the 18th century and can be seen at Ivy Close Farm and All Saints Church, but the original patterns have worn away with weather and alteration. In the 19th century blue bricks became more common and at Trusley “flared headers” were introduced for their decorative qualities in the 1821 dated brickwork and segmental arches at both Home Farm and Ivy Close Farm, and entirely blue bricks were used later on for the “pitching eye” openings at Home Farm.

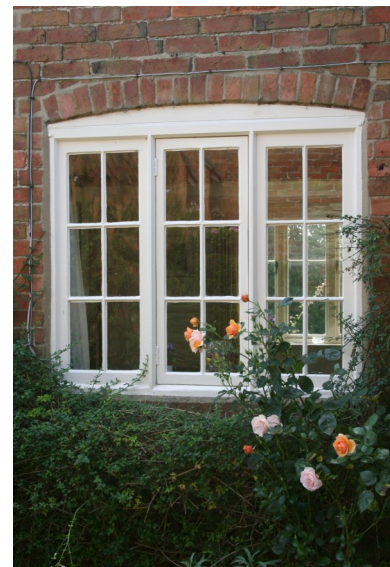
*Early 19th century casement
"estate" window with
chamfered frame at
Lane End Cottage*

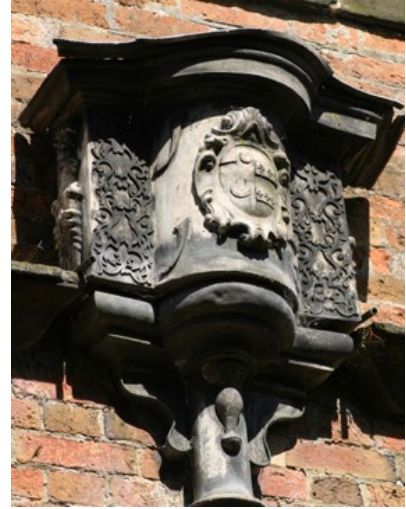
The lead rainwater pipes at All Saints Church are worth mentioning as they are an important original survival dated 1713 (pictured right). William Coke married Catherine Ballidon and these lead drainpipes bear the Coke family crest (the sun in splendour) and the Ballidon crest (the swan), whilst the hopper above bears the shield of Coke impaling Ballidon.

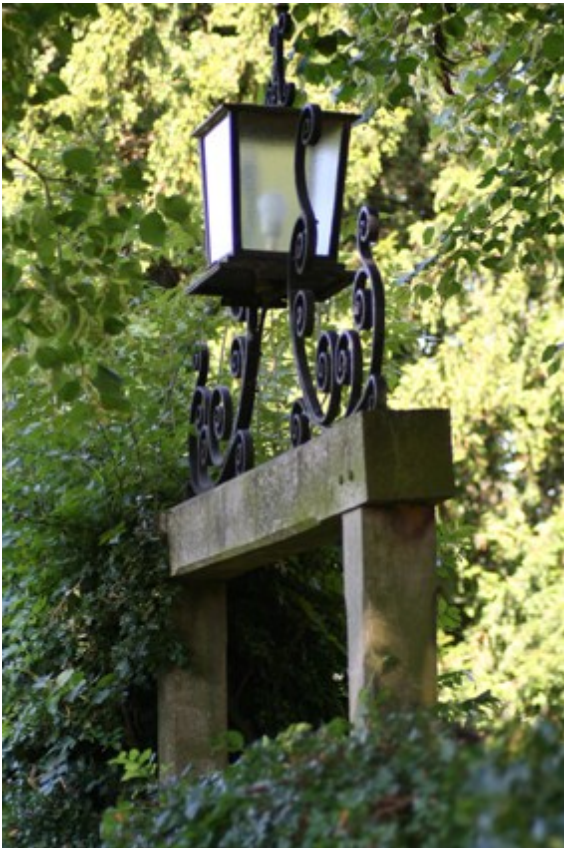
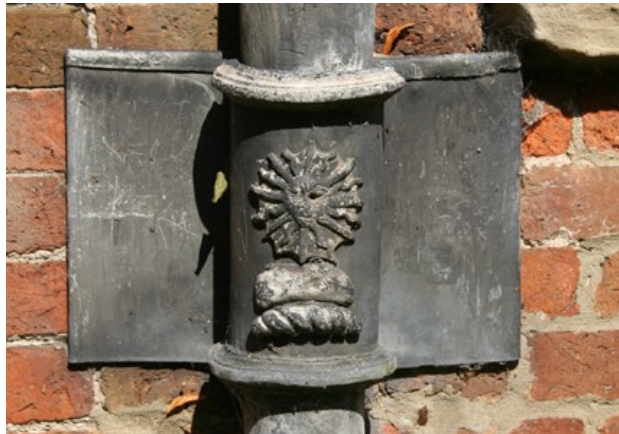
*Above - The Coke family crest “the sun in splendour” emblazoned on the lead rainwater pipe.
Left - lantern and bracket to the churchyard gate*

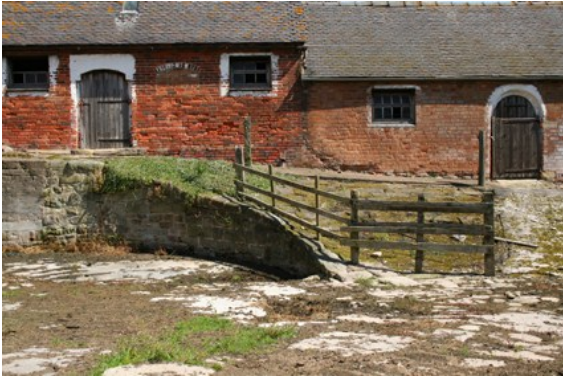
*Raised stone path and lower "midden yard"
at Ivy Close Farm*

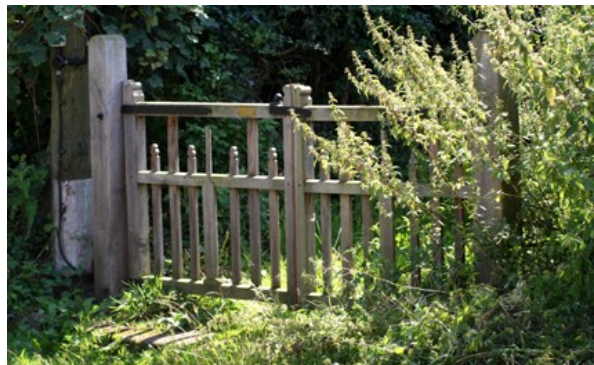
Above - a pair of oak gates serves the path to the churchyard, incorporating little trefoil finials.

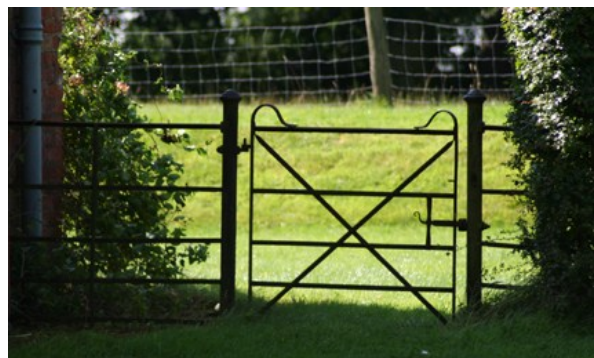
Below - wrought iron five-bar gate and railings with cast iron posts separates the Old Hall from the Village Hall.

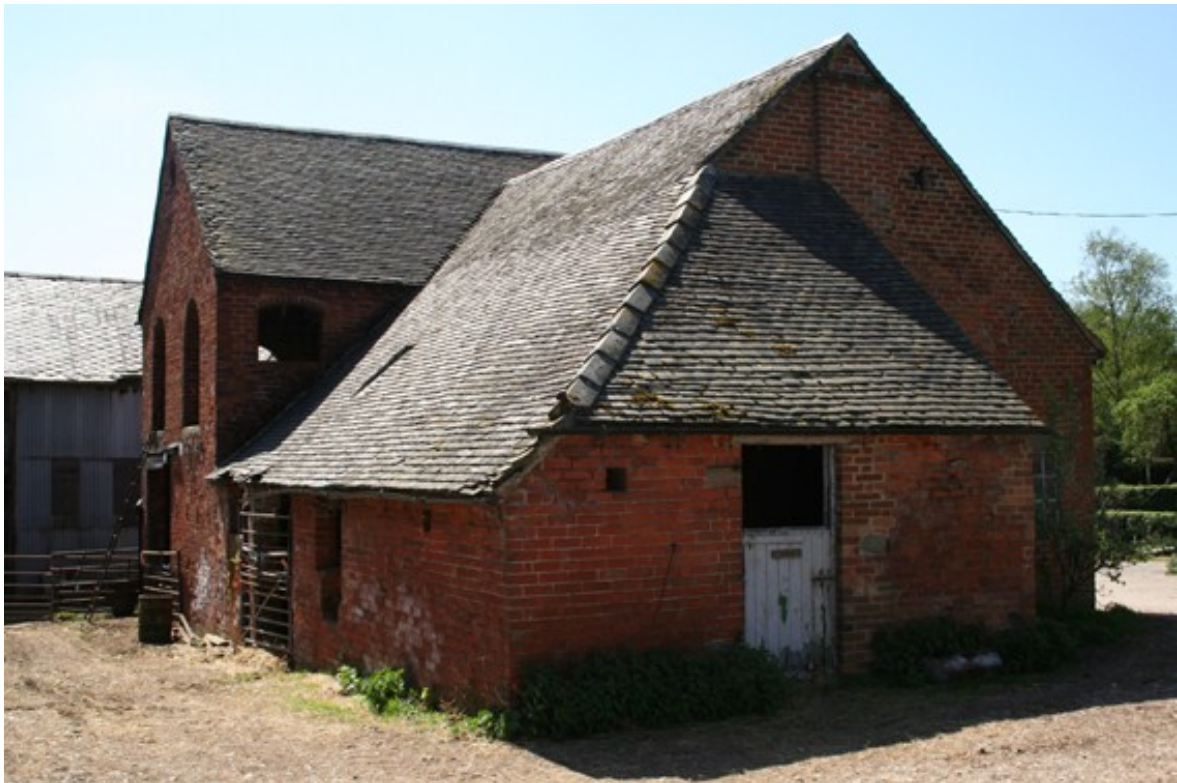
Above - the farm buildings at Home Farm incorporate a wide array of roof profiles clad mainly with Staffordshire blue clay tiles, creating a varied roofscape. Above - pitched roofs with plain close verges, hipped roofs and a catslide roof.

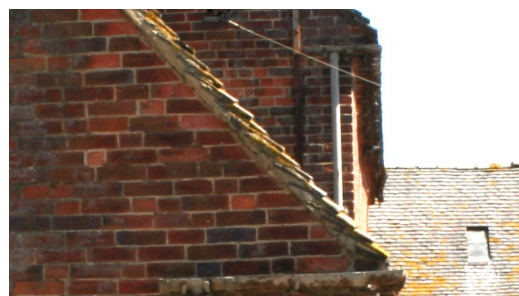
Right - a plain close verge at Ivy Close Farm.

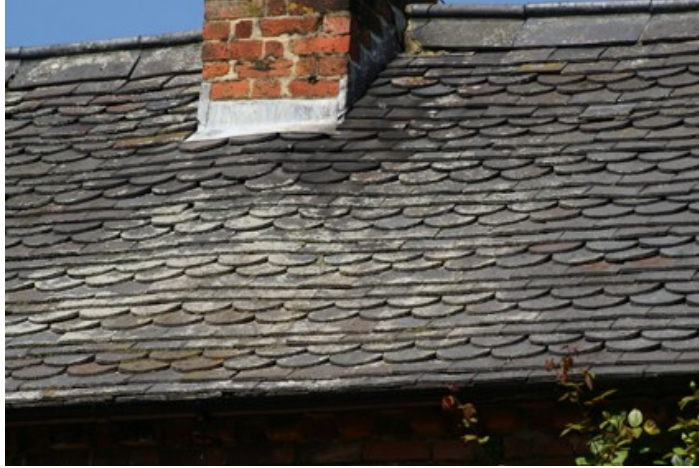
Above - Staffordshire blue clay tiles with alternating bands of fish-scale tiles at Eaton's Cottage. 19th century picturesque estate cottages often incorporated patterned tiled roofs.

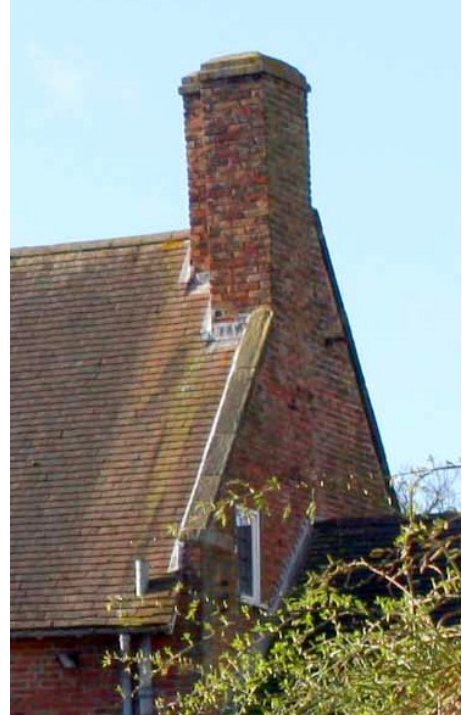
Above - raised coped gable with stone coping at the Old Hall.

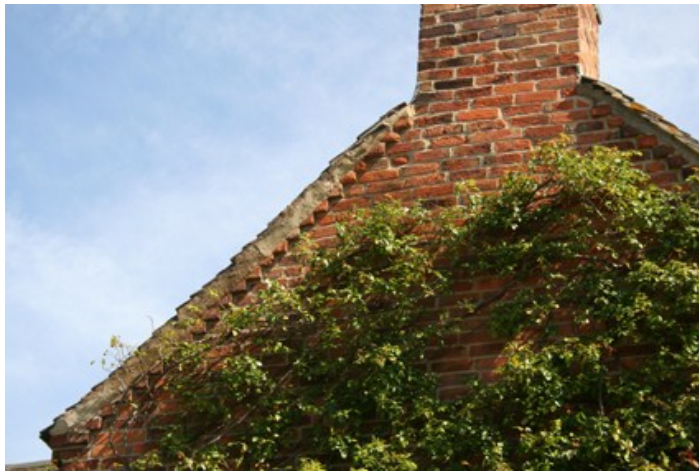
Left - stepped brick verge at Lane End Cottage, a detail shared with Ivy Close Farm.

Another decorative brick detail that can be found is the use of a stepped brick verge on the gable end of brick houses. This provides a drip moulding to throw water away from the wall (e.g. Ivy Close Farm and Lane End Cottage). The roof at The Old Rectory has a plain, corbelled verge. Otherwise, the majority of the gable ends have a “plain close verge”, where the tiles simply overlap the brickwork and the gaps underneath are filled with mortar.

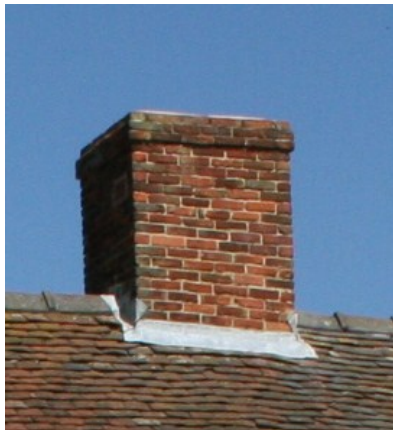
Chimney stacks are generally plain with a few oversailing courses in brick (Ivy Close Farm - below).

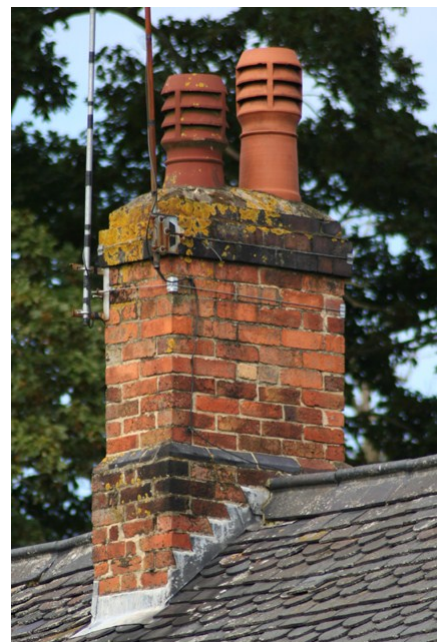
Right - the chimney stack at Eaton's Cottage is more unusual and incorporates brindled brick oversailing courses and a chamfered blue brick weathering.

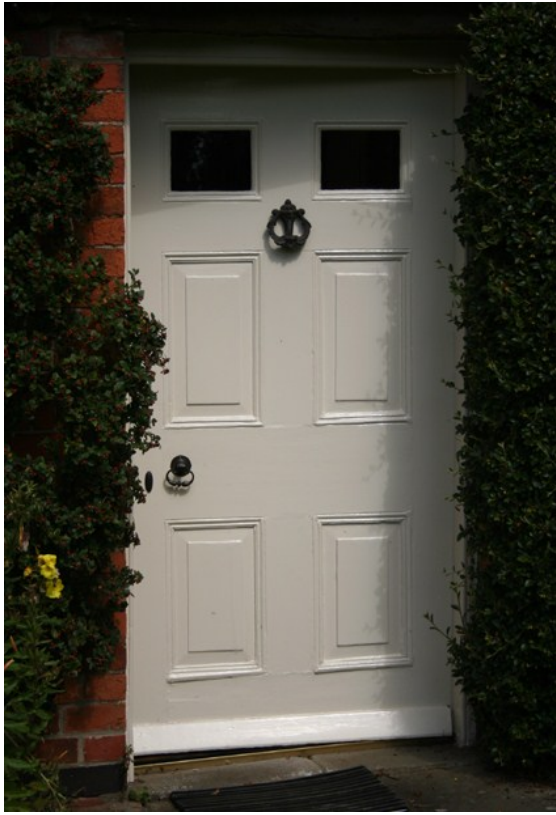
Above - 6-panel Georgian door at Lane End Cottage, incorporating raised and fielded panels and applied mouldings.

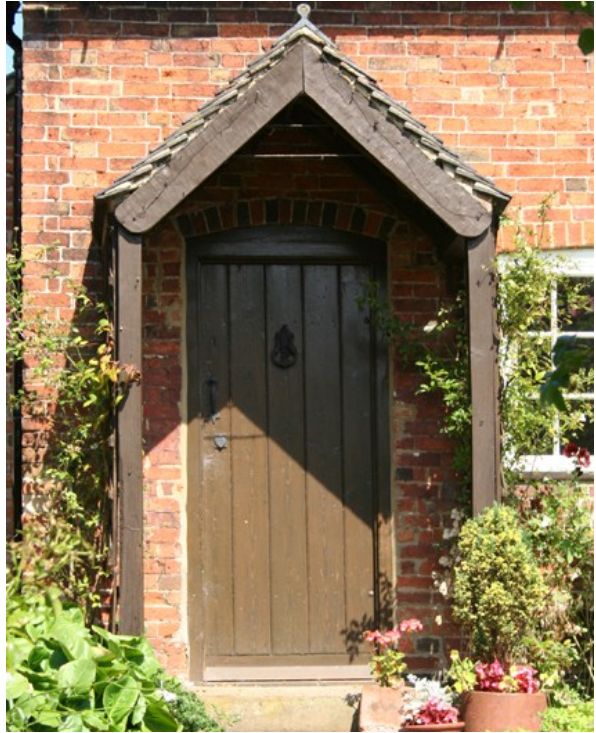
Above - vertically boarded door at Eaton's Cottage, a common style for small estate cottages.

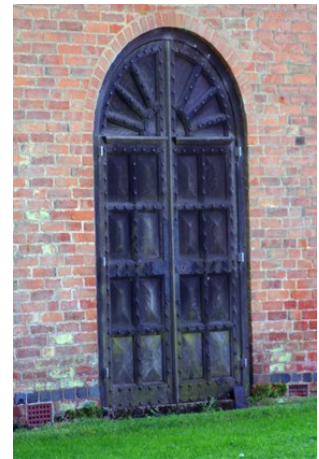
Right - panelled and studded oak door at the Village Hall. This door was moved here from Trusley Manor.

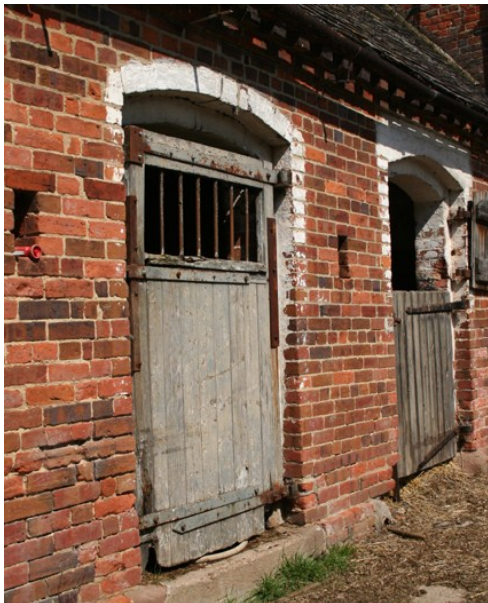
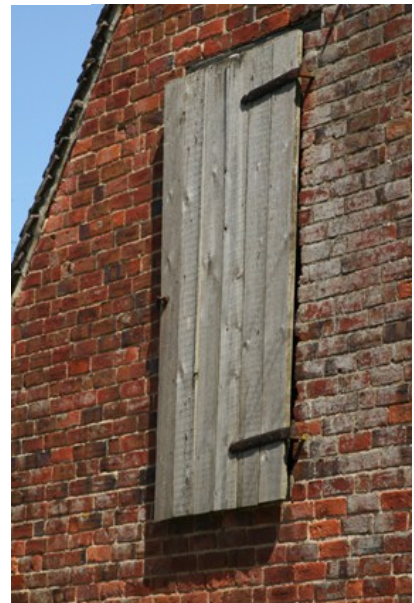
Left and right - a wide variety of boarded doors serve the farm buildings at Ivy Close Farm.

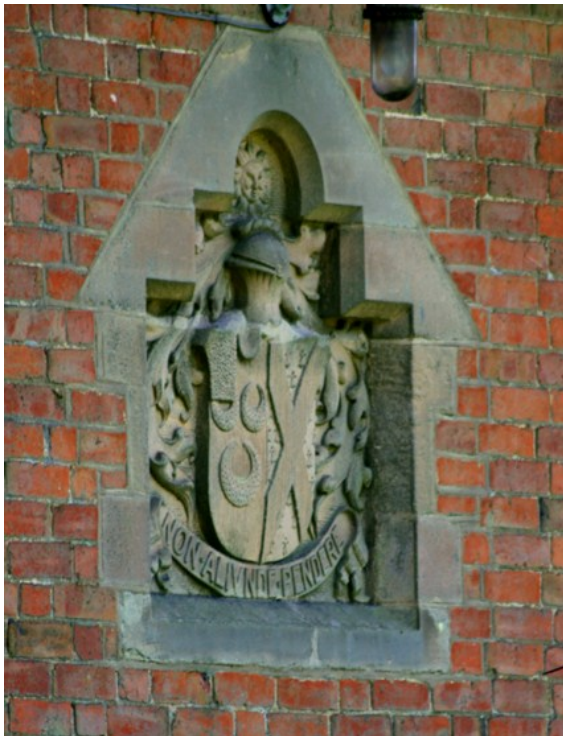
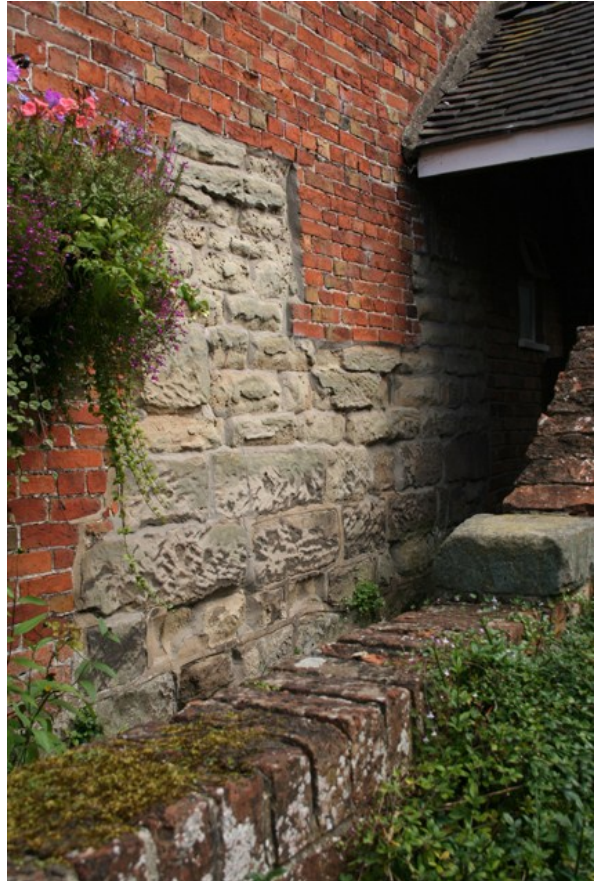
Right - a section of coursed stone survives within a largely brick-built structure (Tatlow's Cottage).

Above - stone panel with the Coke family coat of arms at the Village Hall. This was re-located from Trusley Manor when it was partly demolished.

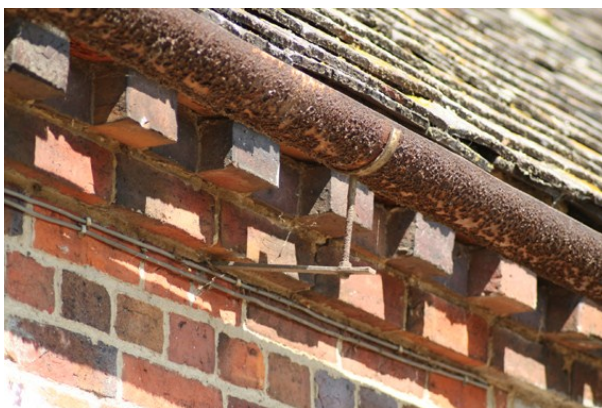
Above left - dentilled brick eaves at Ivy Close Farm.

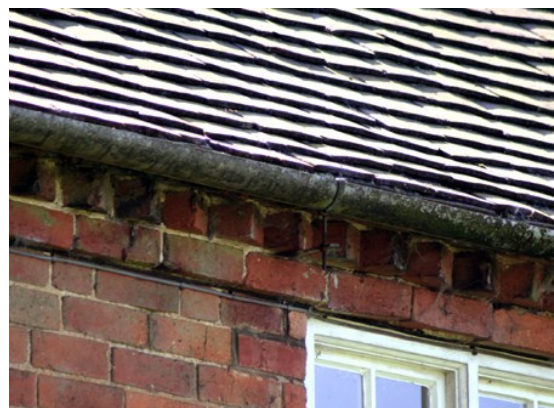
Above right - sawtooth brick eaves at the Village Hall.

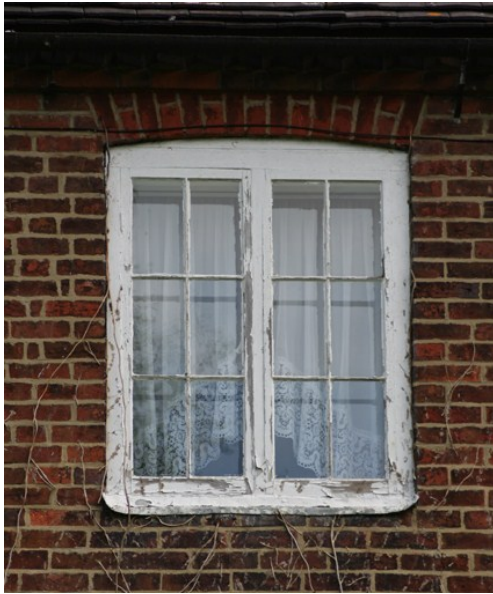
Above and right - side-hinged, small-paned timber casements at estate buildings.

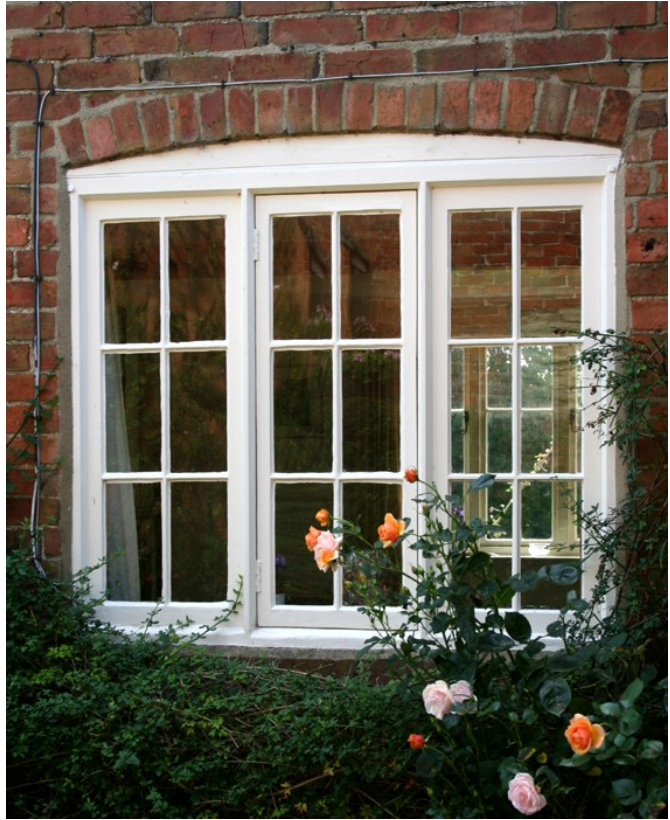
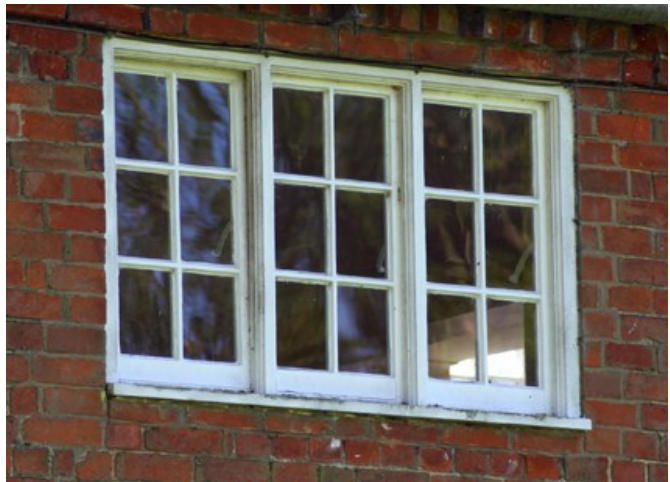
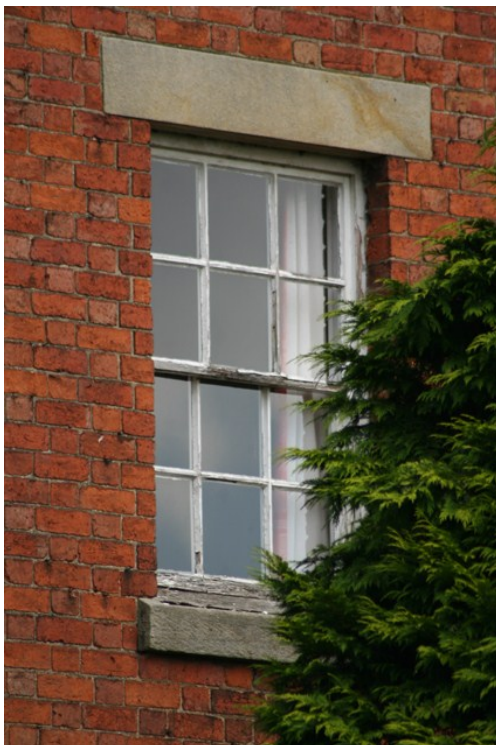
Flush casements at Home Farm (above) and casements set recessed within chamfered frames at Lane End Cottage and the Village Hall (top right and right).

Left - Home Farm. "6 over 6" vertically sliding sash window, introduced in the 19th century, in conjunction with a stone lintel. Most of the buildings with stone lintels also have stone cills.

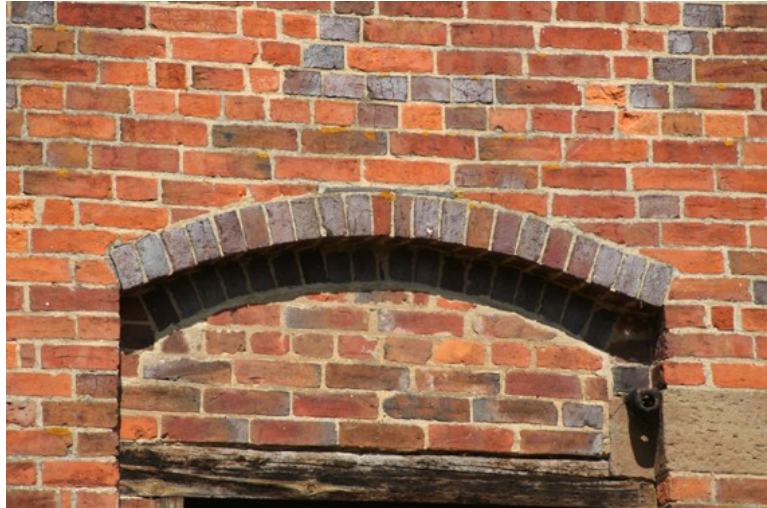
Right - where economy was important, lintels were simple in form. A segmental arch formed by flared "header" bricks at Ivy Close Farm.

There are several types of lintel, but the most common is the segmental brick arch. This is found throughout the village on both the smallest cottages (e.g. Lane End Cottage, below) and the larger houses (e.g. Ivy Close Farm). This was the simplest and easiest lintel to construct as the taper was accommodated wholly in the mortar joints, without the need to cut the brick.

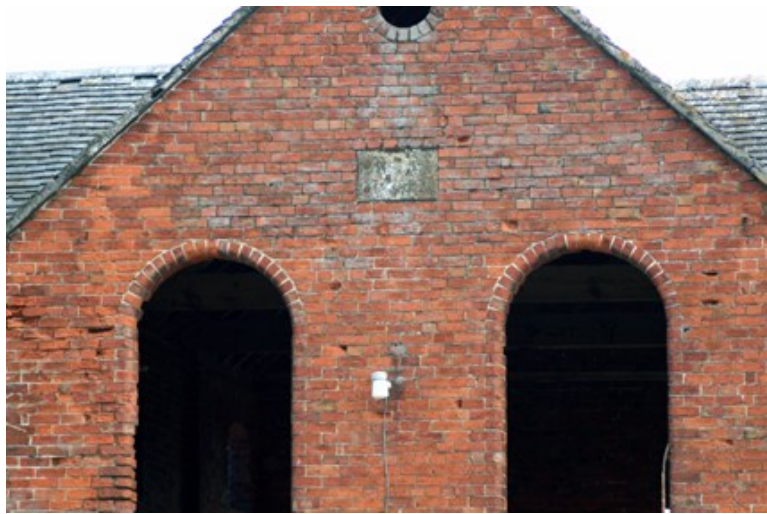
Right - semi-circular arched openings at Home Farm make a bold statement.

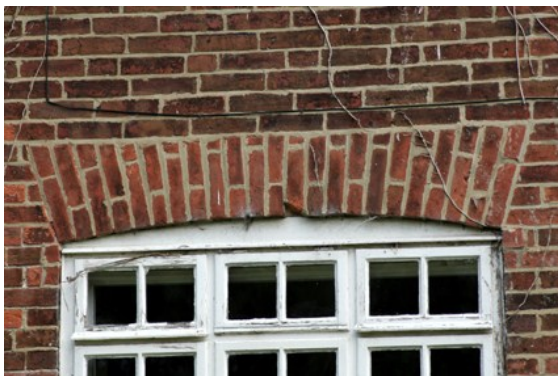
Left - cambered arch lintel at Home Farm. This was one of the most difficult to construct and was typically used on a high class farmhouse. The heavy re-pointing disguises the original gauged brickwork and the skilled work of the bricklayer.

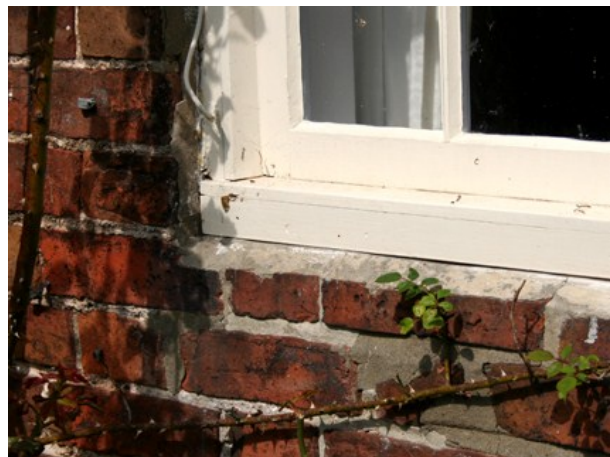
Many of the smaller cottages had no cill, relying on the weathering properties of the brickwork. Right - Lane End Cottage. The flat brick cill has been adapted over the years with a slim mortar flaunching.

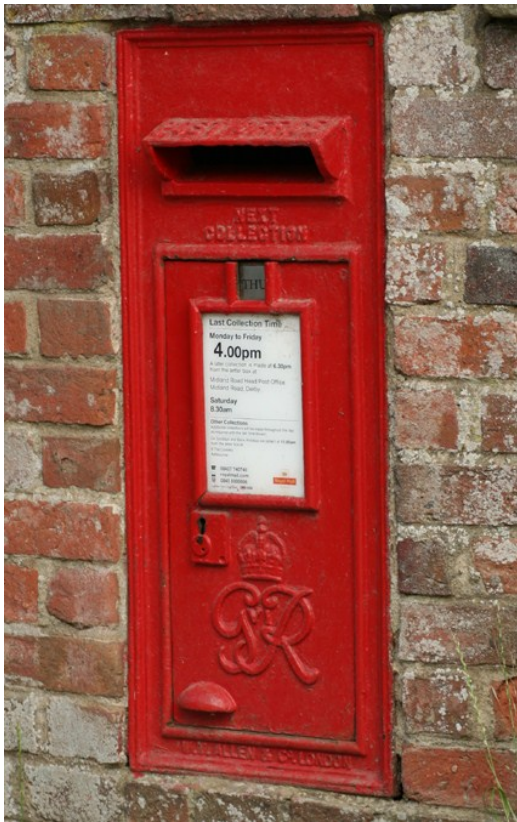
Left - Wall mounted red letter box (GR for George Rex), circa 1950
