# Milton *Conservation Area* Character Statement

**2013**

**SOUTH DERBYSHIRE  
DISTRICT COUNCIL**

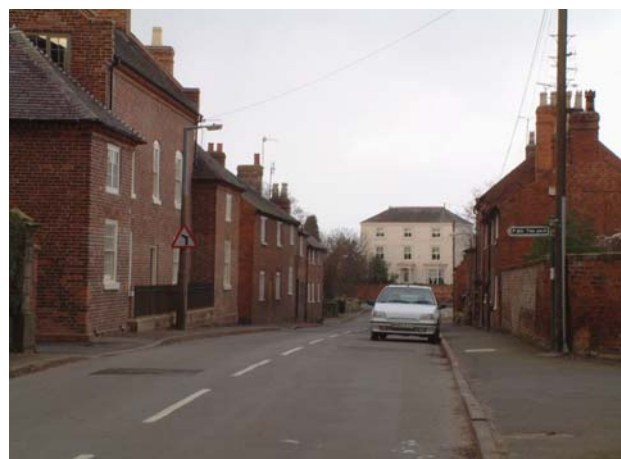
*View along Main Street*

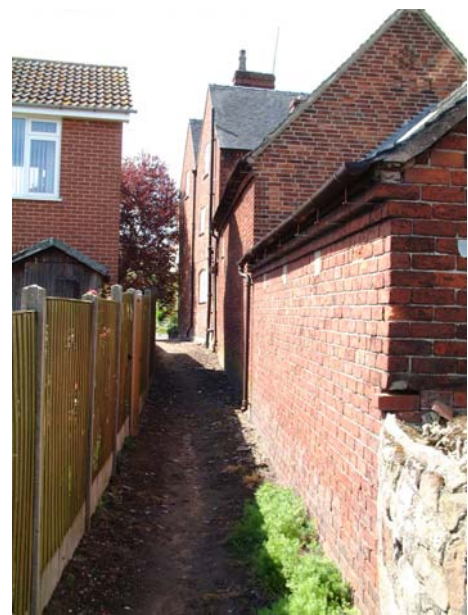
*Narrow passage—public footpath leading to Mill Farm*

There is limited public access between the brook and the built-up area although there is a public footpath running from the Main Street to the north of Mill Farm. The wooded edge of the valley defines the east edge of the conservation area.

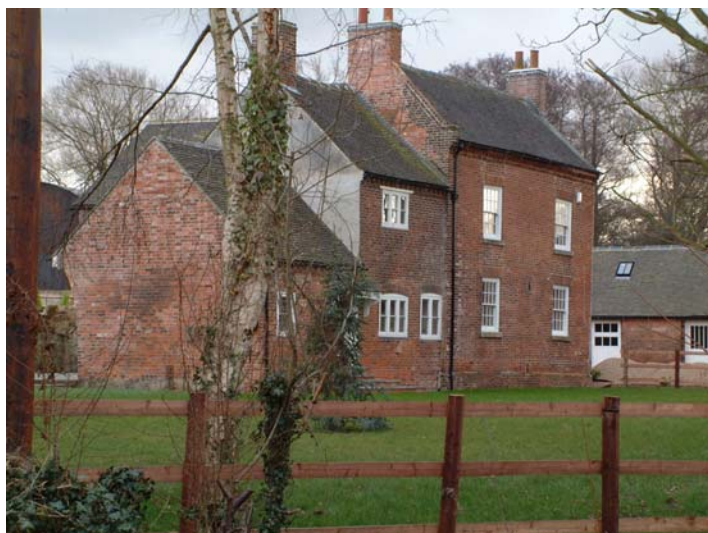
*Mill Farm*

The brook supported a water mill and a late 19<sup>th</sup> century fishery. Remains of the fishery stews can still be seen, as can the remains of the broad leat to the mill pond and the shell of the mill building itself, now converted to residential use.

Milton is dominated by its three-storey farmhouses and farm complexes. Three of the farms share common characteristics. Mill Farm, The Farm and Common Farm all share moulded brick eaves, brick-coped parapet gables, gauged brick lintels and sash windows. Brook Farm also probably had brick-coped gables, later removed. It would, however, be a mistake to assume that they were built by the same estate. Mill Farm and Common Farm were Calke estate property until 1824, while The Farm was already Burdett property in

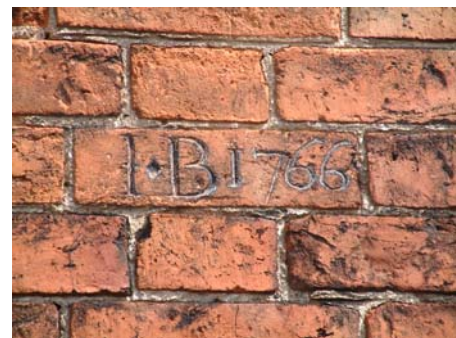
*Initialled and dated brick at Brook Farm, built by the Brown family in 1766*

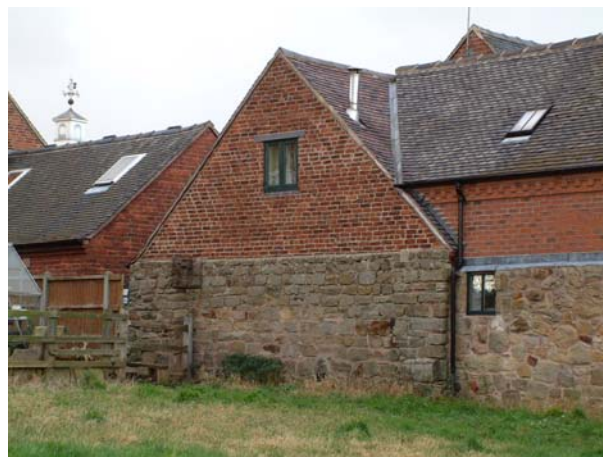
*Stone and brick at The Farm*

There is physical evidence for earlier buildings having been built in coursed and squared stone, or simply rubblestone, but the examples of this are scarce, most having been replaced during the 19<sup>th</sup> century with brick buildings. The range of 2½ storey cottages on Main Street (11-15) incorporates a stone plinth, which appears to be original to the late 18<sup>th</sup> century construction. The same detail appears at Brook Farmhouse and the boundary wall that served its former farmyard. Other buildings that incorporate a stone plinth are generally related to earlier footings of buildings that fronted the road. Lilac Cottage (10 Main Street) is an 18<sup>th</sup> century brick reconstruction. It has a 17<sup>th</sup> century plan form and incorporates a stone plinth and section of gable wall, also belonging to its earlier history. Ivy Cottage has footings from an earlier building that was probably set gable-end onto the road and 5 Main Street also incorporates a section of coursed stonework, revealing an earlier building on this site.

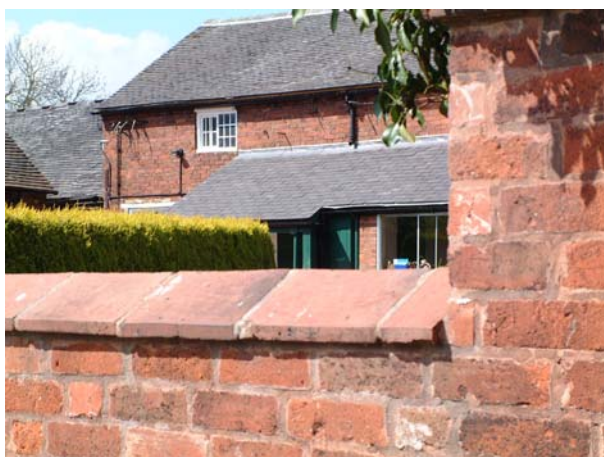
*Boundary wall at Common Farm*

Although the buildings are largely brick, boundary walls are built from local sandstone or red brick. There are only two instances of the use of railings (The Farm frontage and Kirby Holt).

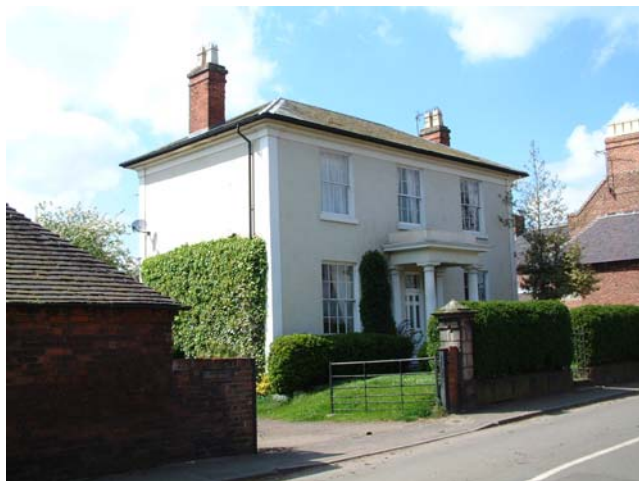
*Kirby Holt*

Other prominent historic buildings are those built during the first half of the 19<sup>th</sup> century, such as the villa No. 22 (Kirby Holt). The care and attention to detail lavished on this house reflects its private ownership by the Somers family who appear to have built it and put it up for sale in 1869. This and Holly Grange stand out with their generous front gardens, a fashion of the early 19<sup>th</sup> century, although the front of Holly Grange was rebuilt in the later 19<sup>th</sup> century and it has since lost its garden setting and enclosure.

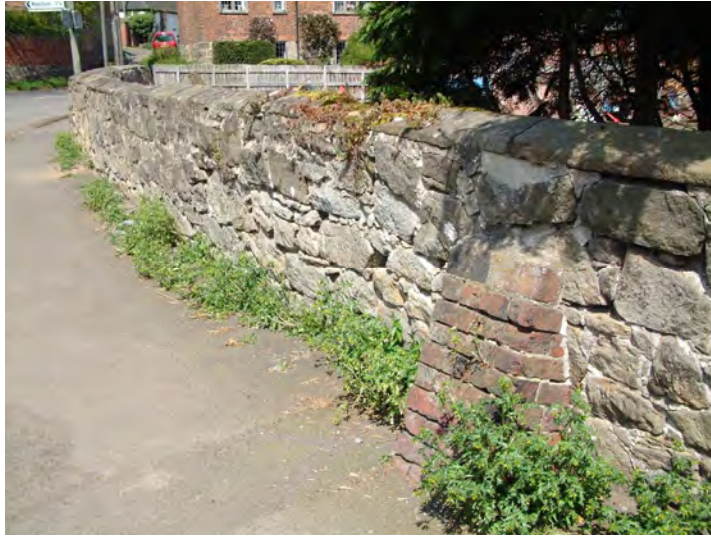
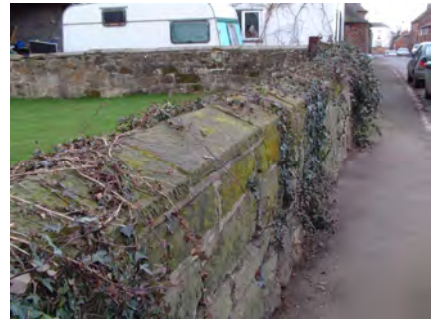
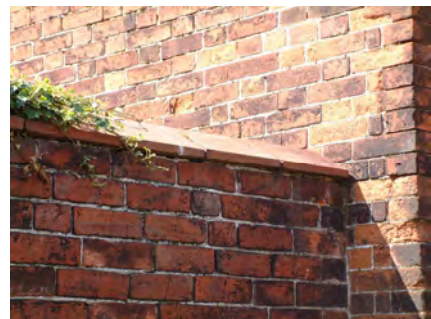
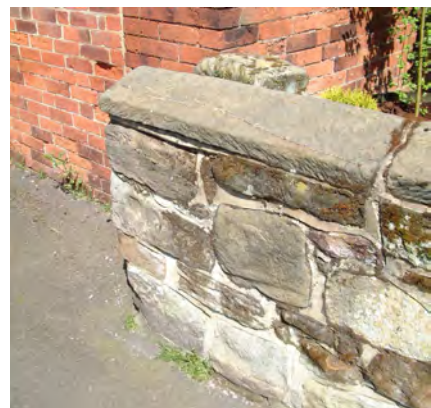
## BOUNDARY TREATMENTS

Within Milton boundary walls are predominantly local sandstone, with dressed stone copings, triangular or half-round, more rustic than genteel in character. There are a few instances of brick boundary walls, finished in red clay copings but only two surviving examples of wrought-iron railings set into a stone plinth, of which the example at The Farm (below) has recently been restored.

- Stone boundary walls with triangular chamfered stone copings
- Red brick boundary walls with moulded red clay copings
- Traditional wrought-iron railings, directly set into ashlar plinth walls, sometimes with cast-iron finials

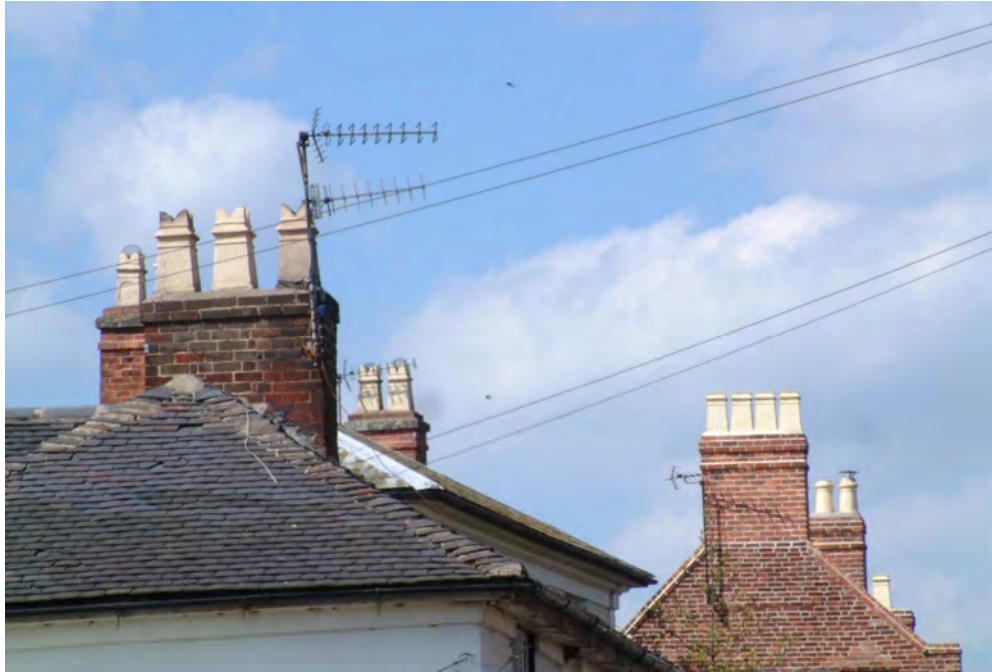
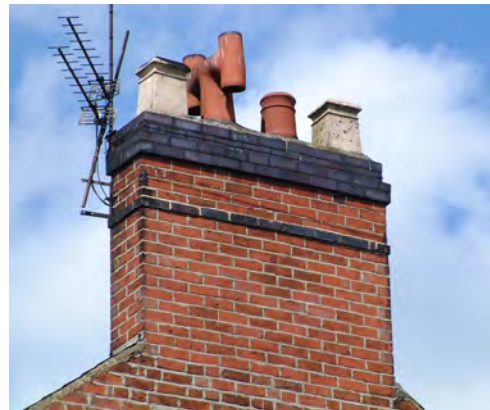
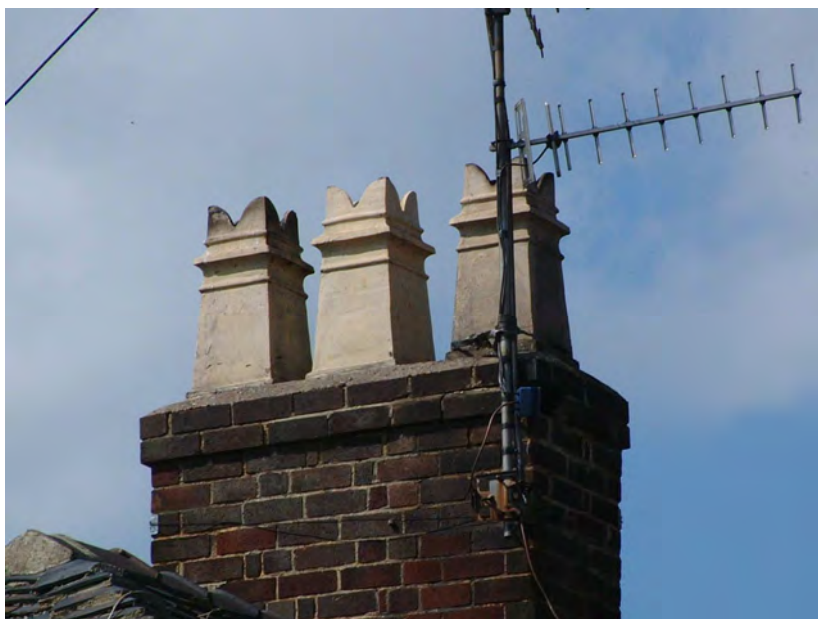
## CHIMNEY STACKS AND POTS

Milton has a distinctive roofscape, emphasised by the uniform character of the chimney stacks and pots. Buff-coloured square and square spiked pots are the dominant pattern.

Blue bricks were occasionally used as an oversailing course, where a stronger brick was required (right), but this was generally a late 19th century replacement, carried out for practical reasons, rather than for decorative effect.

- Buff-coloured and square spiked pattern chimney pots (Burdett Estate)
- Simple brick stacks with a few plain oversailing courses

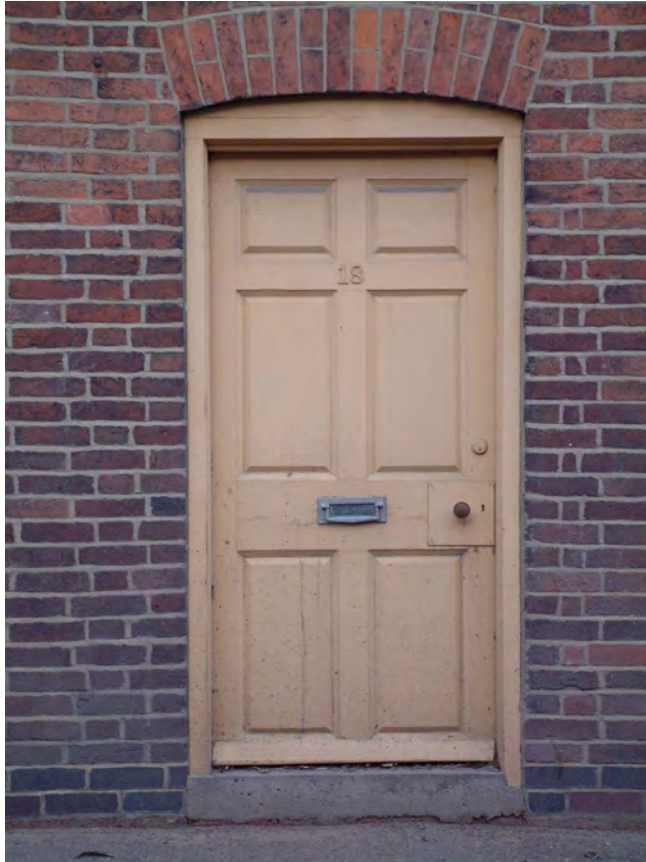
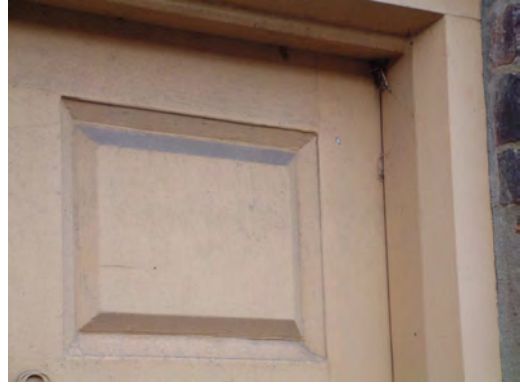
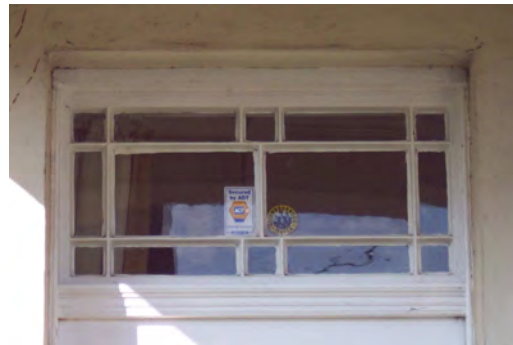
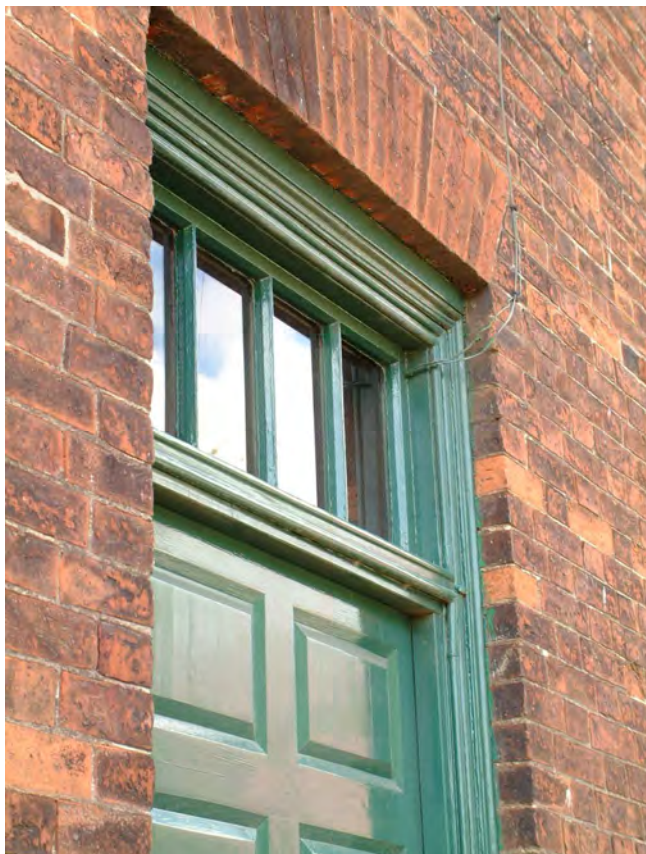
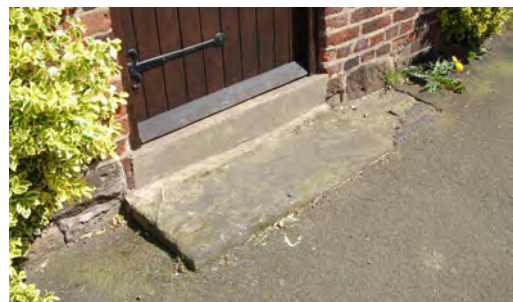
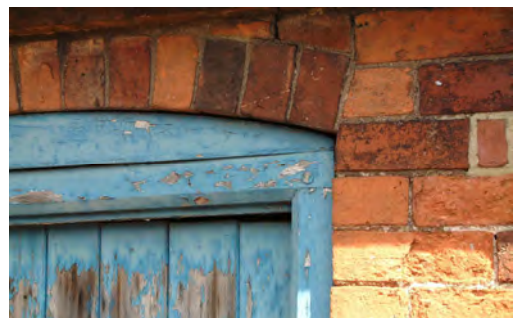
## DOORS

Of the few surviving historic doors in Milton, the “double chamfer” 6-panel door is the most common (left, bottom left and detail above). For the smaller cottages, door frames were kept simple with a chamfered and timber pegged construction. Many doors may have been constructed with vertical boards. They usually incorporated a stone threshold. In the early 19th century fanlights were reserved for the better houses (below and bottom left).

- 6-panel double-chamfer and raised and fielded panelled doors
- Pegged and chamfered frames
- Rectangular fanlights

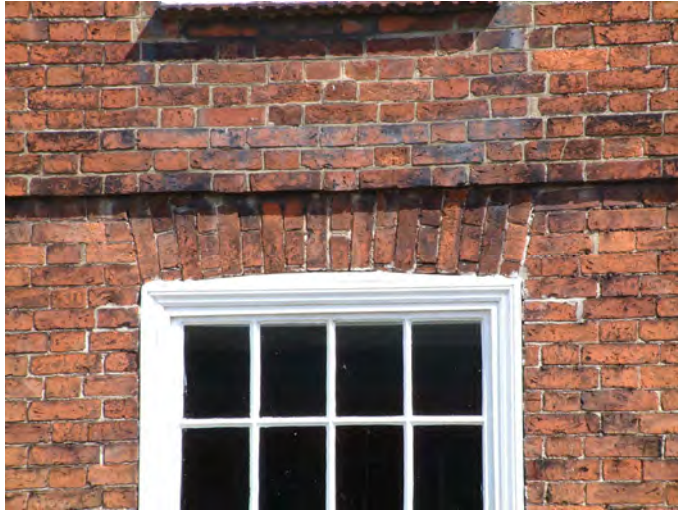
In Milton, brick lintels incorporate the full range of techniques available to the bricklayer, from the most complex and expensive to fabricate - the cambered arch (left) and the gauged lintel (below left) - to the cheapest type of construction - the segmental arch (below). This could be a single course of “headers” or a full brick deep.

- Segmental brick arches
- Gauged brick lintels. Gauged brickwork incorporates fine lines of "false" incised horizontal joints, designed to be picked out in white lime putty mortar
- Plain brickwork without masonry cills
- Ashlar stone cills

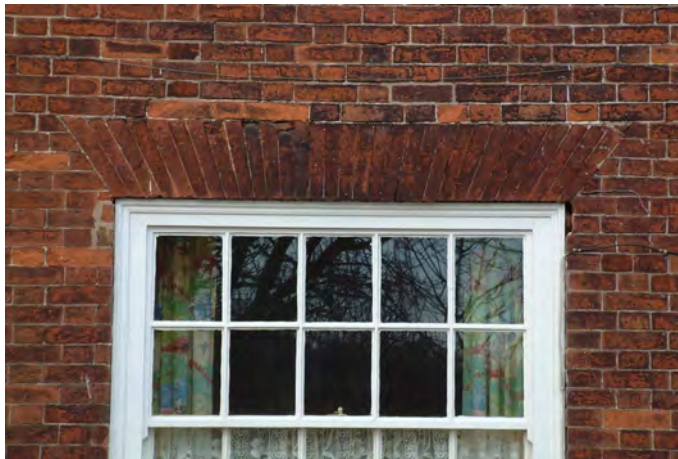
Gauged brick lintels were made from special hand-rubbed bricks incorporating incised lines to simulate fine lime-putty joints (below left).

Timber lintels were often used for the first floor window under the eaves (below), where there was insufficient depth for a stone lintel or segmental arch.

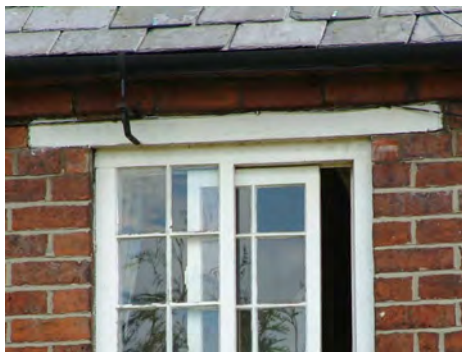
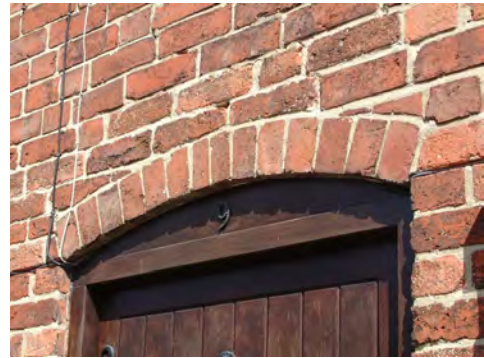
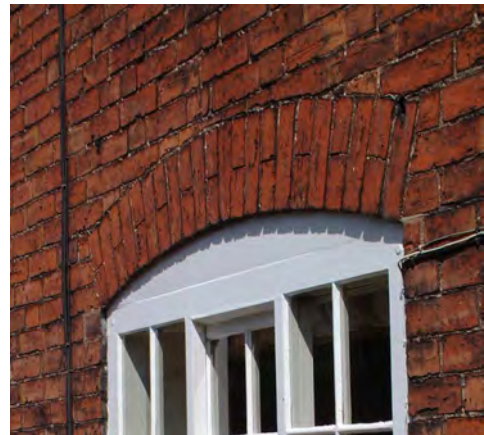
Above - segmental arch

The larger properties generally have stone cills (right), whilst the smaller cottages were originally built without proper cills (far right), although tile-creasing and timber cills were sometimes added later.

In combination with the brick arches, cills were usually omitted, relying on the simple weathering properties of the brickwork, even on the more substantial properties. Several of the more substantial houses and farmhouses have dressed stone cills.

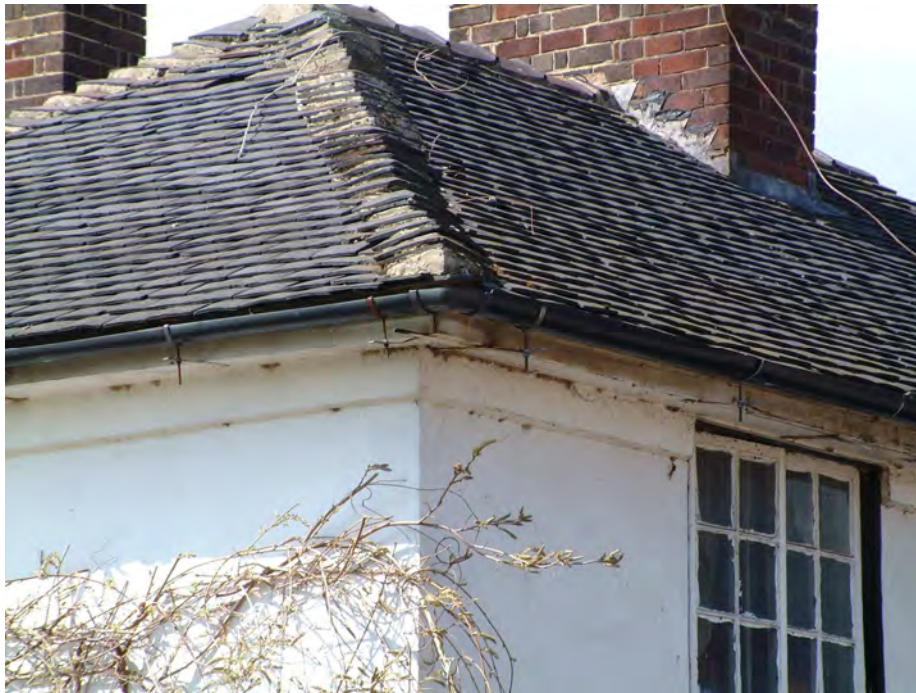
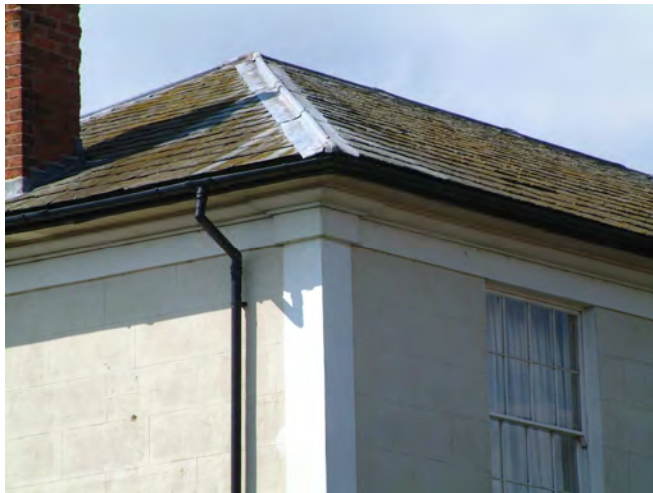
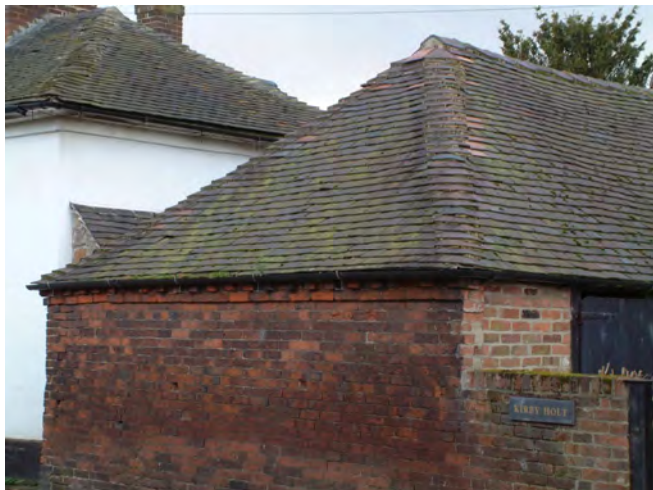
## ROOF TYPES AND DETAILS

Hipped roofs are a distinctive feature of Milton (above and left) as are raised coped gables in brick with a brick-on-edge coping (Common Farm - bottom right). These were generally used on the higher status buildings; villas and farmhouses. The most common roof type, used for the majority of small cottages, is the pitched roof with a plain close verge.

Hipped roofs in clay tiles incorporate special clay “bonnet” hip tiles (bottom left). Graduated Burlington slate, used at Kirby Holt (left), has hips cloaked with lead flashings covering timber rolls.

There are two types of traditional roof found in Milton – the gable roof and the hipped roof. A variation in the gable roof can also be found where a parapet has been added at the gable-end, as at The Farm, Common Farm and Mill Farm. These parapets are simply finished in brickwork. The vast majority of gable roofs in Milton are finished with a plain close verge, where the tiles or slate simply overlap the brickwork. Hipped roofs are less common (e.g. Kirby Holt, 24 Main Street, The Coach House and examples at The Farm).

- Hipped roofs (The Farm, Kirby Holt, The Old Coach House, 24 Main Street, outbuilding to Kirby Holt)
- Plain close verges, and occasional corbelled verge
- Raised coped brick gable parapets

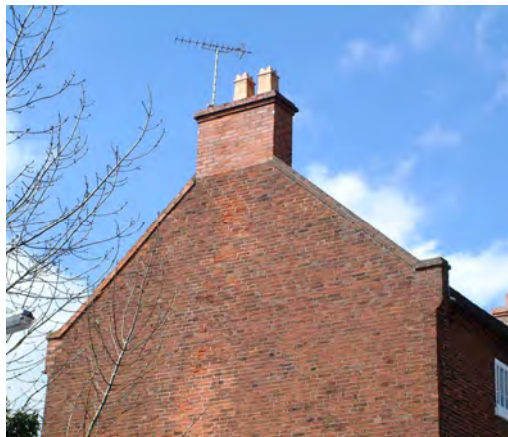
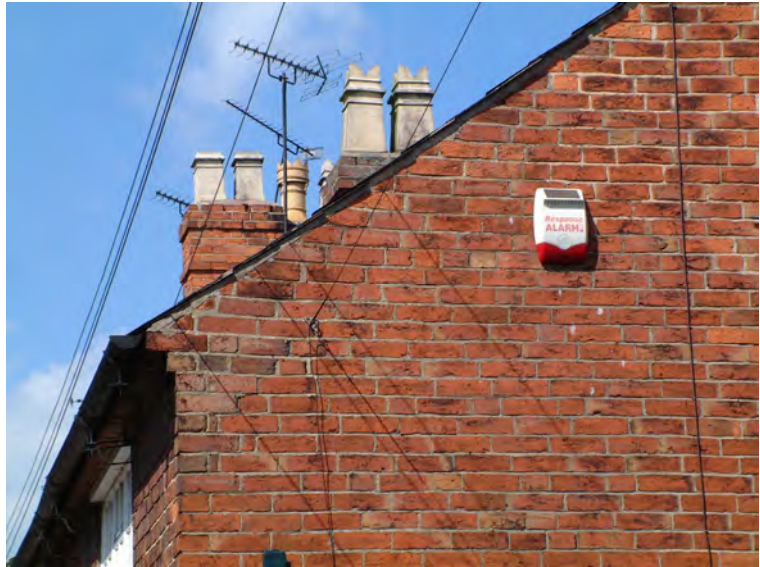
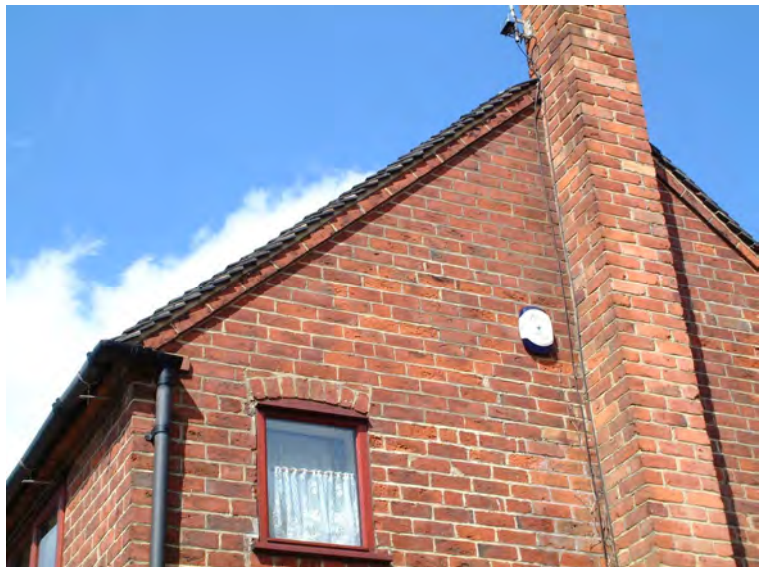
Pitched roof with a plain close verge and corbelled eaves (right), the simplest and most common type of construction.

There is occasionally a corbelled verge, designed to throw rainwater away from the brickwork (below right - No.1 The Hollies).

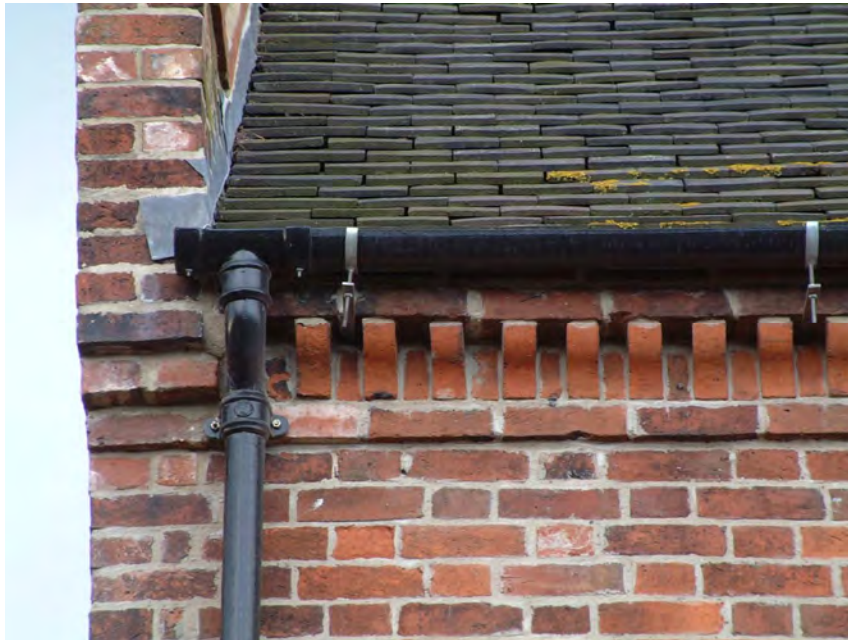
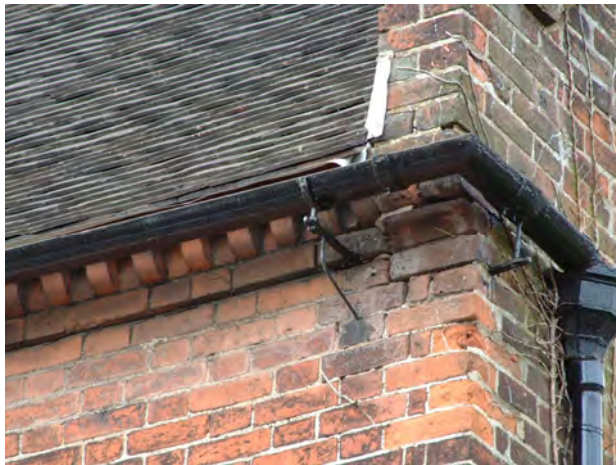
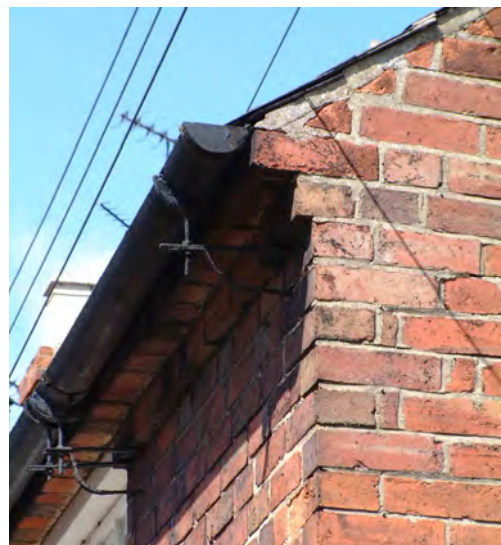
## WALLS - BRICKWORK DETAILS

Moulded brickwork at the eaves (above and left). These were specially shaped bricks made in moulds, a refinement of the more common dentilled pattern created with standard bricks. This is common on the larger farmhouses. These are used in combination with a raised coped brick gable.

Many of the traditional cottages have a plain corbelled eaves (right), one of the simplest and most common types of construction.

- Dentilled and corbelled brickwork at the eaves
- Moulded brickwork at the eaves. These were specially shaped bricks in moulds, a refinement of the more common dentilled pattern created with standard bricks. These are used in combination with raised brick gable parapets (The Farm, Common Farm, Mill Farm)

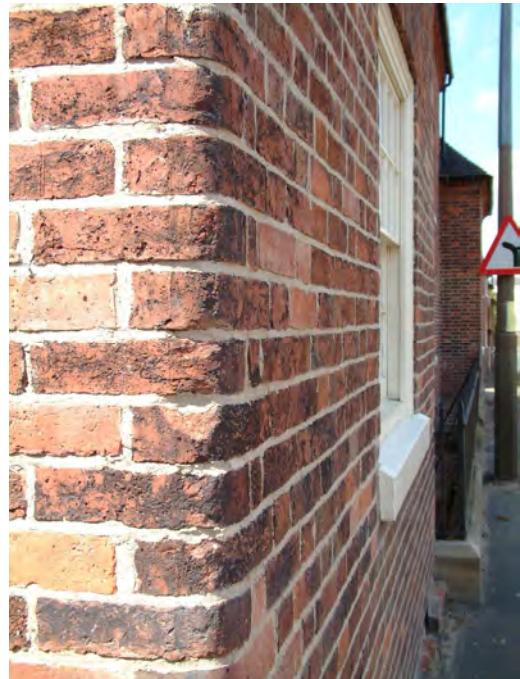
Flemish bond brickwork with penny-struck joint (above) can be found on both the farmhouses and smaller cottages.

The rounded, moulded bricks used to protect corners of buildings from physical damage (The Farm - right) are a local feature of several villages in South Derbyshire.

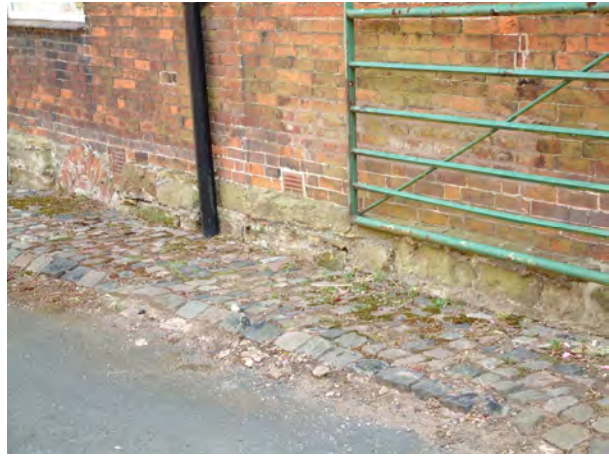
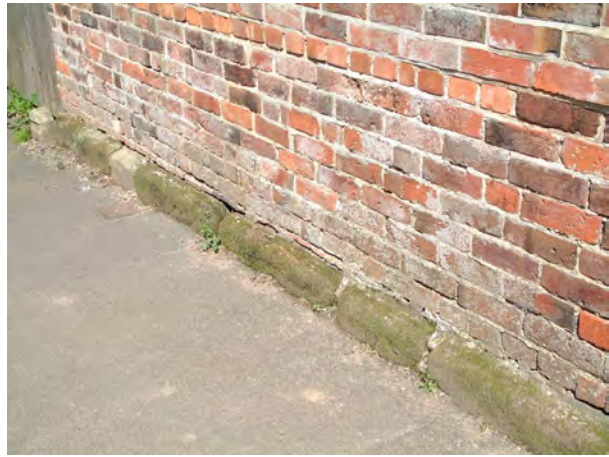
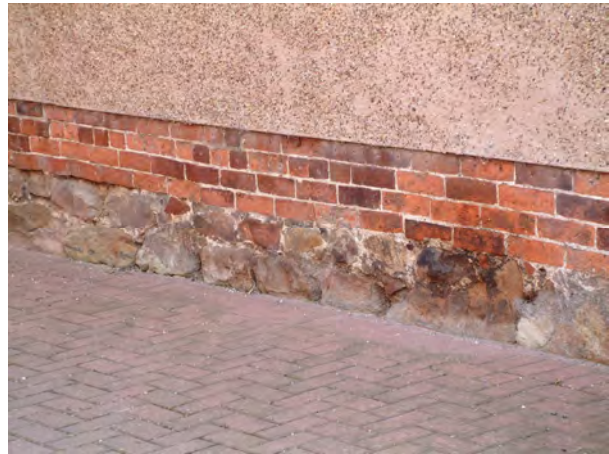
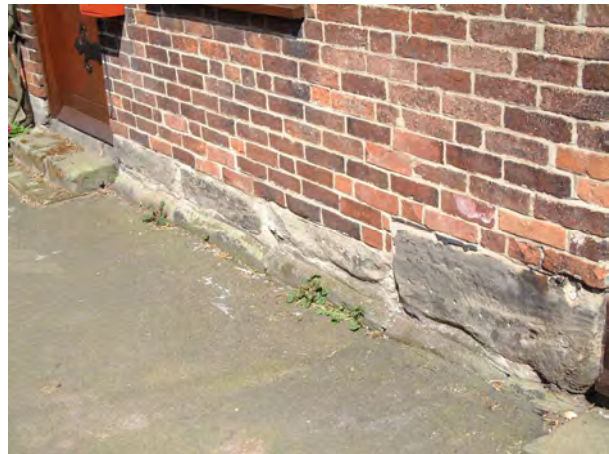
## WALLS - Plinths

Milton has a number of brick buildings with a shallow stone plinth. In some cases this represents the rubblestone footings of an earlier building on the same site, but it was also adopted as a base for new walls (roughly coursed examples - right).

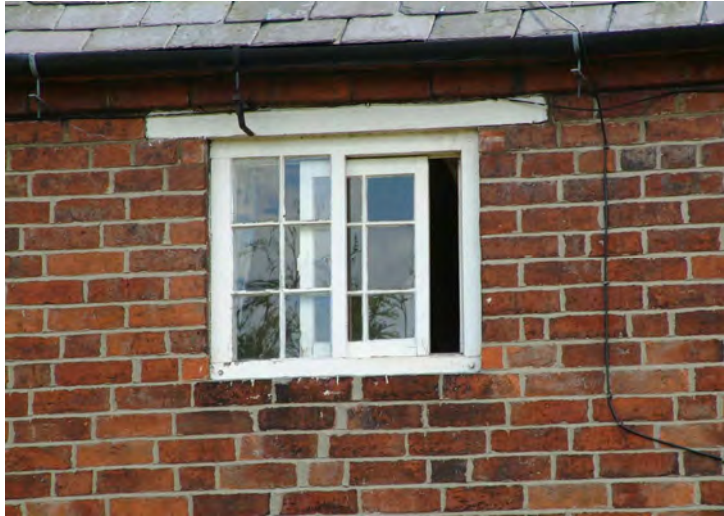
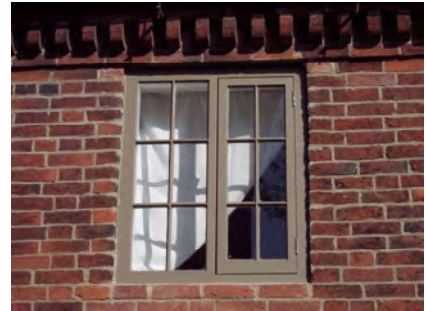
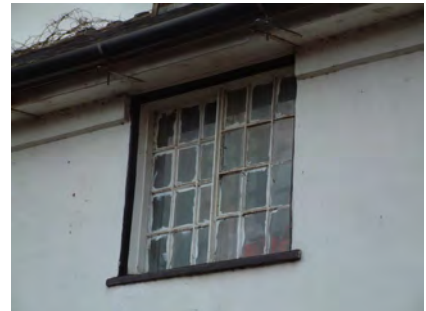
## WINDOWS

Within Milton the main historic window types were vertically sliding sashes (below and below right) and timber casement windows, set within chamfered timber frames. There were also occasionally horizontally-sliding sashes, also known as Yorkshire sashes (above and bottom right). There are now few examples left of the once common casements. The example from The Farm (top right) is a recent copy of a traditional style.

Above - horizontally-sliding multi-paned Yorkshire sash

- Casement windows
- Yorkshire horizontally sliding sash windows
- Vertically sliding small-paned sash windows, most with visible sash boxes, set flush with the brickwork

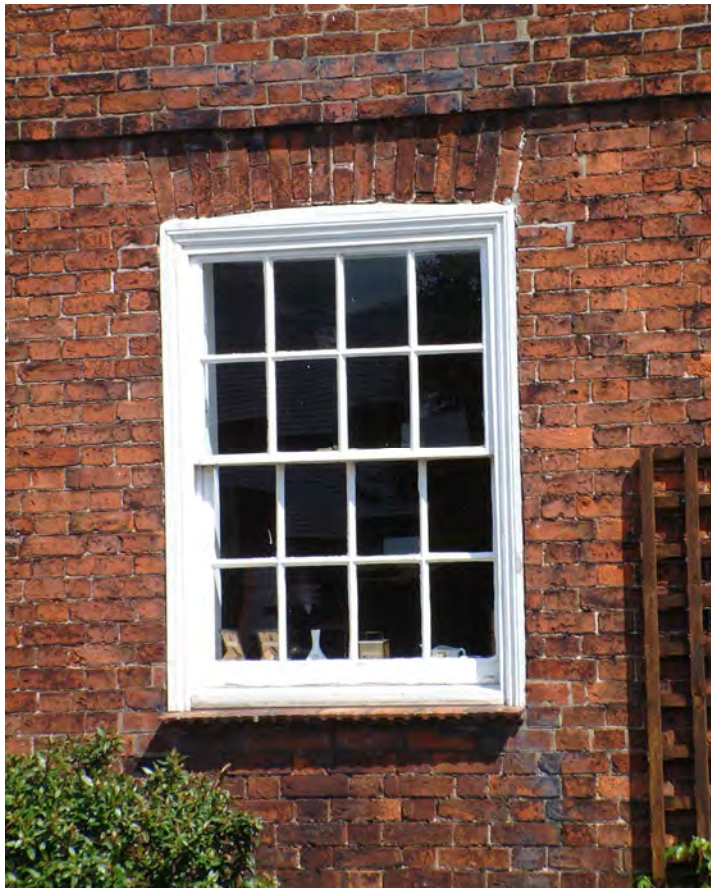
Below - vertically-sliding sash windows (8 over 8 panes)

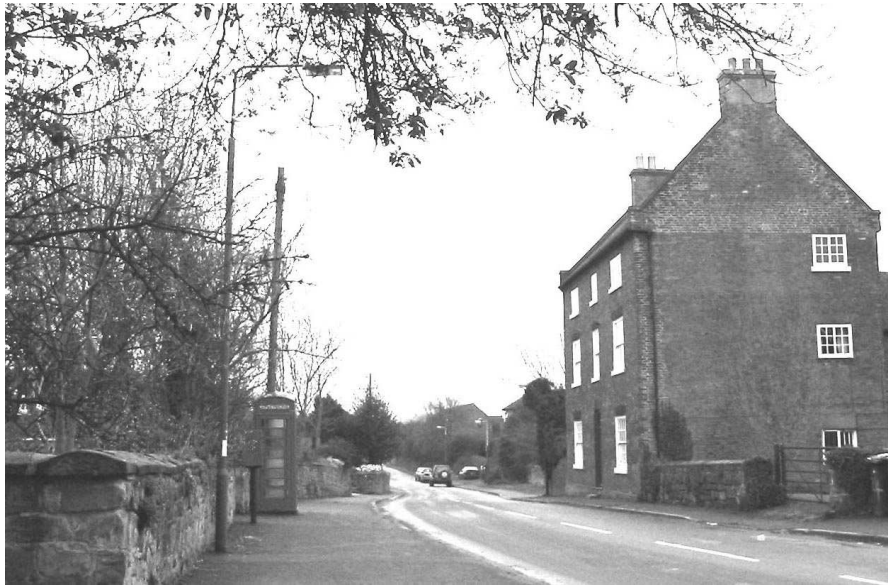
(grid ref. N 432, 059 / E 326, 471)

Below - Listed Grade II K6 red telephone box (Sir Giles Gilbert Scott Design) at the north side of entrance to Mill Farm.
