Bretby *Conservation Area* Character Statement

2011

**SOUTH DERBYSHIRE
DISTRICT COUNCIL**

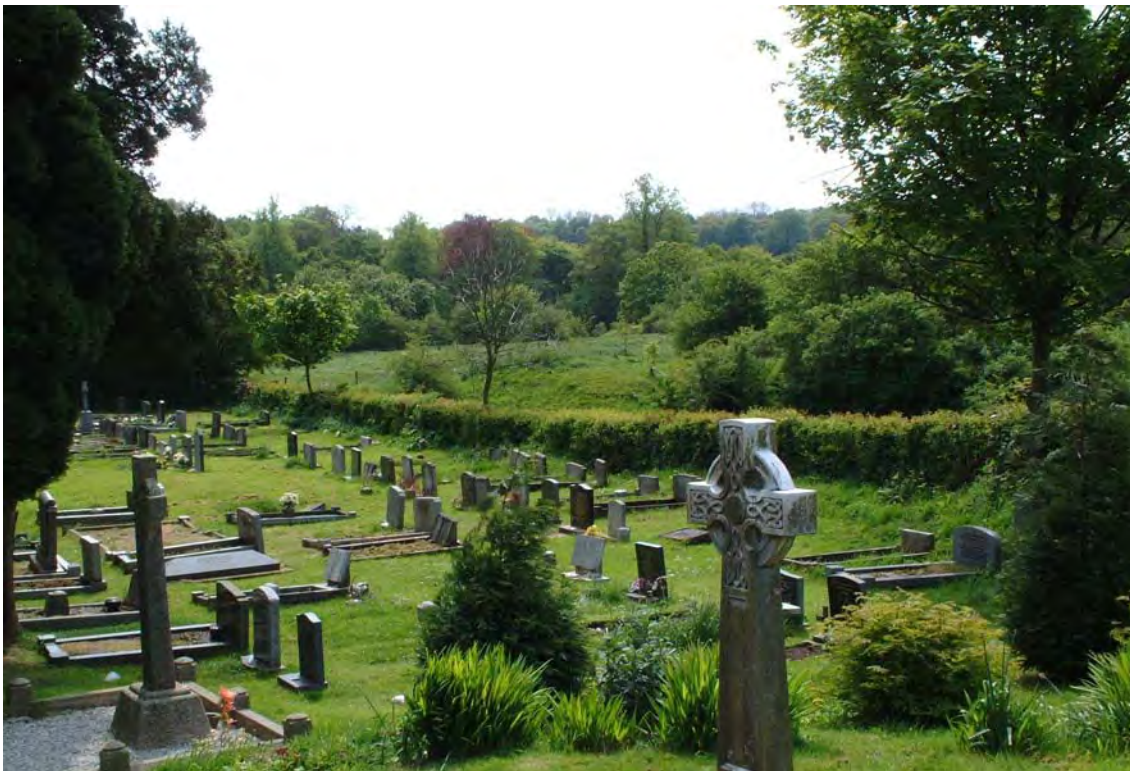
View of the Castle site from the church yard

- from the Village Green looking south across the shallow valley into the Park
- from the church looking north-west to Bretby Mount
- from the churchyard looking west to the site of Bretby Castle

In all three cases time has taken its toll - the numbers of trees has depleted and the ruins of the Castle have dwindled to grassy mounds, but these are nevertheless strategic views of long-standing.

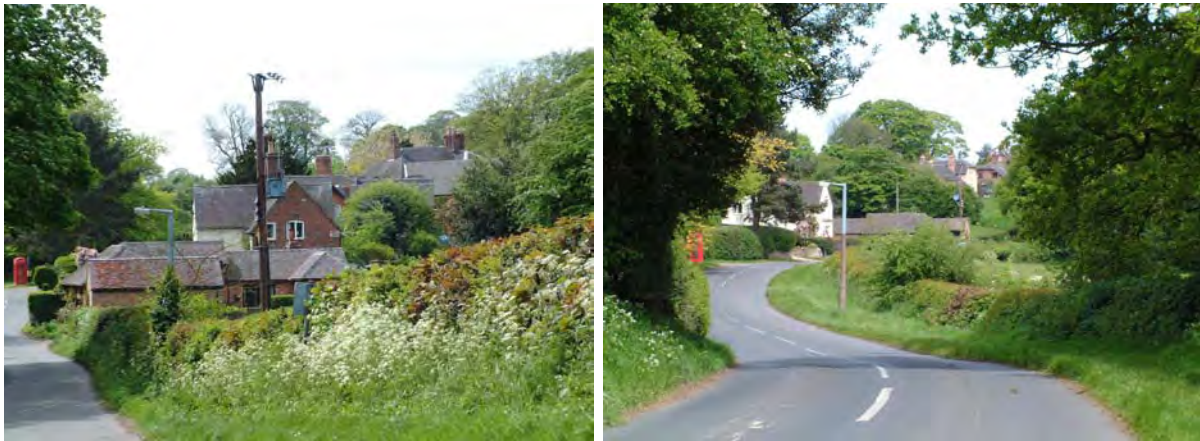
Views towards the Village Green from the east (left) and west (right)

From the Village Green and along this length of road there are long views into the park to the south east. It is likely that before the growth of Philosopher's Wood there would have been clear views of the original 17th century house from The Green.

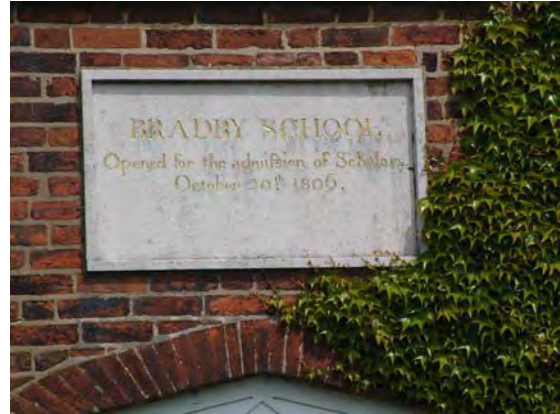
School sign 1806

The 5th Earl of Chesterfield built two schools on the village green, one for boys on the east side and a later one for girls on the west side. The boys' school also had a schoolhouse for the master. The boys' school has an inscription, which reads "Bradby School – Opened for the admission of scholars October 20th 1806" (pictured right). The former girls school on the other side of The Green is now rendered and has less tangible evidence of its historic use but shares features in common with the boys school, i.e. a central 2-storey hipped roof, single-storey wings and star-shaped chimney stacks, which were an interpretation of a Tudor stack. The boys' school still incorporates Gothick glazing, but the original windows in the girls' school have been replaced.

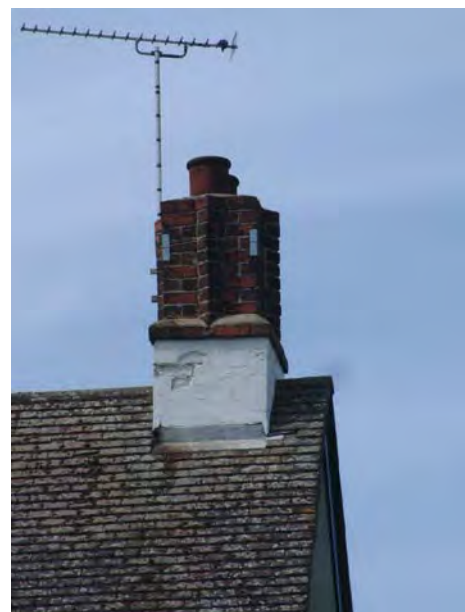
The lowered remains of an original star-shaped chimney

One of the most striking features of the village is the decorative brick chimney stacks. These do not follow any vernacular tradition but appear to have been adopted by the estate as a device to add a picturesque quality to the buildings. There are several types. The earliest is the star-plan chimney, found on the two former school buildings. Fragments of two such stacks also survive on the stone and rendered house below the church, suggesting that it might have earlier origins than its late 19th century appearance would suggest. Then, chronologically there are several variations of ribbed and panelled brickwork found on the buildings at The Square and Rose Cottage (The Green).

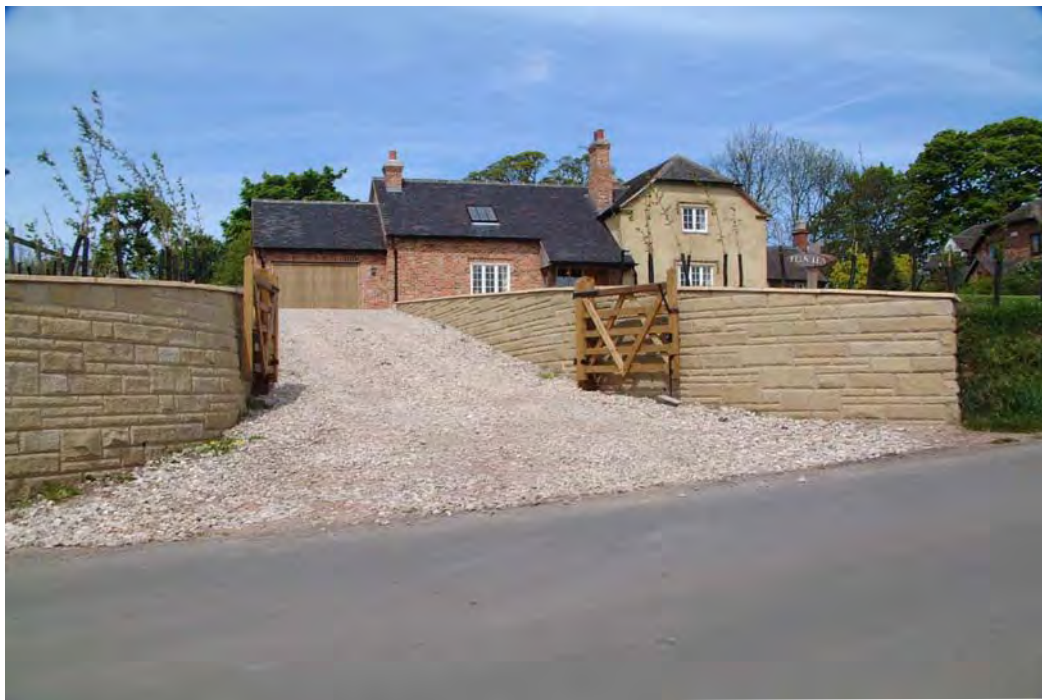
Fern Lea, The Square - stone walls with sharp-edged and snecked courses

The boundary wall in front of Fern Lea (The Square), that retains the garden, is quite dominant and has been constructed in “snecked” sawn stone. This is an unfamiliar treatment in this rural setting, where coursed rubble stone walls are the traditional hard boundary feature.

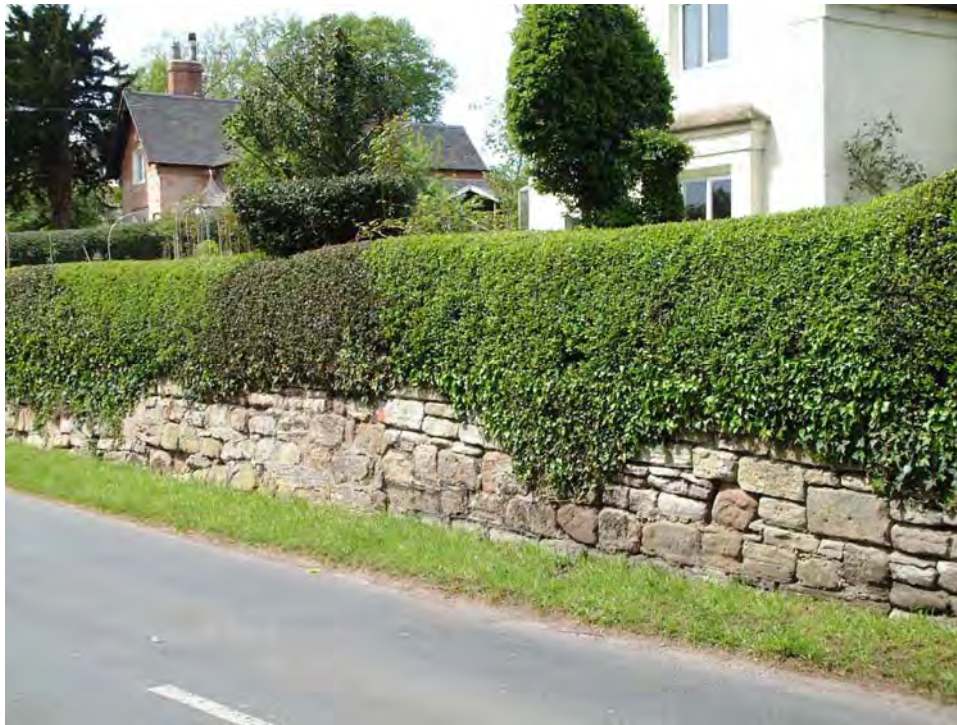
Within Bretby village boundaries are predominantly hedges of hawthorn and holly (bottom), with the occasional stretch of privet. There are few walls. The local sandstone in front of Rose Cottage (above) is one of only two traditional stone walls in the conservation area. The other, at Home Farm (right), is evenly coursed stone, reputedly taken from the castle ruins.

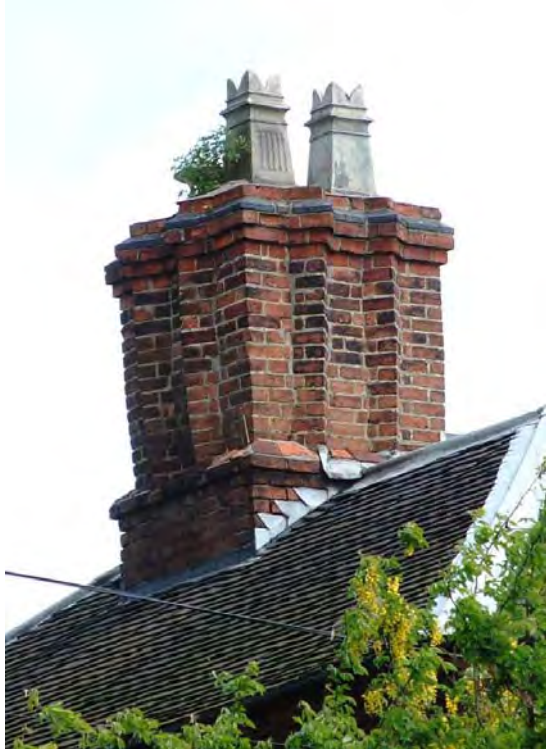
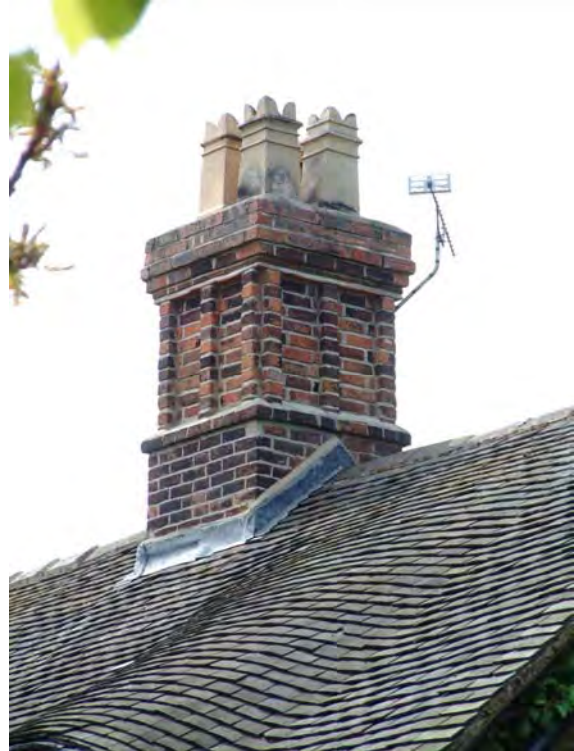
CHIMNEY STACKS AND POTS

The picturesque chimney stacks of Bretby village present the visitor with one of its most distinctive and enduring images.

They were built from local hand-made red brick. There are some common themes or patterns; star-shaped on plan (above), and those with raised strips of brickwork creating panels (right). Chimney pots are predominantly buff-coloured, and square shaped, sometimes with spikes.

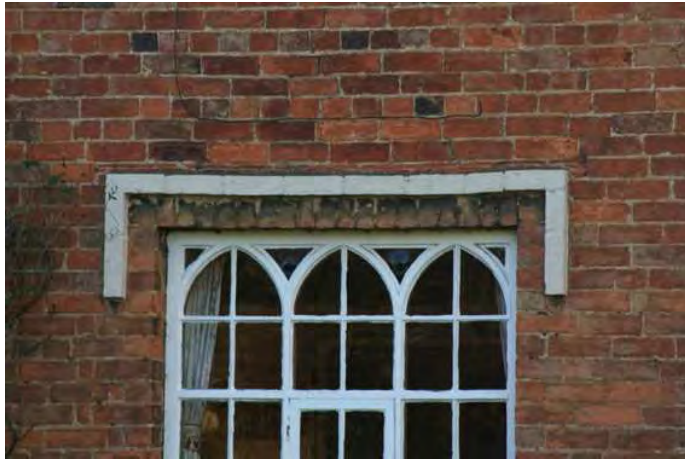
Left - hood mould constructed from painted bricks, over soldier course of brickwork forming a lintel. This window relied on the strength of the timber window to support the brickwork above.

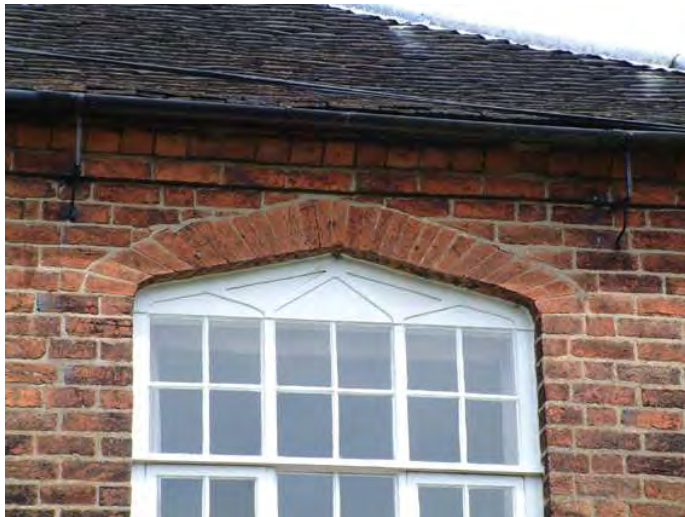
Below left - gauged brick lintel, shaped into a pointed arch.

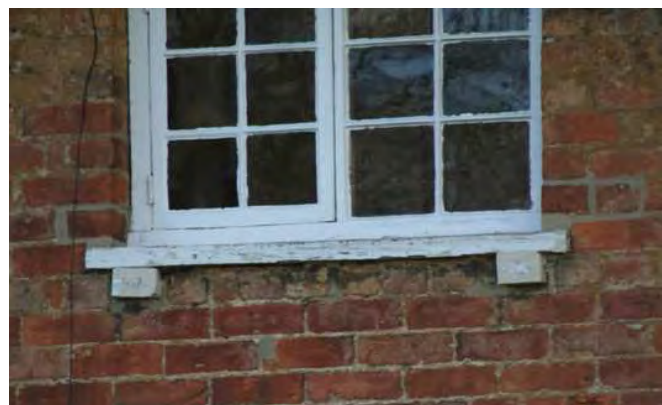
Right - although projecting cills, of any kind, were rarely used on the smallest vernacular buildings in this part of South Derbyshire, this example at Bretby (right) is quite rare. It incorporates a projecting oak cill laid on top of timber plugs.

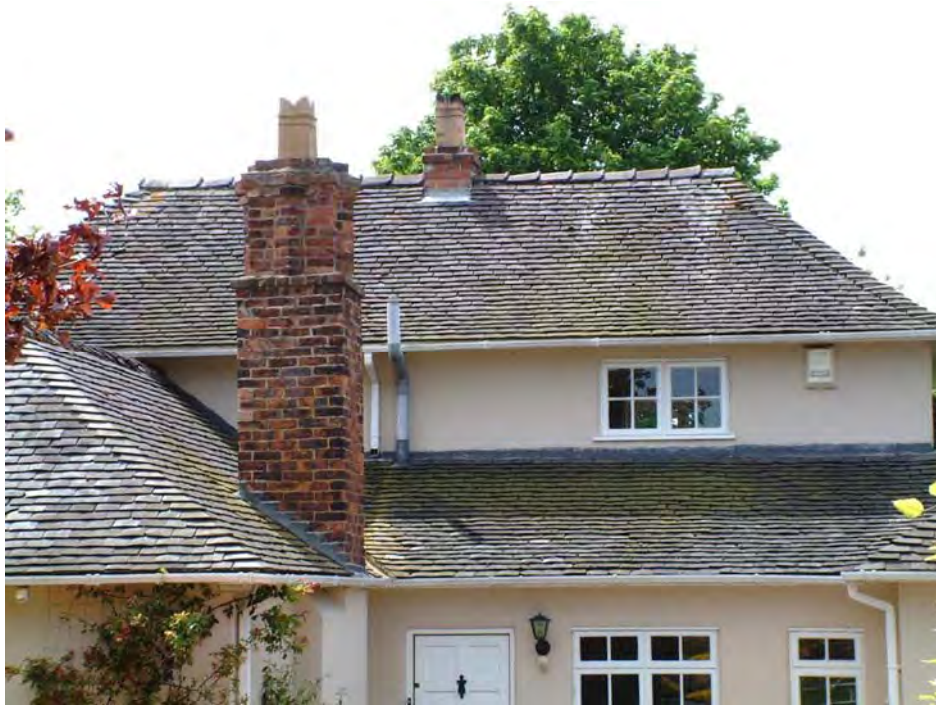
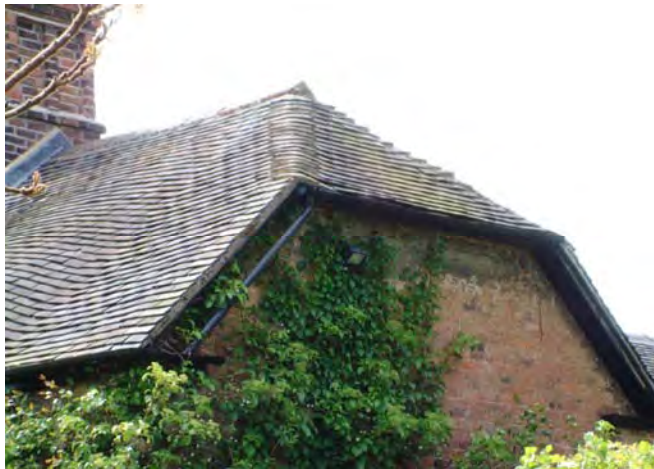
ROOF TYPES AND DETAILS

Hipped roofs (above) and half-hipped roofs with “eyebrow” dormers (left) are a distinctive feature of Bretby, deliberately used by the estate to enhance the picturesque quality of the village scenes.

The half-hipped roofs of Staffordshire blue clay tiles, with “bonnet” hip tiles and deep overhanging eaves, echo thatched roof forms. Note the contrast between wall and roof, highlighted by deep shadows.

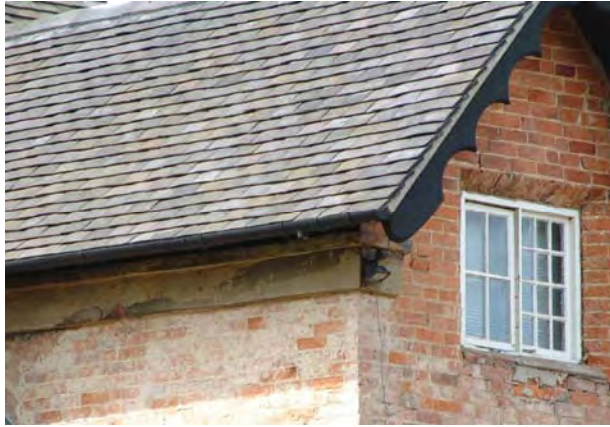
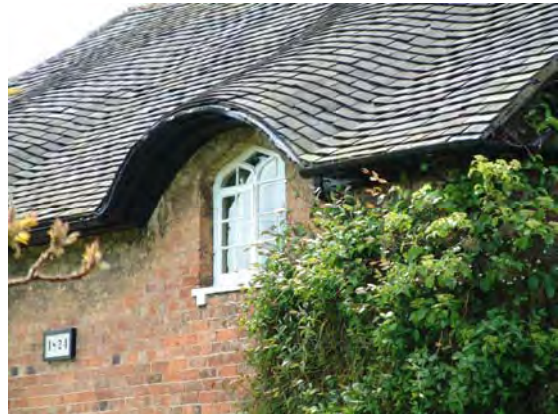
ROOF TYPES AND DETAILS

Eaves can be accentuated with a raised band, as on the 1860s examples (left) or a large overhang, as on the eyebrow dormer (below).

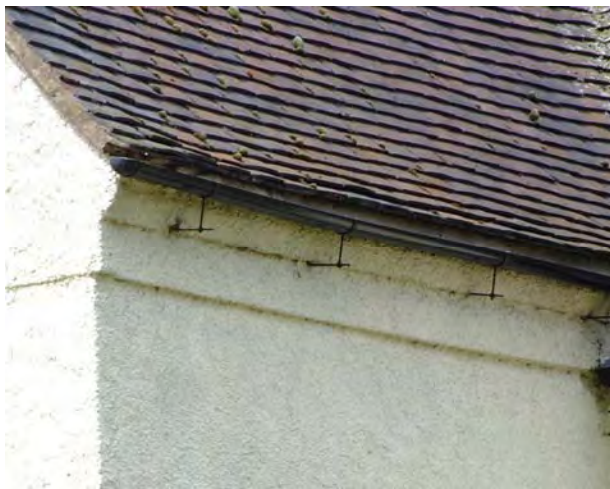
The example of decorative scalloped bargeboards at Yew Tree Cottage (right) is the only surviving example in the village.

Ornamental bargeboards create pretty shadows. They were commonly used in the mid 19th century in a style called Gothic Revival and were designed to emphasise picturesque character.

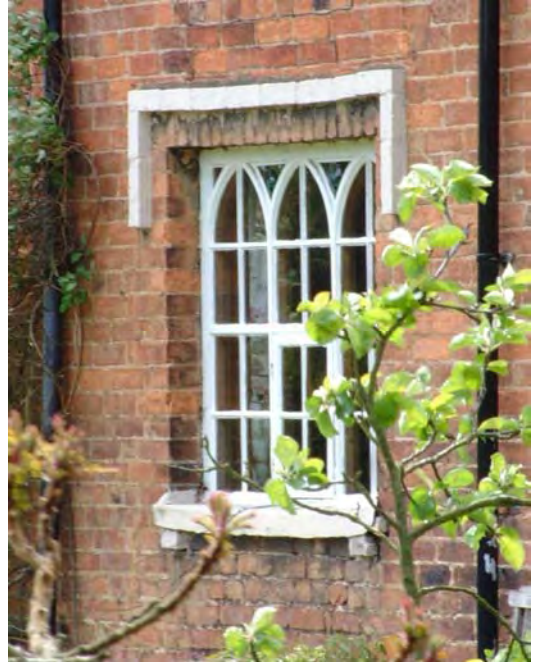
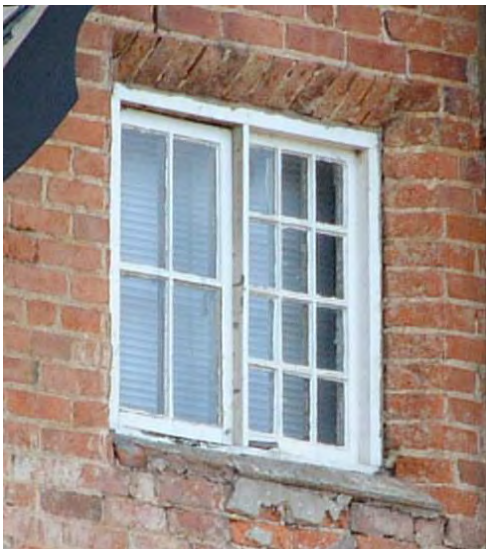
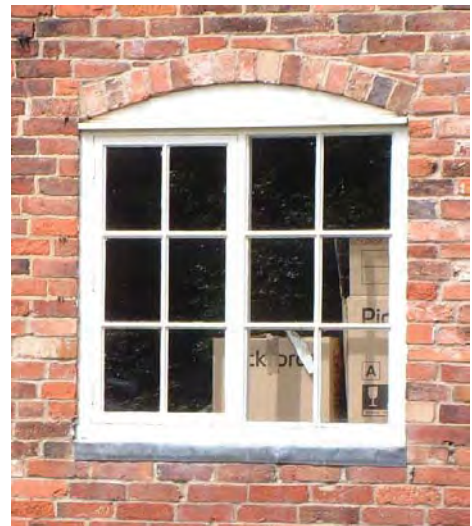
WINDOWS

Within Bretby village the main historic window type was the timber casement window. This had several historic forms based on a “Gothick” style, some with pointed arches incorporated into the joinery (right and bottom). All shared the common multi-paned, painted characteristics.

The original 12-paned casement at Yew Tree Cottage survives (below – on the right), although the left casement was later replaced by a 4-paned casement.

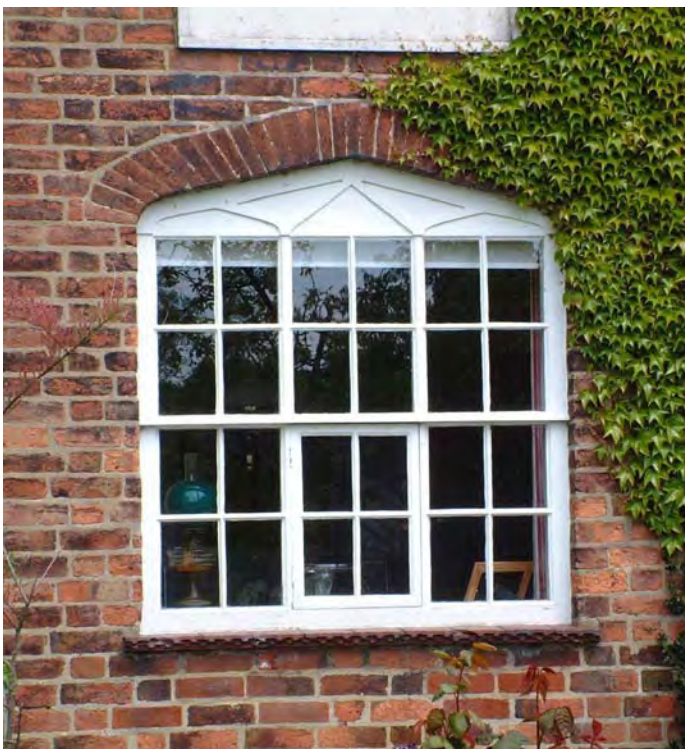
The casement windows (above) at Rose Haven are new and were based on an historic pattern.
