# Swarkestone *Conservation Area* Character Statement

**2014**

**SOUTH DERBYSHIRE  
DISTRICT COUNCIL**

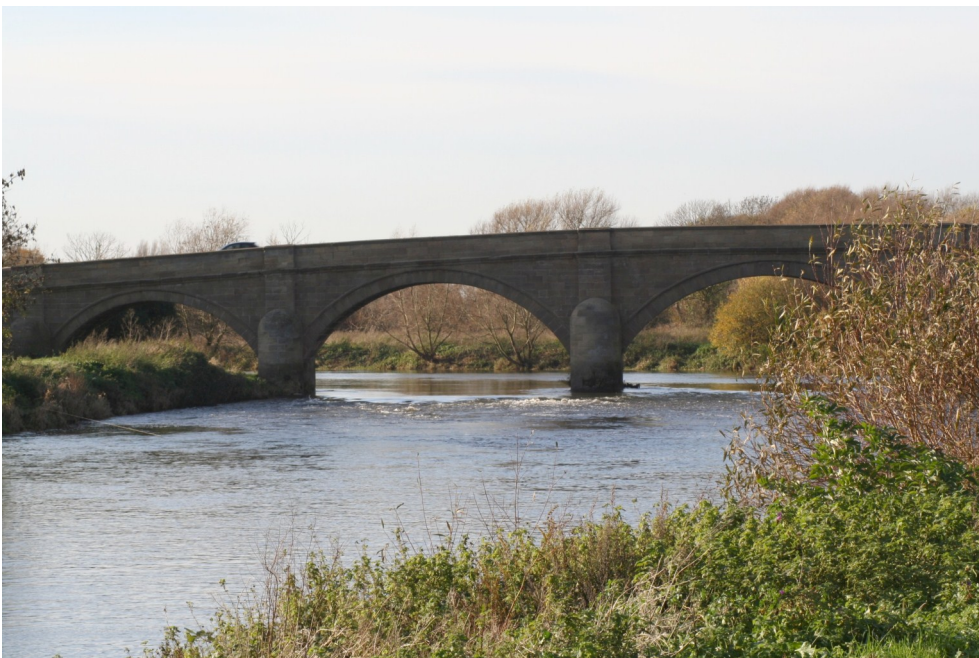
*Swarkestone Bridge 1795 - 97*

Swarkestone Bridge is a major landmark and it incorporates both the medieval causeway and the late 18<sup>th</sup> century bridge over the River Trent. The approach from the south, therefore, along the  $\frac{3}{4}$  mile long bridge provides a long meandering route across the floodplain and a sense of anticipation as there are long distant views of the small settlement on the east side of the bridge, dominated by a ribbon of brick-built cottages that front the River.

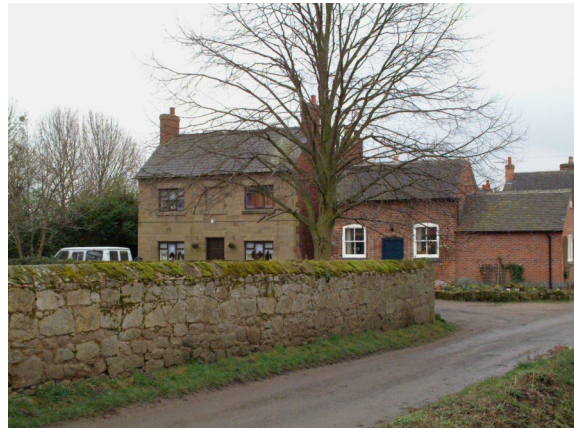
*Church House, coursed stone*

The stone buildings are of some age, with one exception (Church House), which dates from the first half of the 19<sup>th</sup> century and was simply faced with stone possibly as an expression of its increased status being located opposite the church. In addition to the bridge, the earliest stone buildings are:

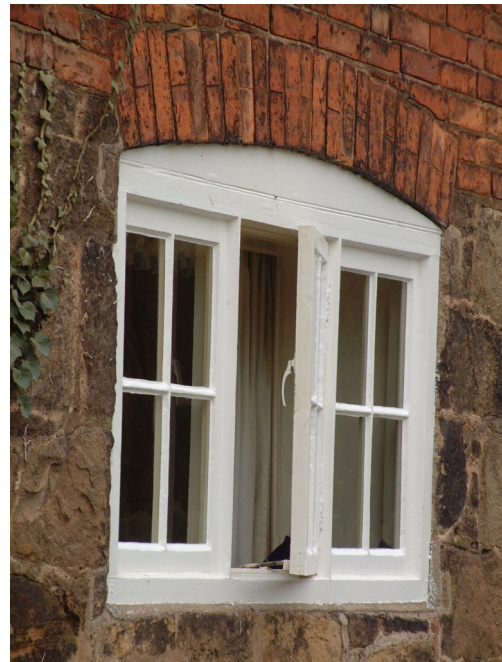
*Harpur Crewe estate casement window with chamfered frames*

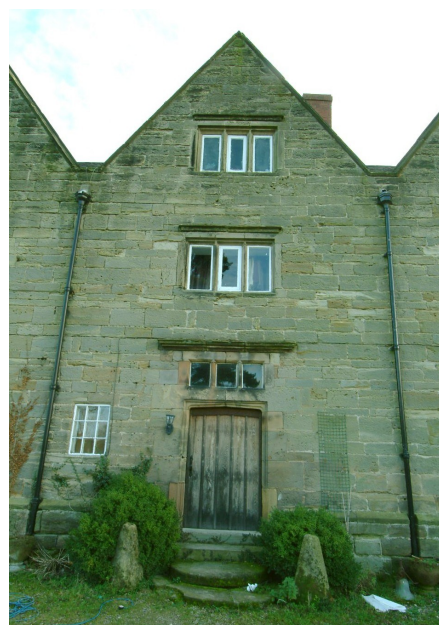
*Steep roof pitches at Old Hall Farm*

The roof pitches associated with clay tiles vary between a minimum of 35 degrees and a more typical pitch of 45 degrees, a requirement of the material. In Swarkestone the roof pitches of the early stone buildings (e.g. Old Hall Farm, Derby Road) are generally steeper than the 18<sup>th</sup> and 19<sup>th</sup> century buildings, typically 50 degrees.

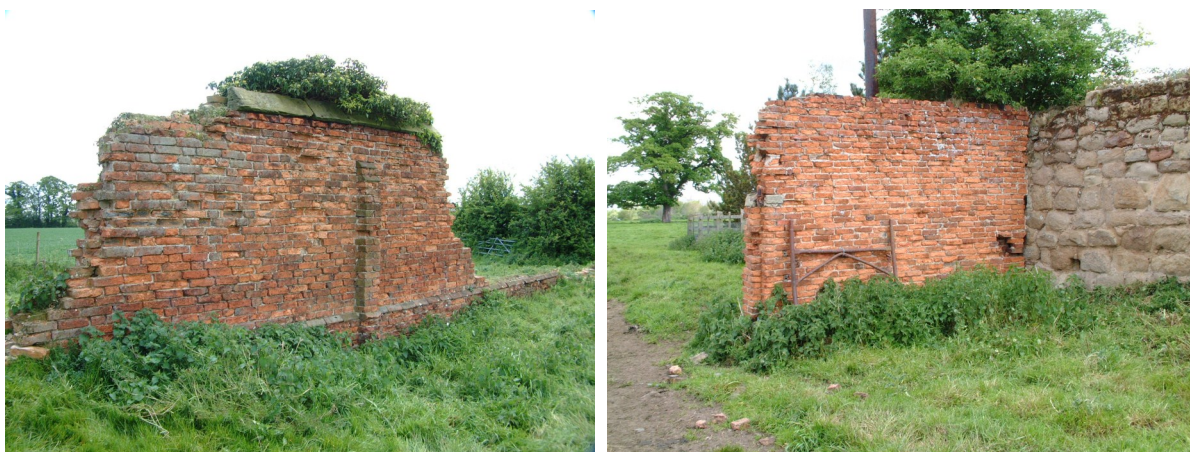
*Remains of early brickwork in walls associated with the former Old Hall*

The garden nearest the church comprises two walled enclosures. These have brick walls to the north, west and south and a roughly central stone wall dividing the space into two large segments. The east wall is stone and forms the perimeter of the enclosed garden to the east. It seems likely that the brick walled enclosure was slightly later in date than the stone walled enclosure nearest the hall. The use of bricks was customary for a kitchen garden in the 18th century, but there are few examples of brickwork in this region of earlier origin and the scale of the garden is very large for a pre-18th century kitchen garden. The use here of 17th or even 16th century brickwork is very early. The walls are over 2 metres high in places, but have still lost their original copings, much material having been removed in recent years as a result of theft. At the base of the walls is a brick plinth with a moulded course of brickwork. Along the northern wall are three later brick buttresses. In fact the brickwork is identical to that used at the dog kennels (a walled enclosure running along the north eastern perimeter of the conservation area). In the 17th century the walls would have relied on the properties of the south and east facing bricks to convey heat, and there is no evidence of any flues or method of heating to keep the chill off ripening fruit.

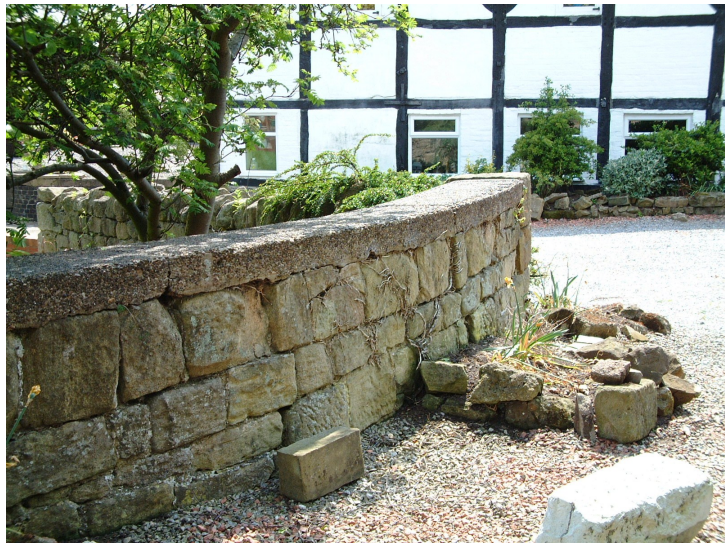
*Concrete copings, Woodshop Lane*

The main threat to the character of the village is the potential loss of the historic infrastructure – the stone and brick boundary walls that define much of the character of the conservation area. These are suffering from localised damage, loss of copings (some have been replaced in concrete) and neglect; some materials are even getting stolen. At present, walls can be removed in sections or fragments without the need for planning permission. If still in use as boundaries, these are likely to survive. Where they have become redundant, there could be future pressure for development or more active use of the land, leading to a desire for their removal.

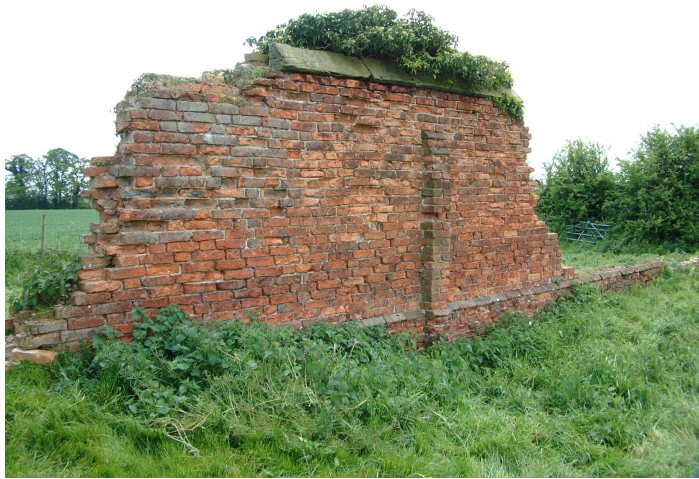
Brick boundary walls (left). These walls, built from long, thin bricks, with an ashlar coping, are fragments of the probable early 17th century kennels and kitchen garden at the former Swarkestone Old Hall.

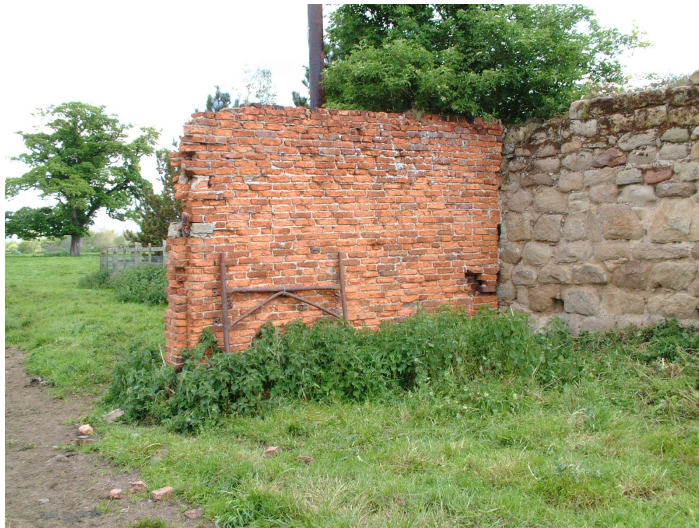
Stone walls to former gardens at the Old Hall (right). Mortared walls built of large blocks of sandstone with copings laid in two courses, of triangular section with a weathering. Shallow arched lintel over doorway with rebated stone jambs may have once been an internal door.

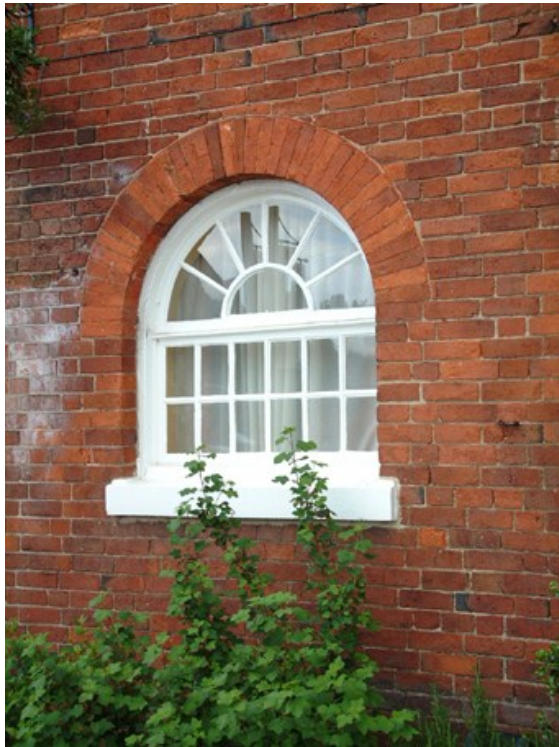
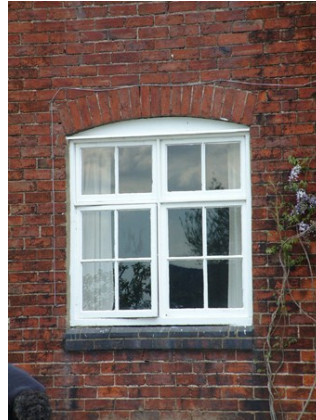
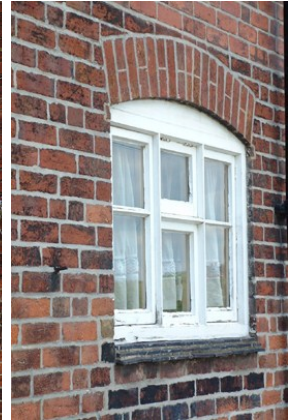
## Brick lintels

Semi-circular arched lintel (left), with gauged and rubbed bricks and stone cill

Timber lintel (right)

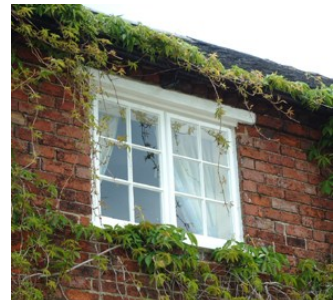
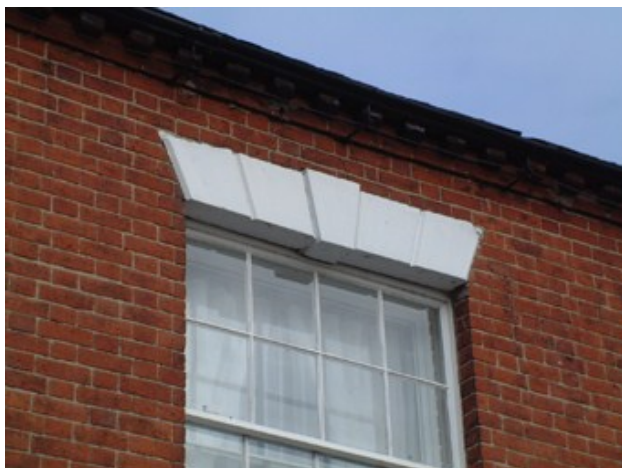
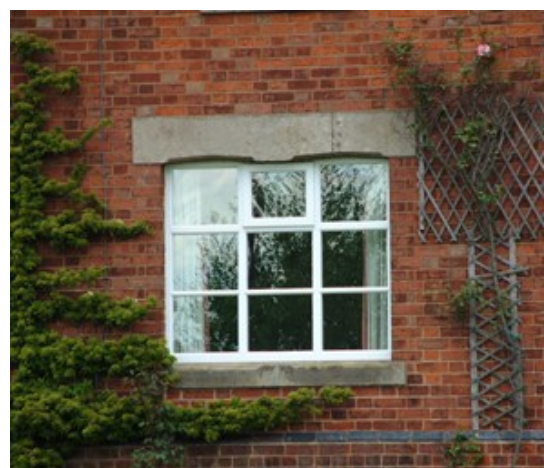
## Stone lintels

Incised stone wedge lintel with keystone (left) of circa 1800.

Wedge stone ashlar lintel with raised keystone (bottom left). Late 19th century chamfered and moulded stone lintel (below right) and stone cill

- the incised and plain stone wedge lintel with dropped keystone, generally found from 1800 and through the first half of the 19<sup>th</sup> century (e.g. Crewe and Harpur Arms, Bridge Farm Hotel, Woodshop House and Church House). In the 19<sup>th</sup> century brick

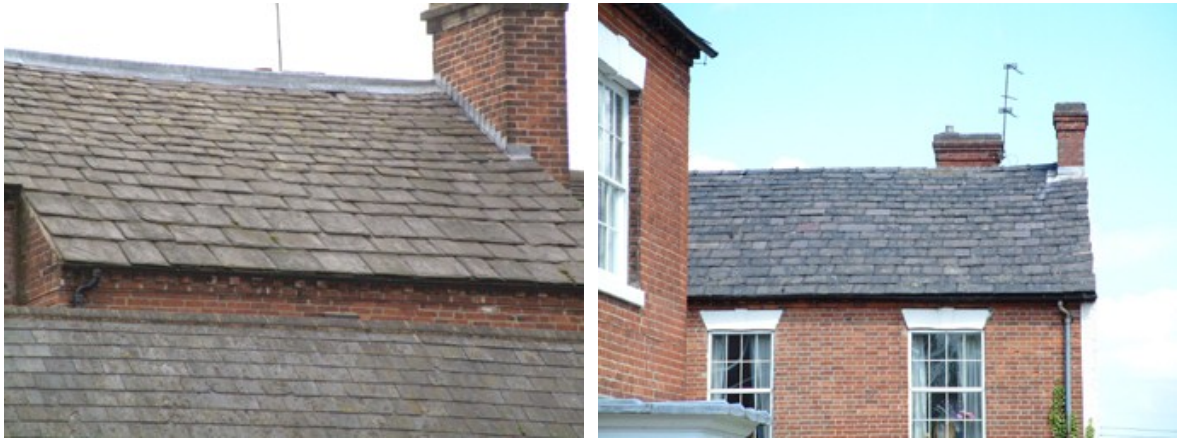
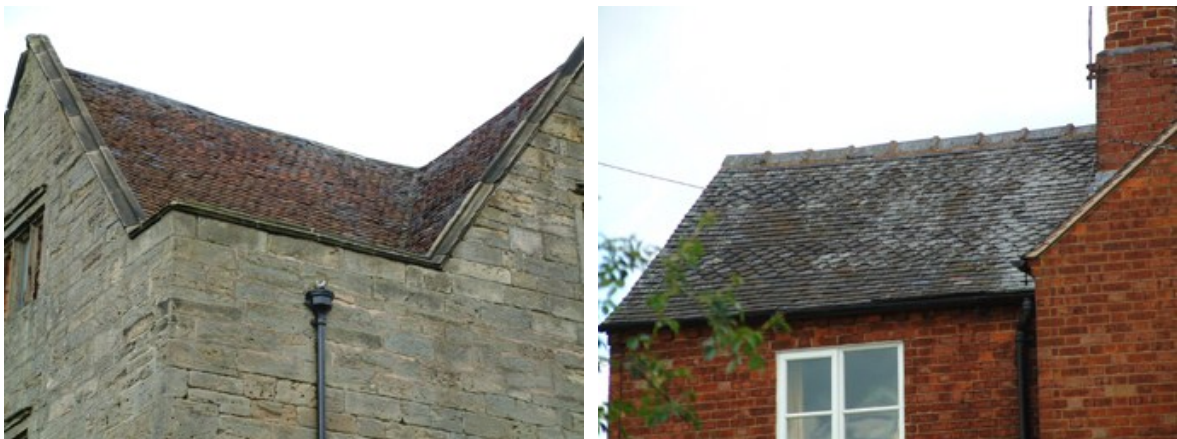
Graduated Burlington slate roofs (above) were imported into the area in the 18th century and used on the grander buildings.

The local vernacular roofing materials were tiles, handmade red clay tiles as used at Old Hall Farm (below left). Staffordshire blue clay tiles were easily imported into the area after the canal network expanded in the late 18th century. They are extremely durable. Bands of patterned blue clay tiles create a picturesque effect on 19th century estate buildings (below right).

Staffordshire blue clay tiles predominate on the roofs of the village, being easily imported into the area after the local stretch of the Trent and Mersey canal was opened in 1777. Blue clay tiles are extremely durable and from the late 18<sup>th</sup> century on they tended to replace the local red clay tiles. The problem with the hand-made red clay tiles was that they lacked the durability of the new “imported” blue clay tiles from Staffordshire, so that they were rarely retained when a building was re-roofed and almost never used on new buildings. Where hand-made red clay tiles survive, therefore (as on the rear roof slope of Old Hall Farm and the pitched church roof of 1876), it is important to try to preserve this local building tradition. Hand-made red clay tiles are still manufactured today and are readily available. There are also several instances of machine-made red clay tiles being used at Swarkestone on the 19<sup>th</sup> century cottages (Hall Farm Cottages at Church Lane and Trent Cottage and Cobster Cottage at Trent Side).

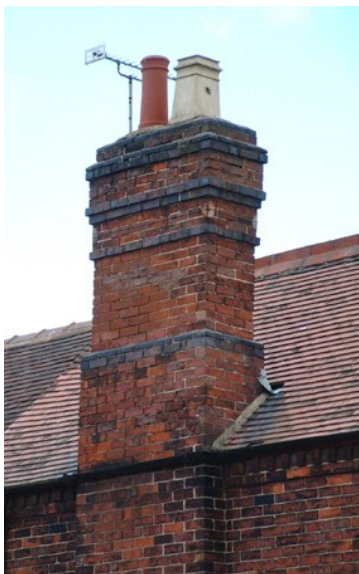
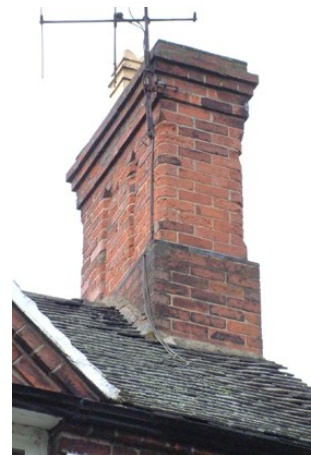
**Chimney stacks and pots** - in the 19th century stacks became quite decorative and the multiple flues were often expressed, aping the style of Tudor chimneys (right).

Blue bricks were introduced in the later 19th century (left). The dark colour of these “Staffordshire blue” bricks (occasionally referred to as “engineering bricks”) is the result of firing clay with high iron content in a high temperature kiln. They were used in small quantities, where a harder and more durable brick was required, as oversailing courses, but they were also intended to have a decorative character.

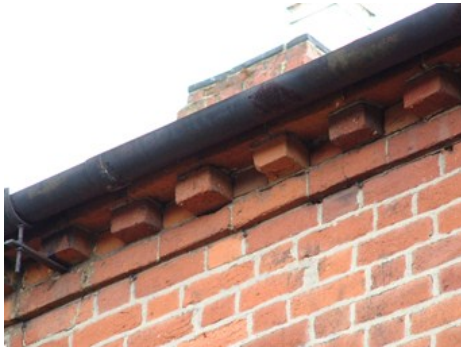
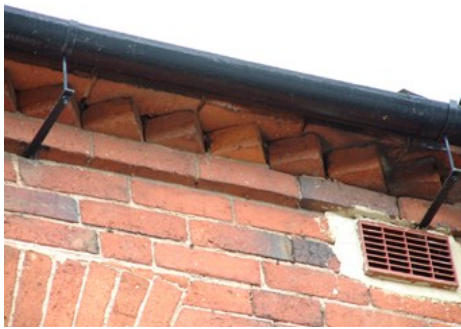
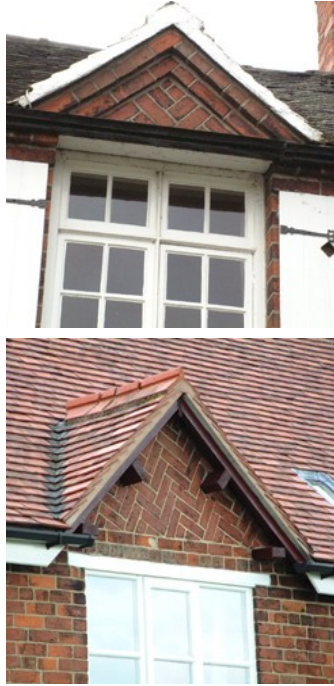
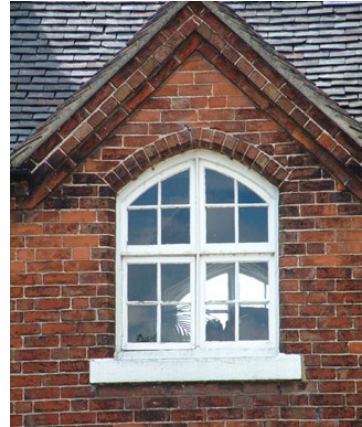
## WALLS - Brickwork details

**Gablets** - brickwork laid in a decorative pattern; herringbone (left), corbelled (above), or a combination of both (top left)

**Brick eaves details** - dentilled and corbelled eaves (top left), sawtooth and corbelled eaves (bottom left)

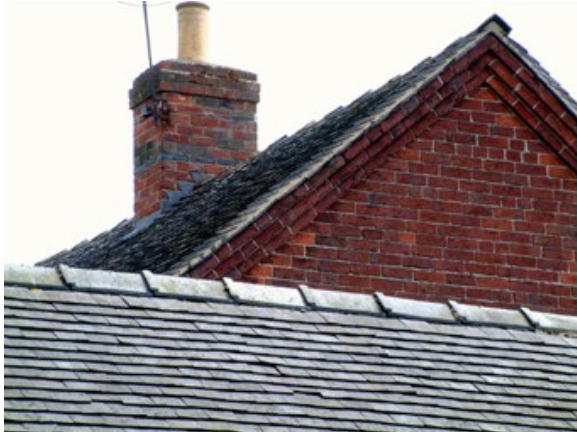
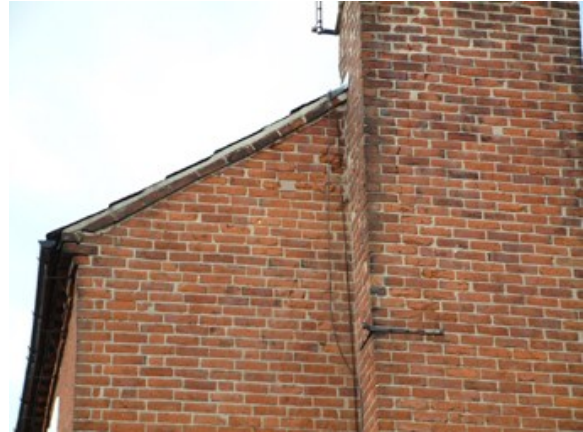
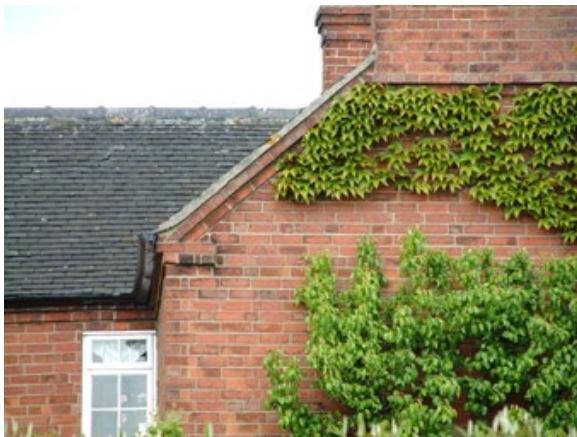
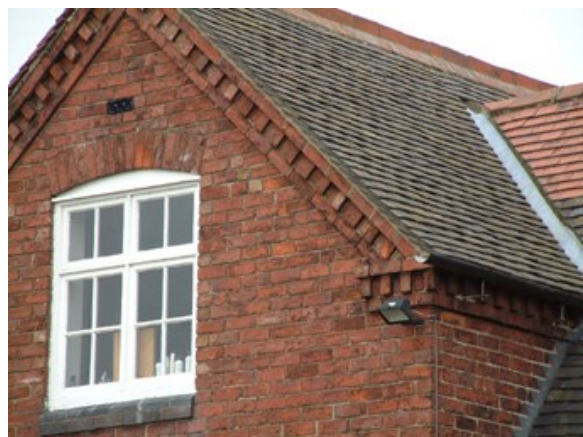
**Brick verge details** - multiple corbels (above left) corbelled with a single course (above right), corbelled with two courses (bottom left) or corbelled with dentilled brickwork (bottom right)

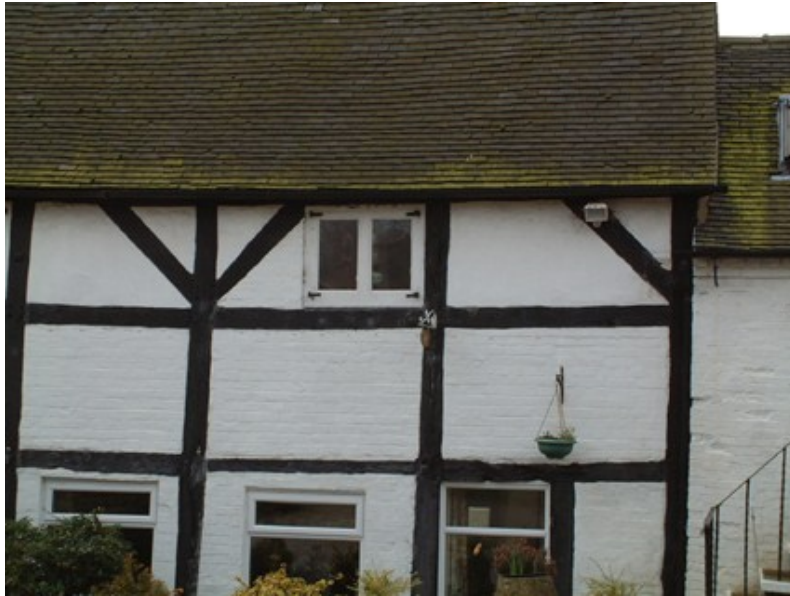
**Timber-frame** - up until the 18<sup>th</sup> century, the principal building materials for the smaller houses were timber, with panels of wattle-and-daub. The type of timber-frame used in Swarkestone is known as small box-framing - a combination of posts and short horizontal rails. The example at Crows Nest (left) is the only surviving remnant in the village. The wattle and daub was replaced with bricks, here painted white.

Remnants of timber-framing survive in several buildings, but the only building where timber framing is now visible externally is Crows Nest. This incorporates box-framing, a type of construction associated with this region. There are remnants of timber-framing within Ivy Cottage on Derby Road and timber-framing and a cruck-frame within Hollies Farm. Most timber-framed cottages would have been built with a stone footing.

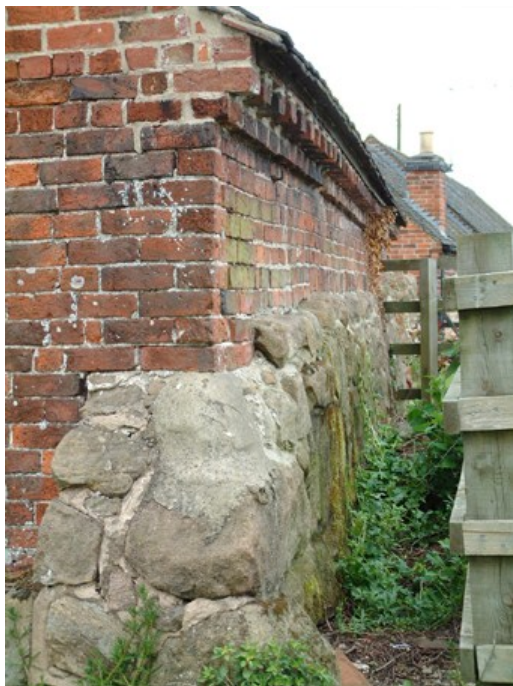
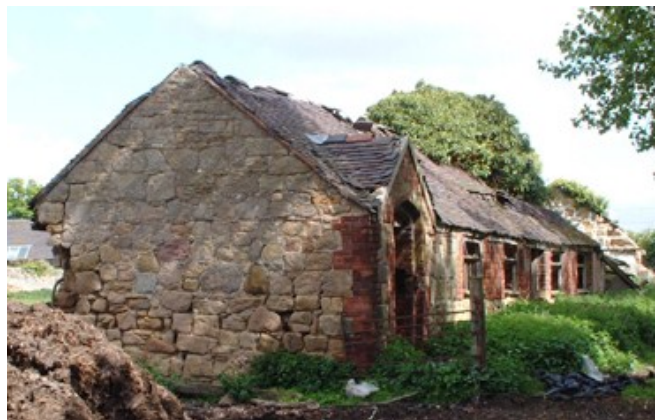
**Stone** - stone was commonly used for the footings of timber-framed buildings and rubblestone was used for small agricultural buildings. Remnants of stone buildings and stone plinths or footings of earlier buildings can sometimes be found, incorporated into later brick buildings (left and bottom left).

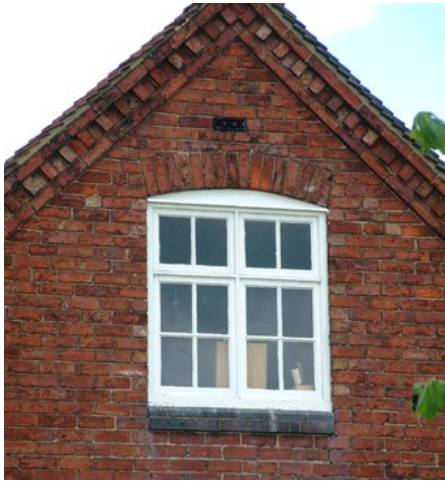
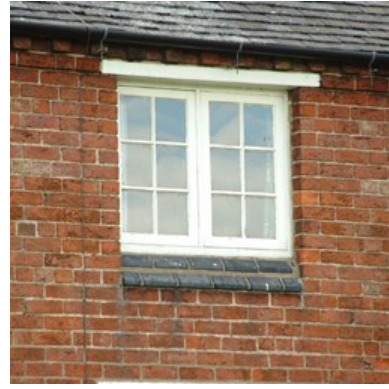
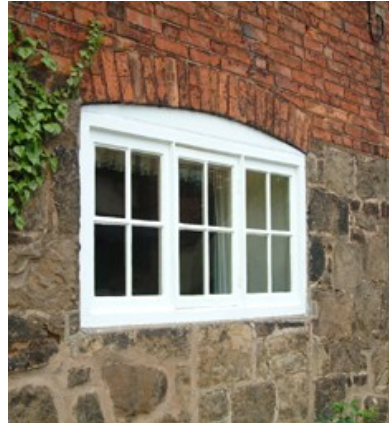
**Casement windows**  
(left and right)  
From left clockwise;  
- two over four  
casements with transom  
and mullion, recessed  
within a chamfered frame

- six paned, two light  
casement, within a flush  
frame (note the double  
row of blue clay moulded  
cills, probably a later  
addition)

- four paned, three light  
casements, recessed  
within a projecting  
chamfered frame (note  
that there is no cill)
