Twyford *Conservation Area* Character Statement

2014

**SOUTH DERBYSHIRE
DISTRICT COUNCIL**

Twyford *Conservation Area*

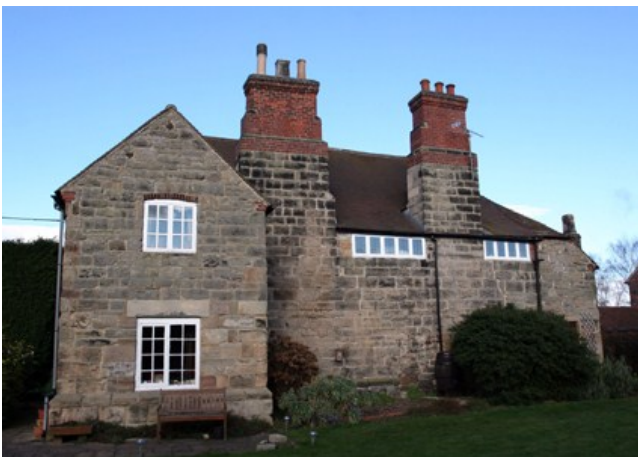
Old Hall Cottage is the oldest standing dwelling, built on the northern edge of the village green (pictured below). The existing building on the site has an unusual orientation, placed so that its front elevation faces north-east, away from the road and the settlement, overlooking a field. Its pair of massive masonry chimneys on the rear wall are a very prominent feature. This unusual orientation can be explained when it is seen as a wing extension to an earlier timber-framed hall house, which fronted the road to the west of the existing building. A painting survives which shows the whole complex. It was a very substantial group, with an ancillary timber-framed barn alongside (now much altered and rebuilt as Old Hall Farm). The owners of Old Hall Cottage have commissioned dendrochronology (tree-ring dating) of the timber-frame and the existing building has been dated to the mid 17th century. With the exception of the painting, there is no physical evidence of the old wing, which may have been earlier, and the date of its construction can only be guessed at.

The other large house mentioned in the Hearth Tax Returns was part demolished in the 19th century but a wing was retained and is now Old Hall Cottage (a grade II* listed building).

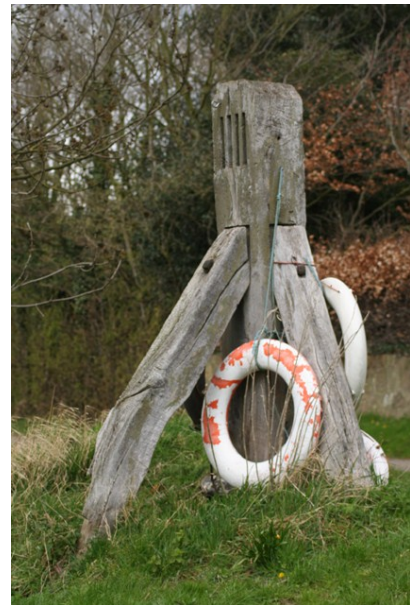
Oak post of former chain ferry on the riverbank at Ferry Lane

A secondary open space is the place where Ferry Lane terminates at the water's edge, unfenced and edged by broad, lush grass banks. The remains of the posts that supported the chain link ferry still stand on both riverbanks. From here there are long views across the river, particularly upstream towards Willington.

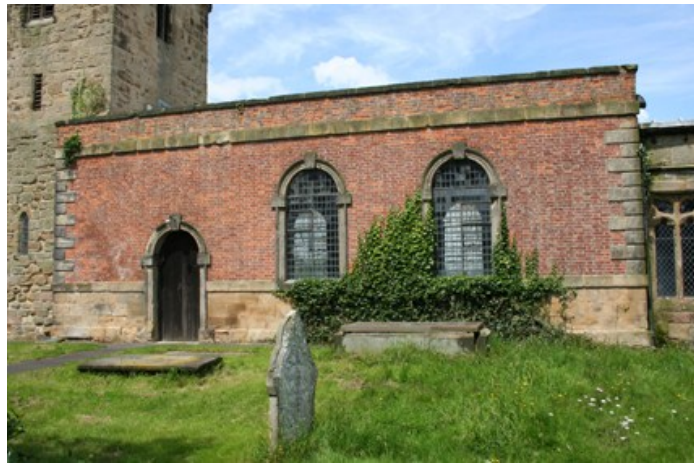
Flemish bond brickwork at St. Andrew's Church c1739

brickwork is at the church where the nave was rebuilt circa 1739, faced in fine Flemish bond brickwork with stone dressings. Old Hall Cottage is an example where the timber-framed front wall was rebuilt in brickwork for expediency, rather than fashion, as it lacks finesse.

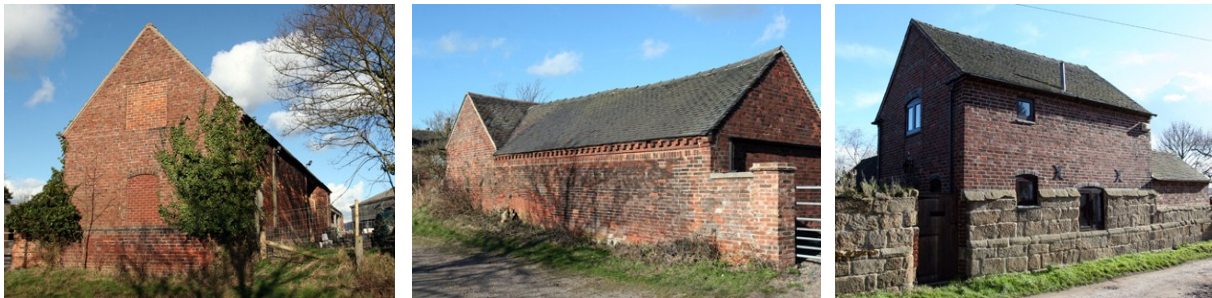
Farm buildings with 19th century brickwork along Ferry Lane

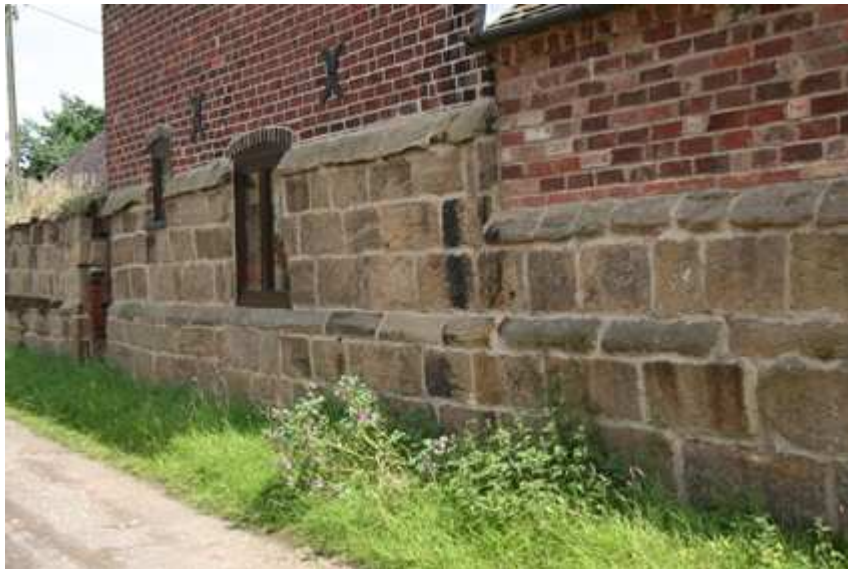
Left - the very old wall that lines the eastern side of the lane approaching the churchyard also doubles as the side wall of a 19th century barn. The large blocks of stone and chamfered plinth and copings may indicate medieval origins.

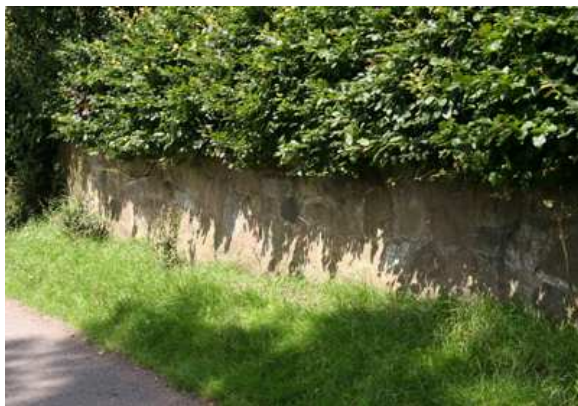
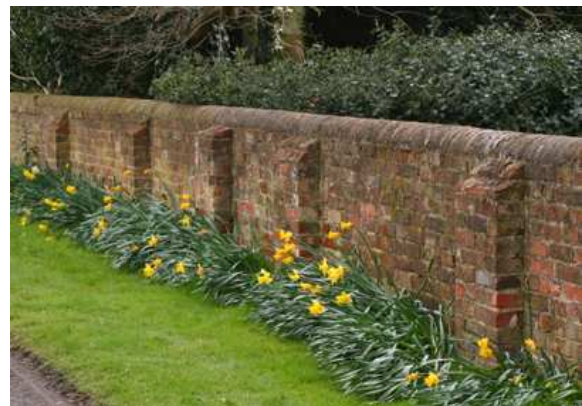
The hamlet has very few boundary walls. Above left - rubble gritstone boundary wall alongside Ferry Lane. Above right - brick boundary wall with half-round moulded brick coping at Old Hall Cottage.

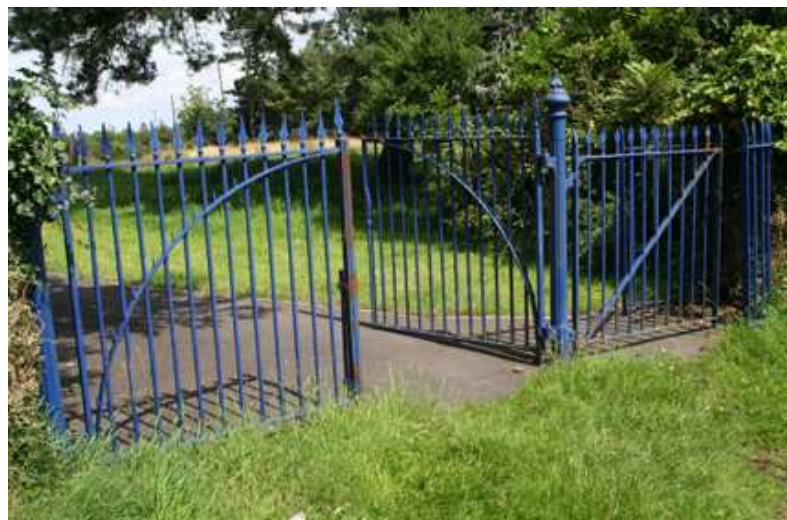
Right - wrought iron railings and gate with cast-iron spear-headed finials and an urn finial to the post, at the entrance to the churchyard. This small amount of ornament sets the churchyard apart.

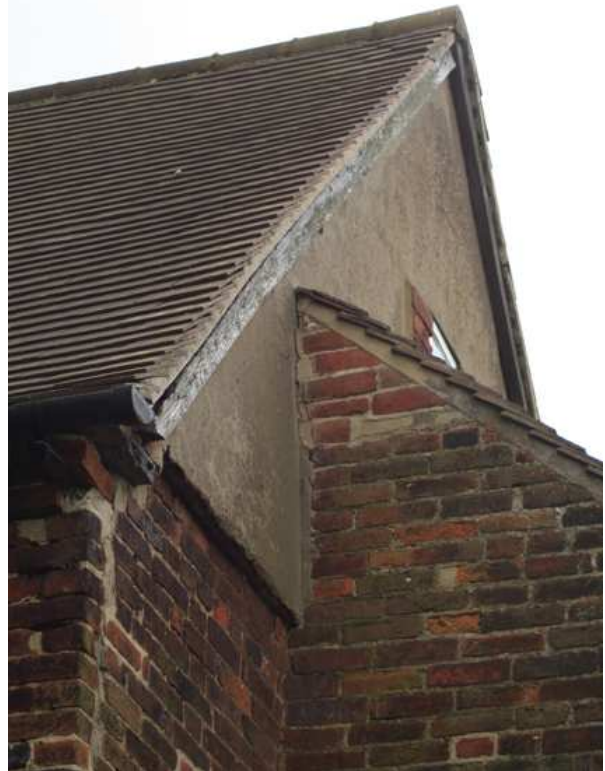
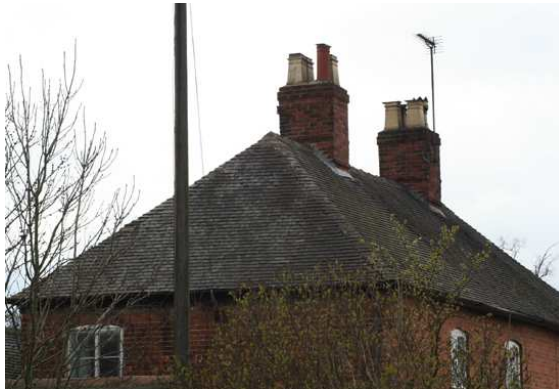
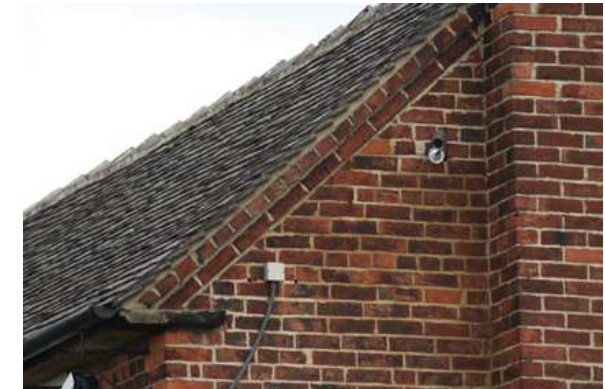
Tiled roofs are the principal roofing material. The example above illustrates the use of the older, handmade red clay tiles alongside Staffordshire blue clay tiles, which became commonplace after the construction of the Trent & Mersey canal in the late 18th century.

Although the predominant roof type is pitched, hipped roofs had a revival in the early 19th century, as found at Green Farm (above). During this century it also became common to add more detail at the verge, such as the corbelled verge at Ferry House (middle right) and the corbelled and sawtooth verge at Ferry Cottages (right). The detail focussed on this gable suggests that the person who built this cottage must have been aware of its landmark location, on Ferry Lane, although in recent times the modern render has tainted its historic character.

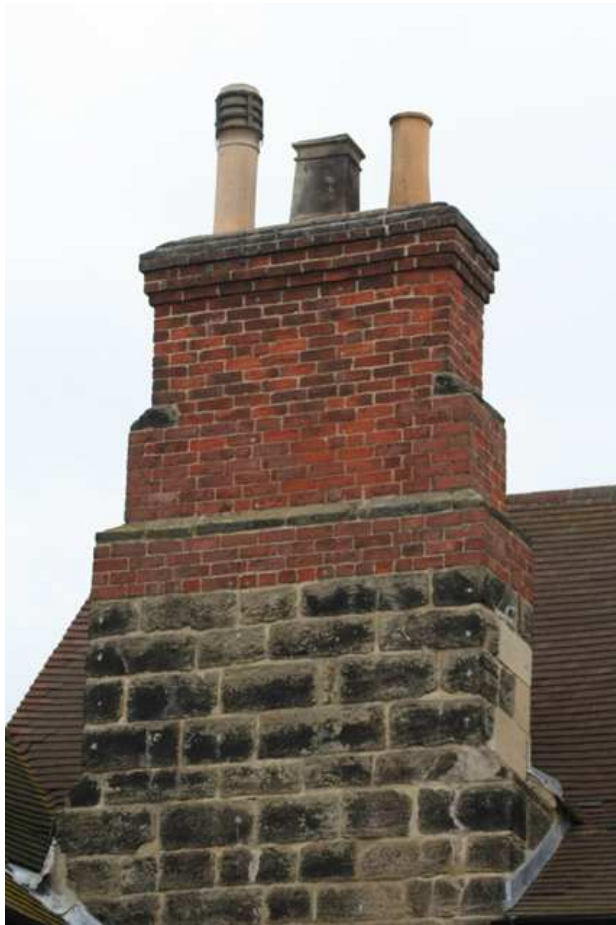
Left - massive stone and brick chimney at Old Hall Cottage. The upper parts of the two 17th century chimneys were partially rebuilt in the 19th century. They are quite exceptional within the hamlet.

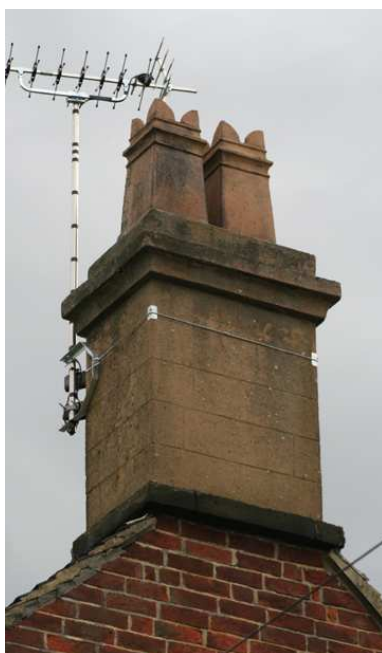
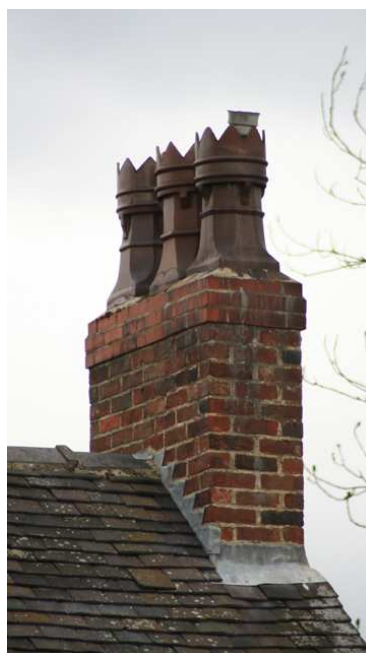
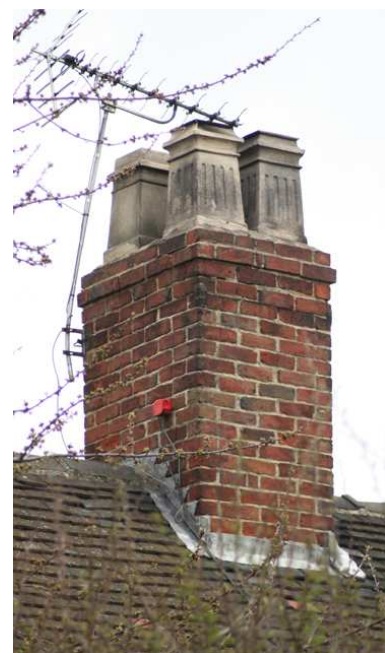
Below left - rendered chimney with stone overthrow band and stone oversailing courses (Smithy Farm). Brick chimneys with one or more oversailing courses at Ferry House (middle) and Black Dub (right).

Chimneys are generally brick and plain, with one or two oversailing courses. The example at Smithy Farm (bottom left) is rendered and "lined-out" to imitate the ashlar on the front of the house.

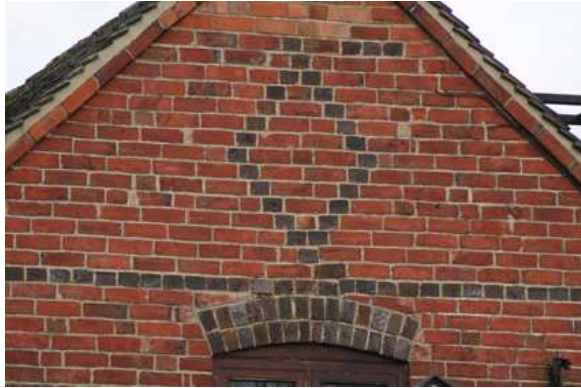
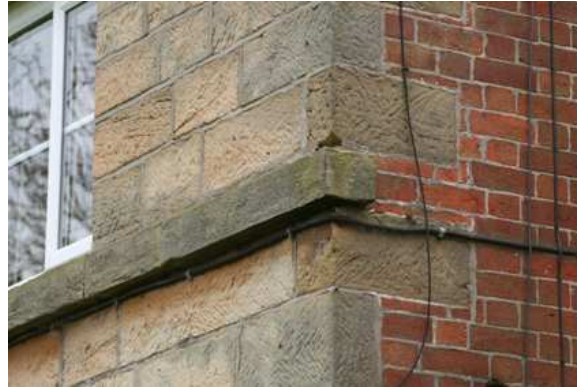
There are very few decorative details within the walls at Twyford. The main exceptions are the use of blue brick to create patterns at Riverview Barn (above left), the horizontal stone band at Smithy Farm (above right) and the stone band and quoins at the church (not illustrated). Flemish bond brickwork was adopted for the walls of the church and Grange Farm.

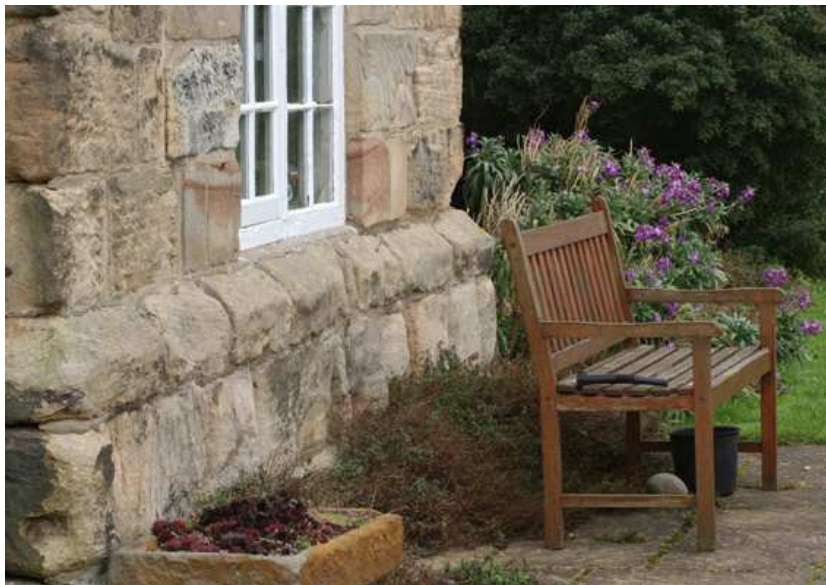
Constructional details, such as chamfered plinths, were adopted in the 17th century at Old Hall Cottage (left) and were also adopted at the 19th century barn at Grange Farm (below), incorporating a chamfered moulded blue brick weathering. Blue bricks were practical, durable and decorative, often used to enrich buildings in the 19th century.

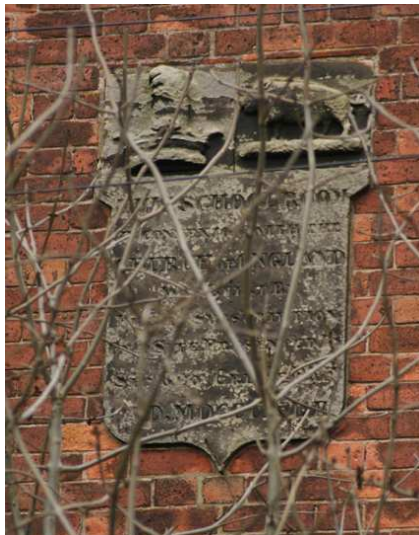
Left - stone dedication plaque of 1842, in the form of a shield, at the former village school, incorporating the Crewe coat of arms.

Sir George Crewe donated the land for a new village National School in 1842, paid for by voluntary and public subscription, and this is recorded on a tablet in the gable end, which bears the Harpur coat of arms. The school eventually closed in 1943 and is now a house.

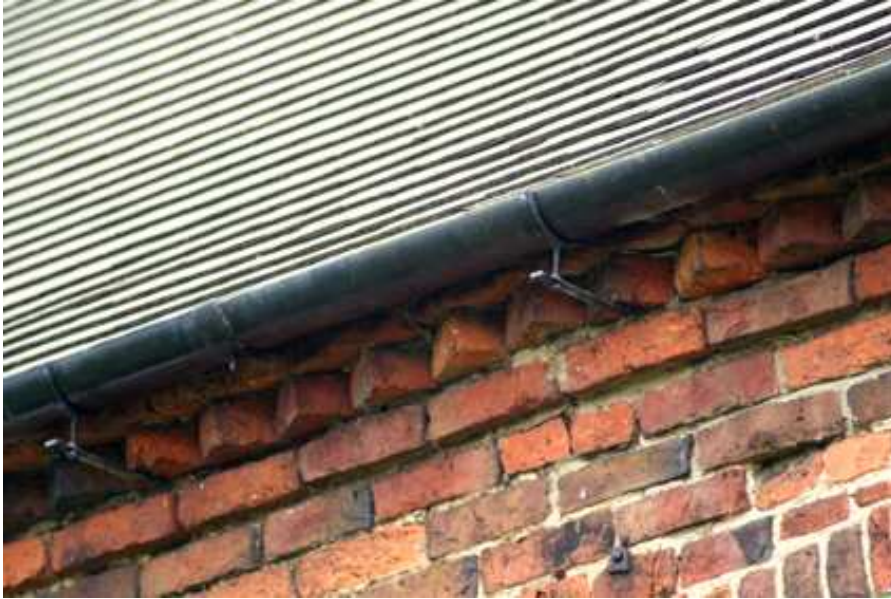
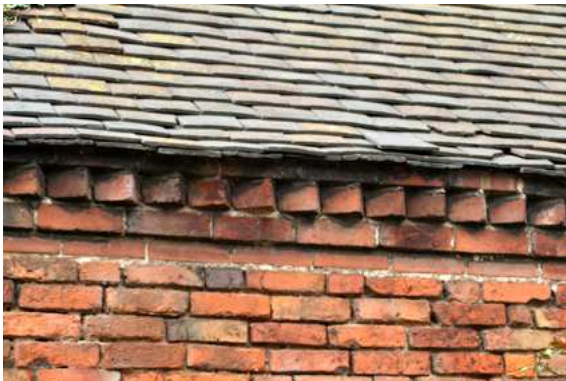
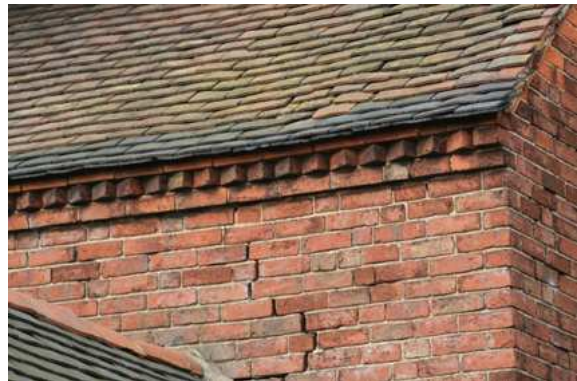
There are a number of examples of decorative “sawtooth” brick eaves within Twyford, where the brickwork is corbelled and then a row of bricks are set on an angle to the face of the wall (above and below, left and right).

Brickwork was used in the 18th and 19th centuries for structural details. Much of the brickwork is detailed with a corbelled verge and corbelled eaves. Sometimes, these are plain with several courses of brick projecting one above the other. Sometimes they incorporate “dentilled” brickwork, where each alternate header brick projects to create a decorative effect. In a number of cases the header bricks are laid diagonally to produce a “sawtooth” pattern. There are examples of both dentilled and sawtooth brickwork at Grange Farm.

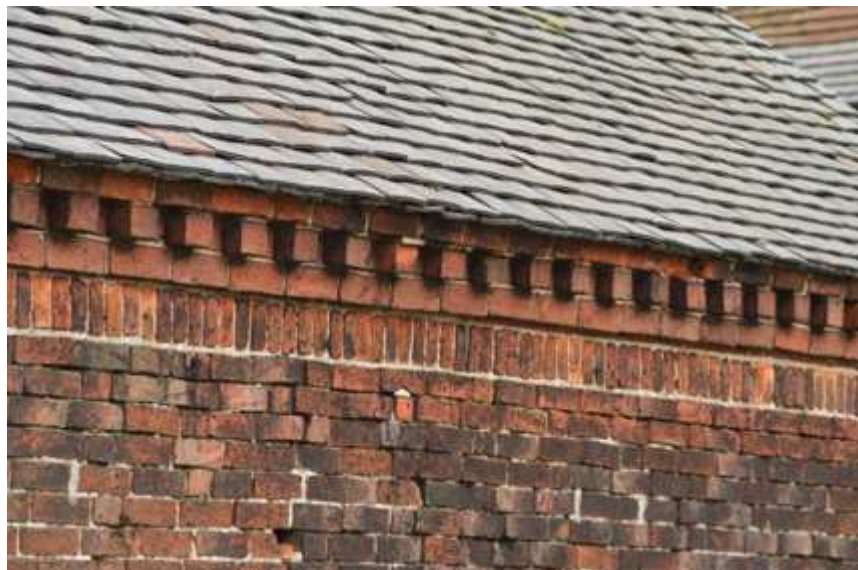
Right - complex eaves at Grange Farm; an old wall has been raised, adding a corbelled and dentilled brick eaves, where each alternate header brick projects to create a decorative effect.

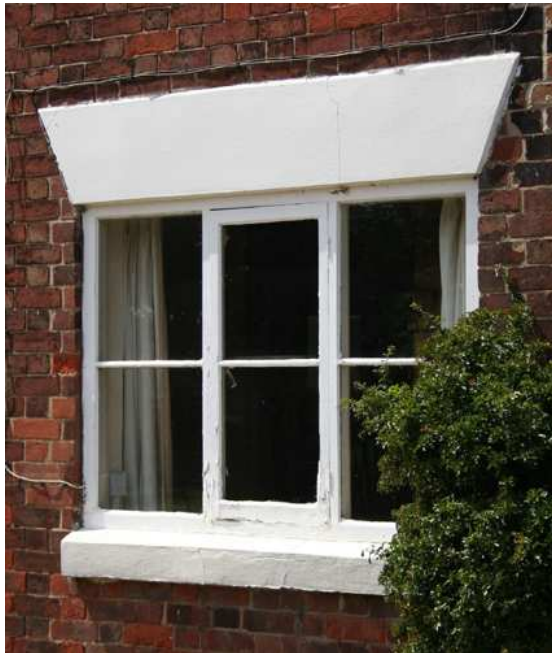
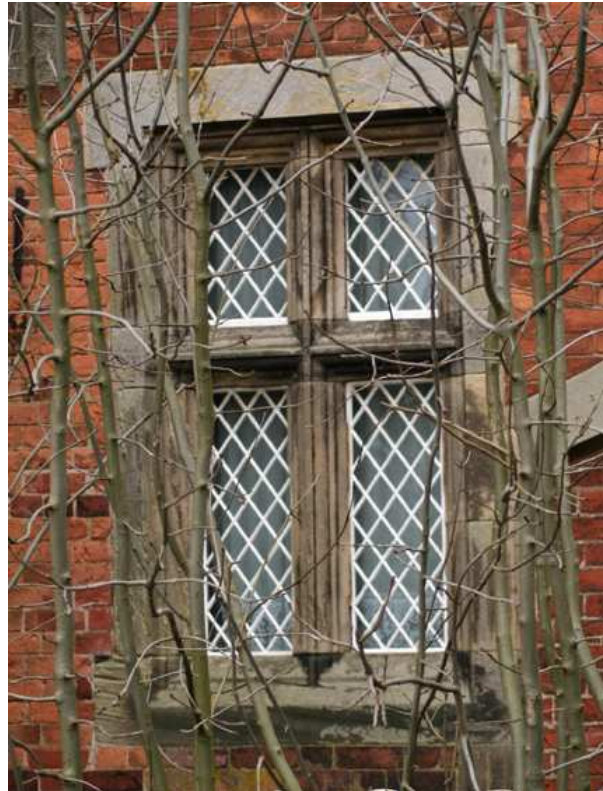
Casement windows - there are many examples of traditional casement window, although no single common form. Above left - two-light casements with a single horizontal glazing bar (Ferry Cottages). Top right - diamond lattice cast-iron casements at the former village school. Right - small-paned side-hinged casements. Below left and right - casements recessed within chamfered frames at Grange Farm.

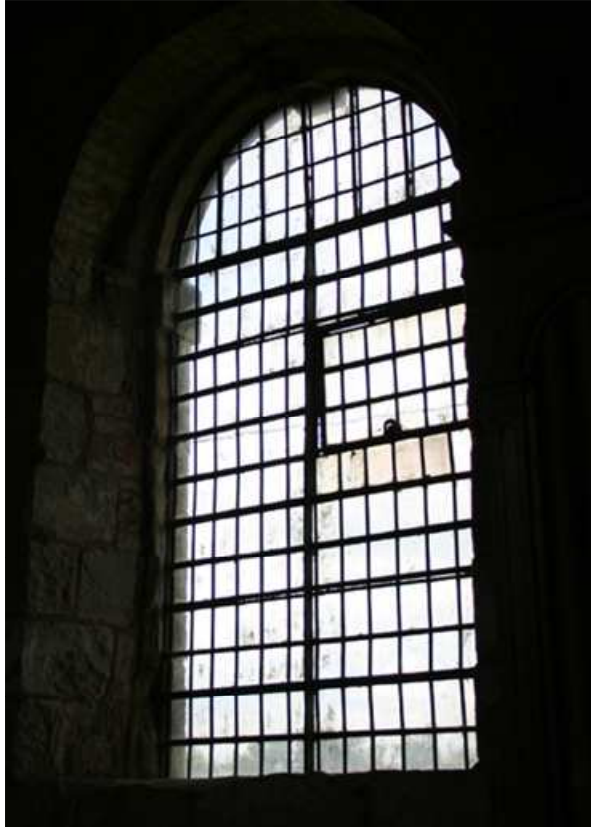
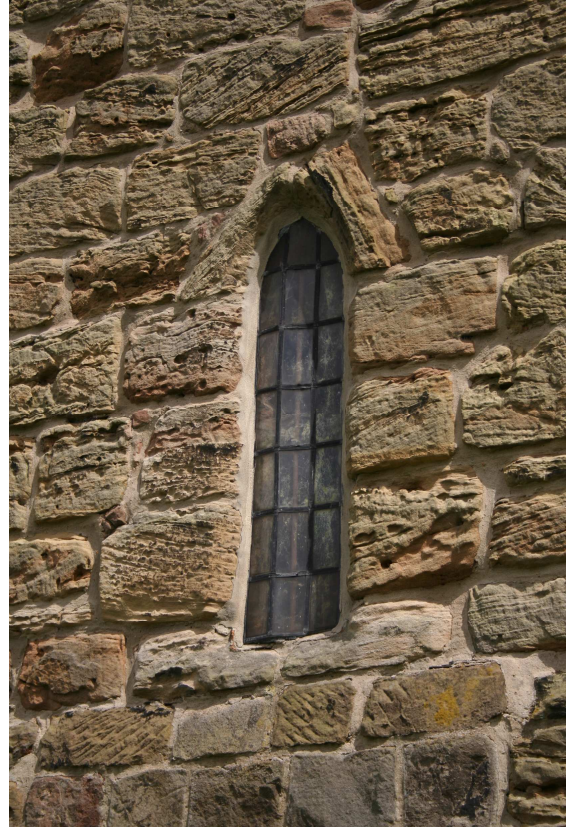
Above - the church of St. Andrew has arched windows with rectangular, leaded-lights, introduced when the nave was built circa 1739. The much older, lancet, pointed arched windows in the tower (above right) also contain leaded-light windows of c1739.

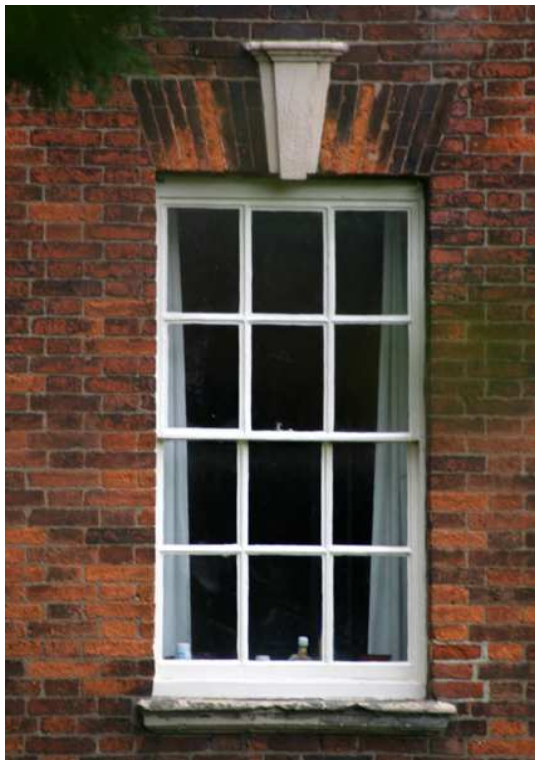
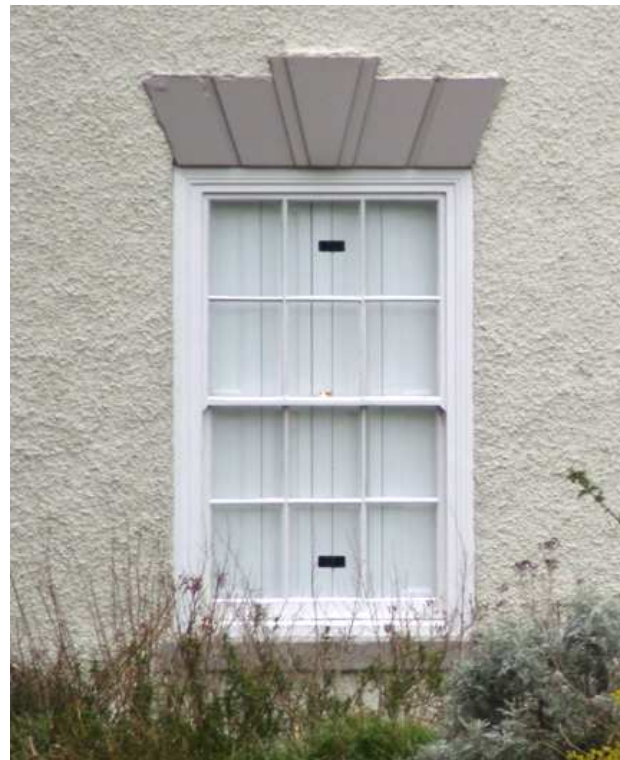
Below - the grander, more formal houses of the 18th century have small-paned sash windows & lintels with decorative, projecting keystones (Grange Farm and Twyford Hall).

A decorative, classical form of stone lintel with channelled voussoirs and raised keystones was adopted at Twyford Hall in the 18th century. During the first half of the 19th century classical building forms had a revival and wedge-shaped stone lintels were used in the village, of which there were a number of permutations. Plain wedge lintels were used at 1 and 2 Ferry Cottages and a wedge lintel composed of separate blocks of ashlar was adopted for Smithy Farm.

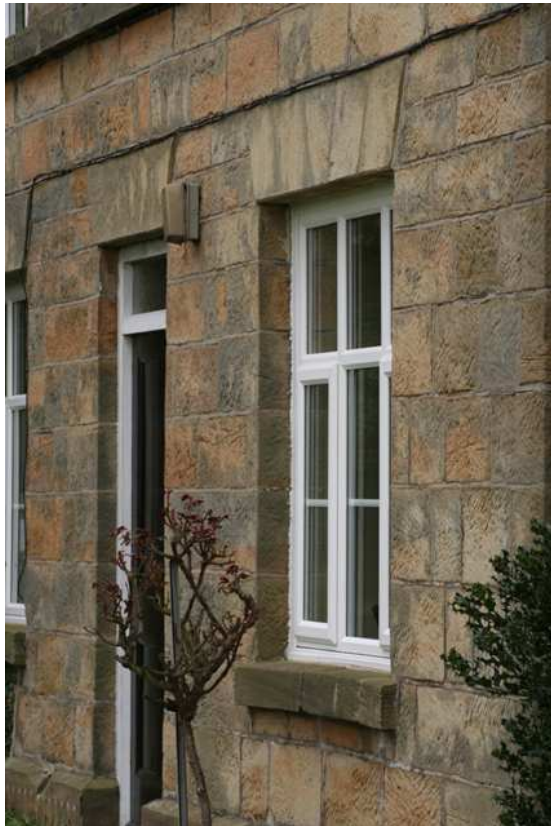
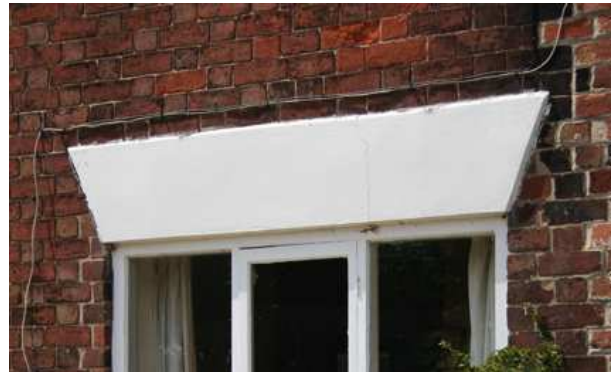
Wedge-shaped stone lintels were adopted for the grand 18th century houses, such as Twyford Hall. They had a revival in use for smaller cottages in the first half of the 19th century, as at Smithy Farm (left) and Ferry Cottages (above). The wedge lintels at Ferry House (below) appear to have been finished in render and may be covering up brick segmental arches.

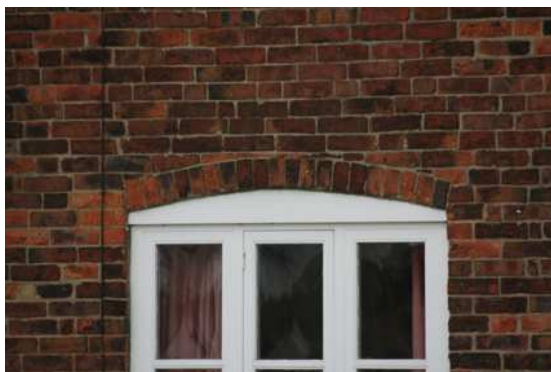
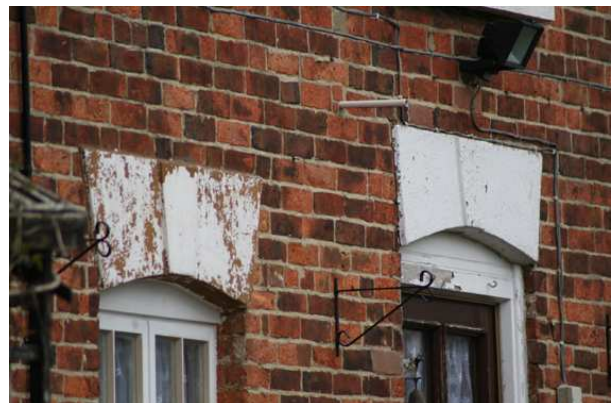
Where economy was important, lintels were simple in form. A segmental arch formed by "header" bricks at Old Hall Cottage (above) and timber lintel at Old Hall Farm (right).

Many of the smallest cottages and farm buildings in Twyford incorporate segmental brick arches (e.g. Old Hall Cottage, Old Hall Farm, Black Dub and Green Farm). These were commonplace during the 18th and early 19th centuries. This was the simplest and easiest lintel to construct as the taper was accommodated wholly in the mortar joints, without the need to cut the brick. In most of these cases the brick arches were made from a single course of header bricks. In combination with the segmental brick arches, stone cills were not normally used, relying on the simple weathering properties of the brickwork. Finely-jointed, rubbed and gauged brick arches were exclusively reserved for houses such as Grange Farm.
