Netherseal *Conservation Area* Character Statement

**SOUTH DERBYSHIRE
DISTRICT COUNCIL**

Netherseal *Conservation Area*

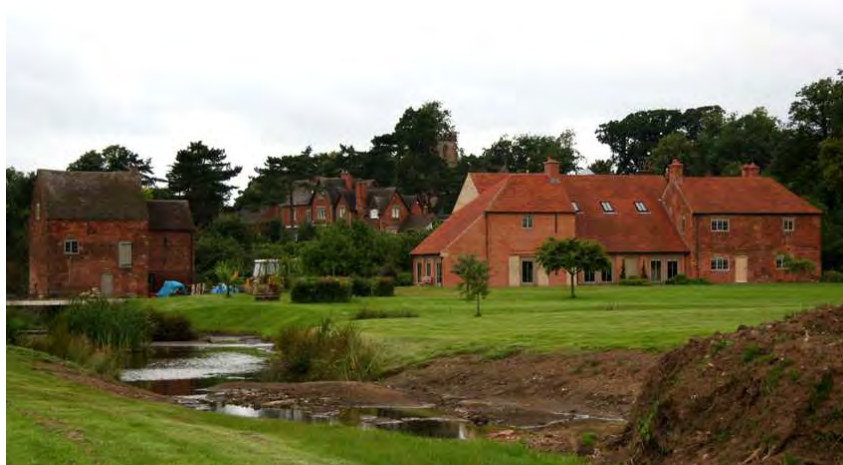
View from the mill leat at river level showing the undulating land and the church tower in the distance

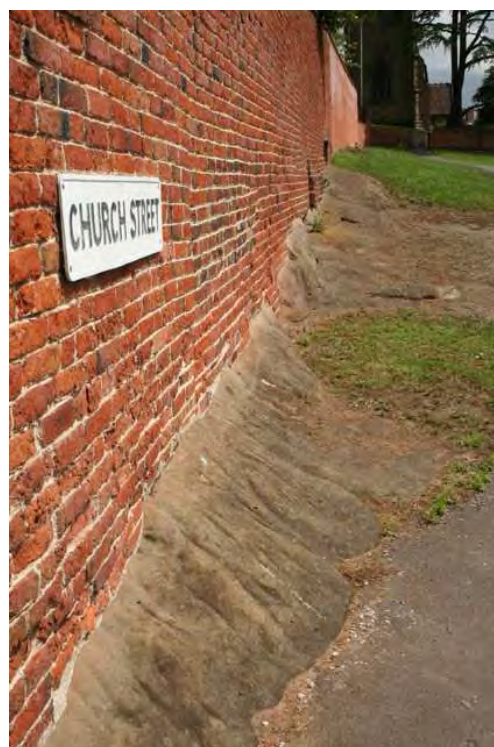
The bedrock of Bromsgrove Sandstone near the church is a prominent feature

The rich alluvial soils of the river valley would not ordinarily generate much building stone but Netherseal is built on an outcrop of Bromsgrove Sandstone, a pale pinkish brown colour where it outcrops. This is classified as highly permeable sandstone and a major aquifer i.e. an underground layer of permeable, water-bearing rock, from which water can be obtained by wells or springs. There are small pockets and outcrops of this stone in the immediate area and a few small quarries were established to the north-west of the village. They are the likely source for local stone, although the use of stone was very limited, it being a scarce commodity. Much of the local stone may have been worked out by the 19th century or it is possible that no-one bothered to work the quarries anymore, as a result of improved transport. Within this area there was a strong tradition of timber-frame and brick building. Examples of rubblestone used in the construction of boundary walls can be seen near the entrance to Newlands House and in front of 23-27 Church Street. Use of rubblestone in the village may have once been more extensive, displaced by the fashion for brick in the 18th century.

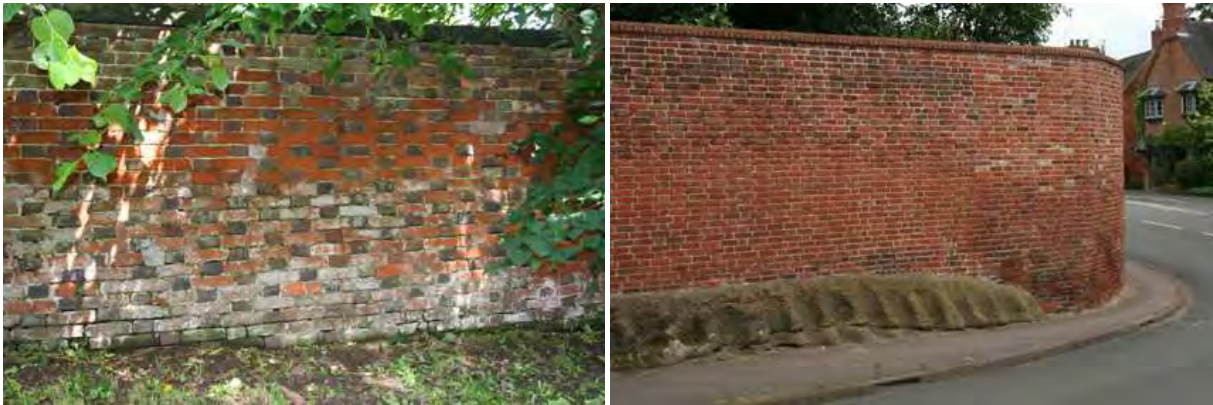
Flared (blue) brick headers (above left) and tall brick walls (above right) are very dominant

Flemish bond brickwork is commonplace within Netherseal and the continued use of Flemish bond brickwork with burnt headers in many of the buildings makes them difficult to date. The 1863 Rectory and St. Peter’s School incorporate English Bond brickwork, as does the boundary wall to the Village Hall, harking back to an older age.

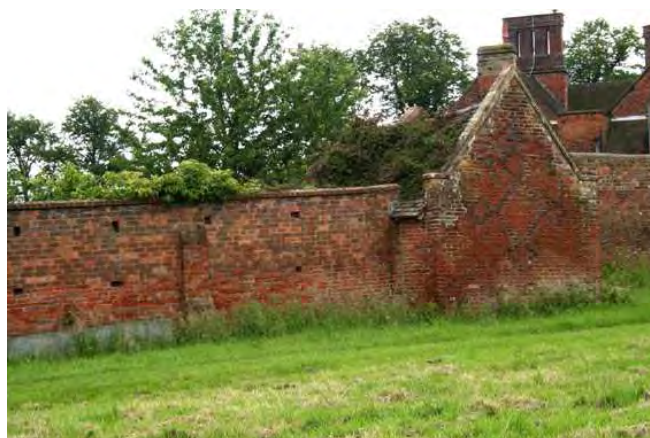
Brick boundary wall and 18th century alcove - the Old Hall garden

length. Some fruit trees still survive. A small late 17th century brick garden alcove stands within the wall, most prominent when viewed from the public footpath at the back of the site. The wall was built in multiple phases and has been heightened, forming a strong barrier to views from the footpath, where the views are dominated by the roofscape, with tall chimneys and stepped and stone-coped gables punctuating the skyline. The wall on the east side of the walled garden is lower and stepped, enabling glimpses over to the garden beyond. It forms a backdrop to a wide east-facing herbaceous border.

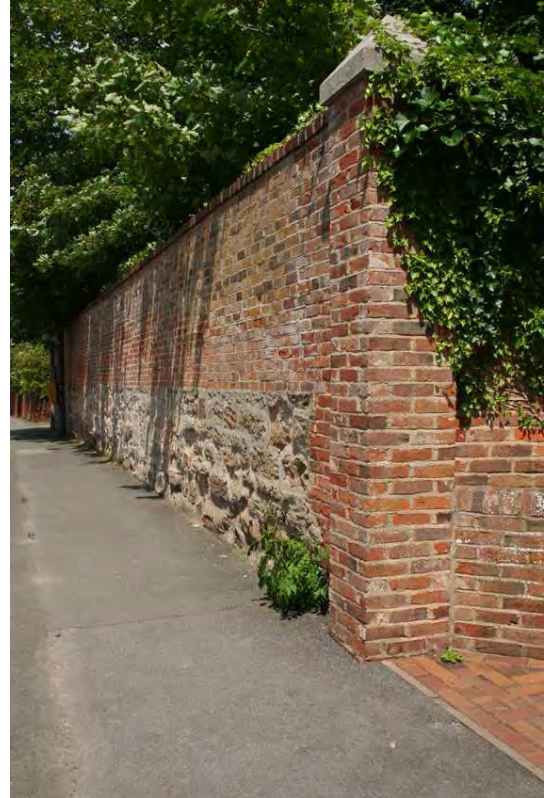
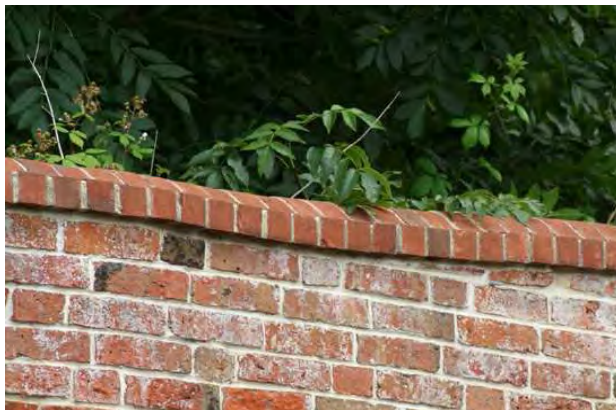
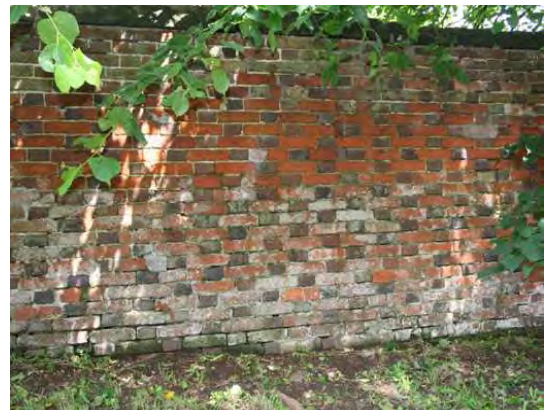
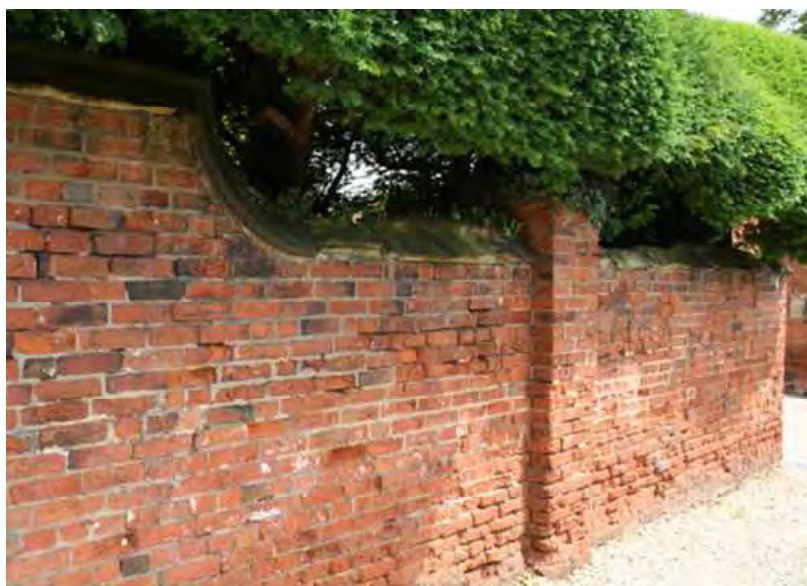
Above - The old wall on the corner of Church Street and Main Street was built on top of the bedrock. The wall at the entrance to Newlands House (right) was part built in rubble sandstone. In both cases moulded red brick copings were used. They were ideally suited to following the undulating wall head (detail below).

Above right - patterned Flemish bond brickwork is predominant surrounding The Old Hall. The headers were burnt at a higher temperature, which gives them a distinct blue colour

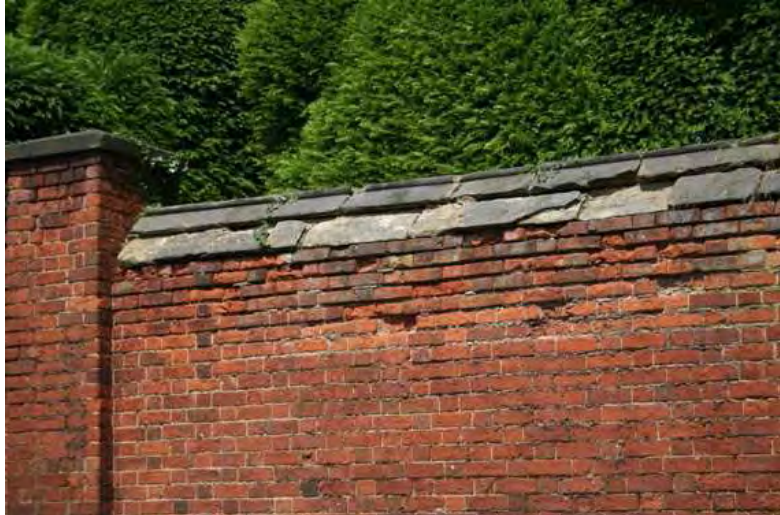
Right - tall red brick walls with double course of triangular moulded copings (The Old Hall)

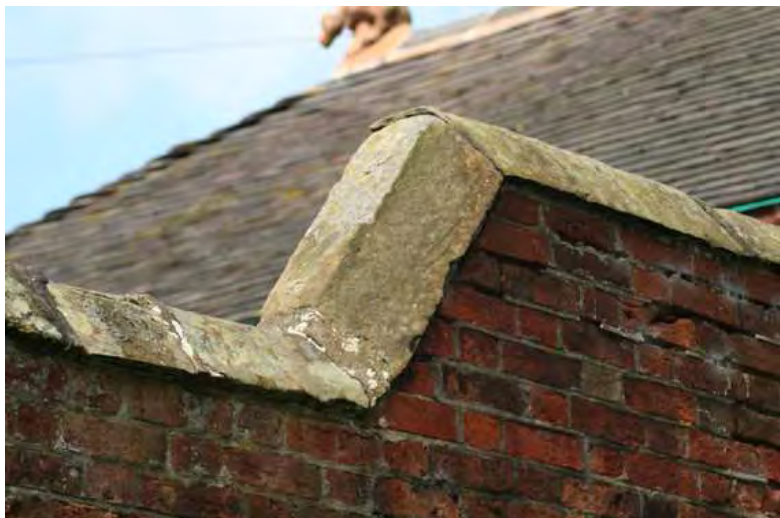
Below right - detail of chamfered, moulded stone coping at The Old Stableyard

Below - moulded triangular blue brick copings finished with a roll-moulding

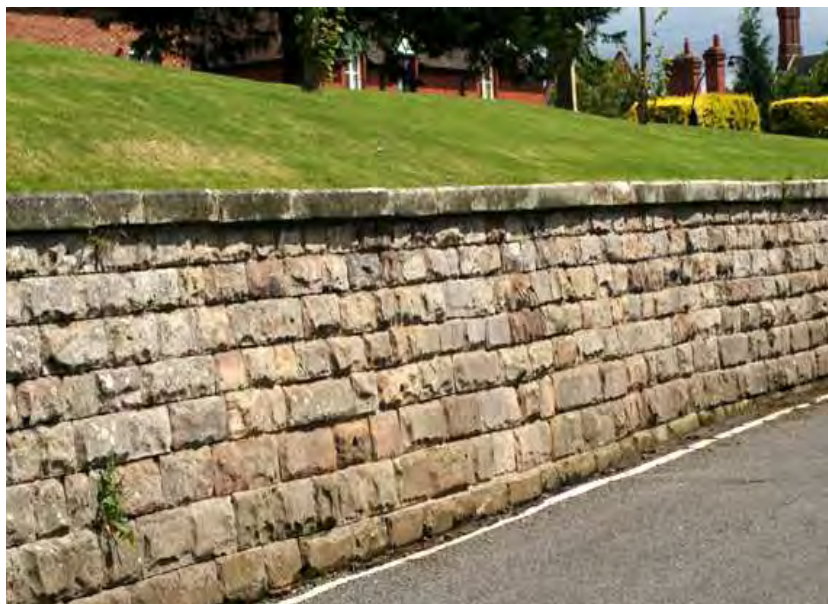
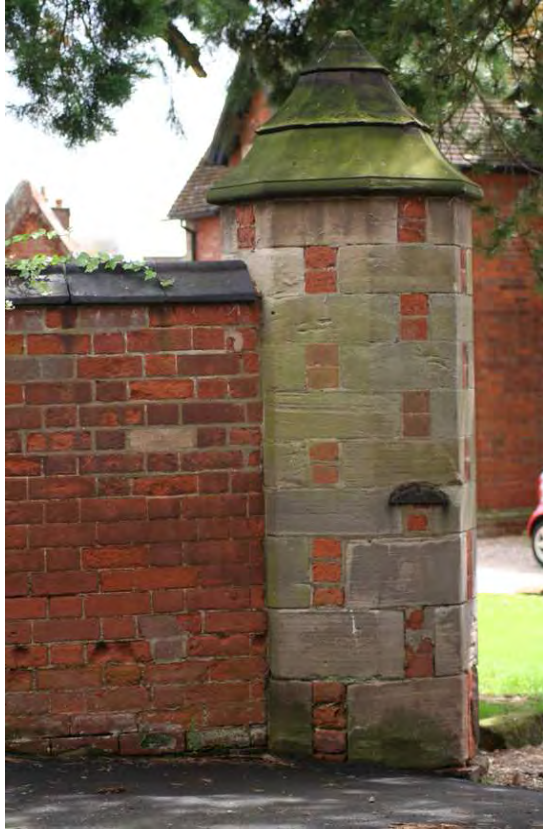
Below left - fragment of random rubble sandstone boundary wall at 23-27 Church St.

Gatepiers - ornate stone and brick gatepier at The Old Rectory (above left). Carved stone cappings to brick gateposts at The Old Stableyard and The Old Hall (above right). The original datestone of 1678 has been copied with one of 1868, asserting the ownership of the Hewett family

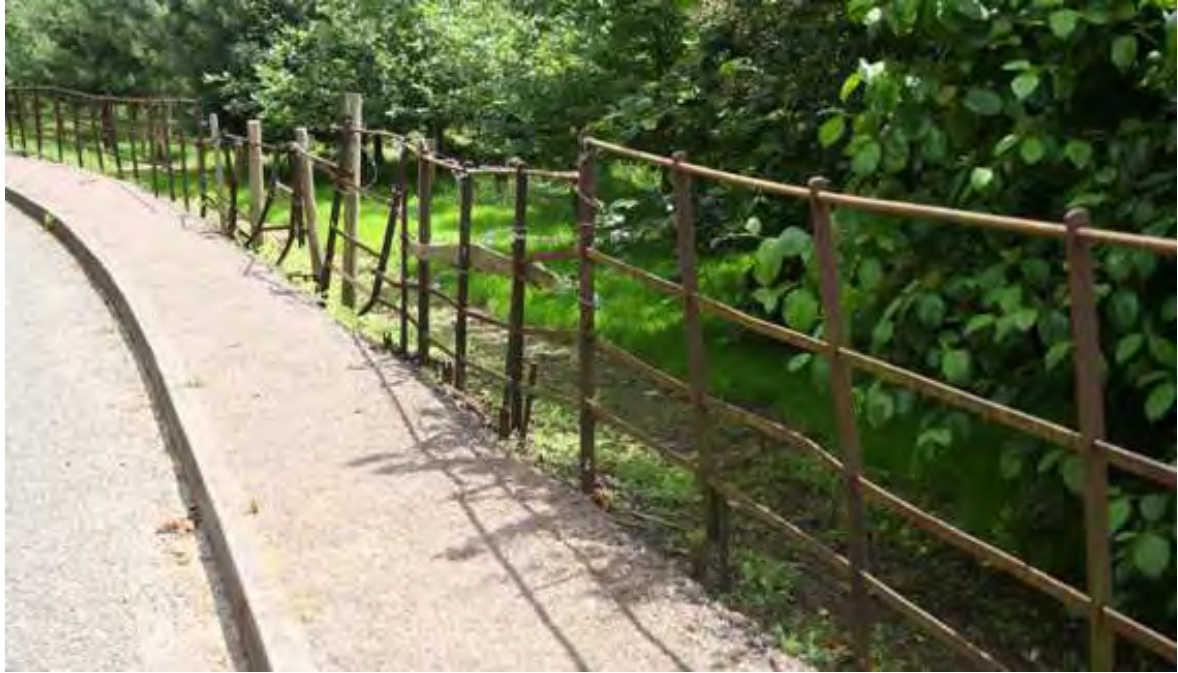
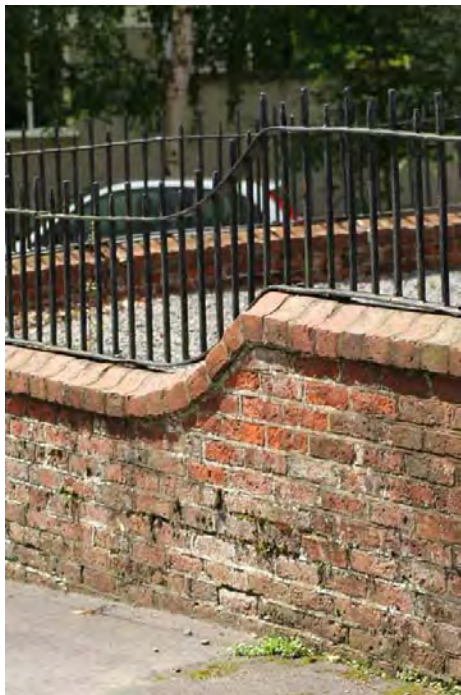
Above - estate railings of wrought iron with round bar top rail and flat bar lower rails (Church St). This type of five-bar estate railing is found in a number of places, but mainly between the private grounds and fields around the former Netherseal Hall

Right - detail of railings and post with sprigs

The periphery and outlying areas of the large estates and gardens are often defined by a wrought-iron estate-type fence; five horizontal bars with slim, regular posts. In general these are not being maintained and are in poor condition, corroded and distorted.

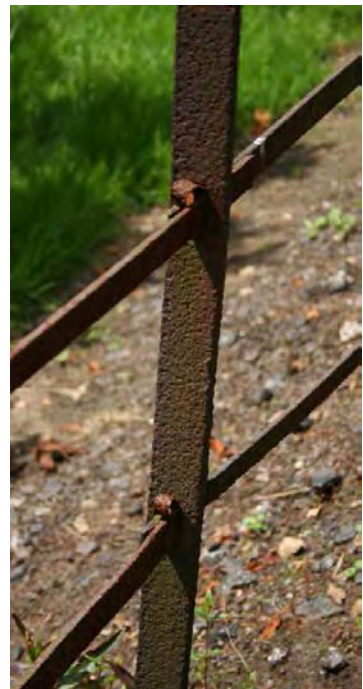
Left - early C20 wrought iron railings fixed to brick wall at the Village Hall, Main Street

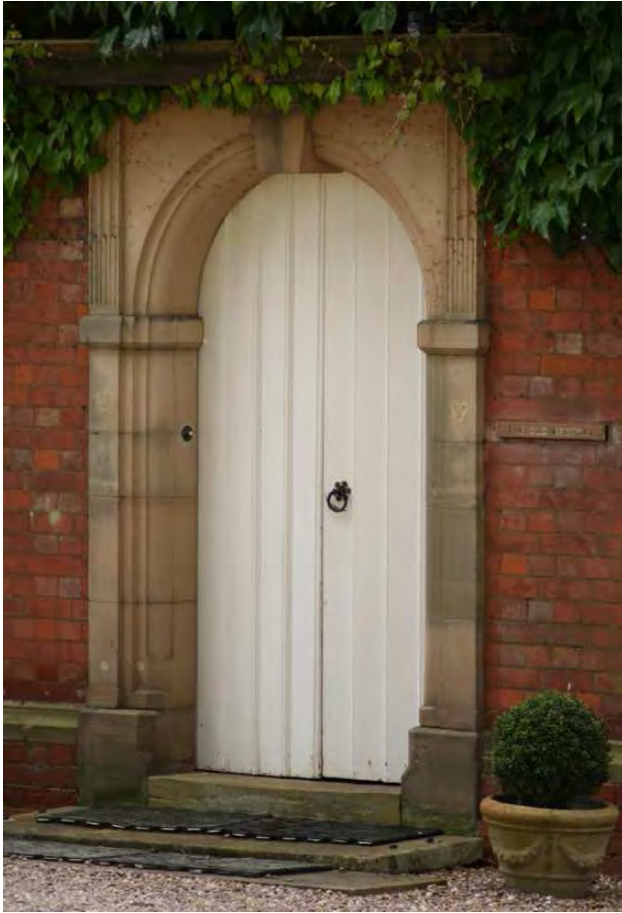
The ornate, classical, stone doorcase at The Old Rectory (above) incorporates part-reebed pilasters, a cornice, dropped keystone and elaborate moulded door surround. The simple, sober, boarded and battened door is also probably original. The amount of attention paid to this doorcase reflects the important status of the house within the village, when it was first built.

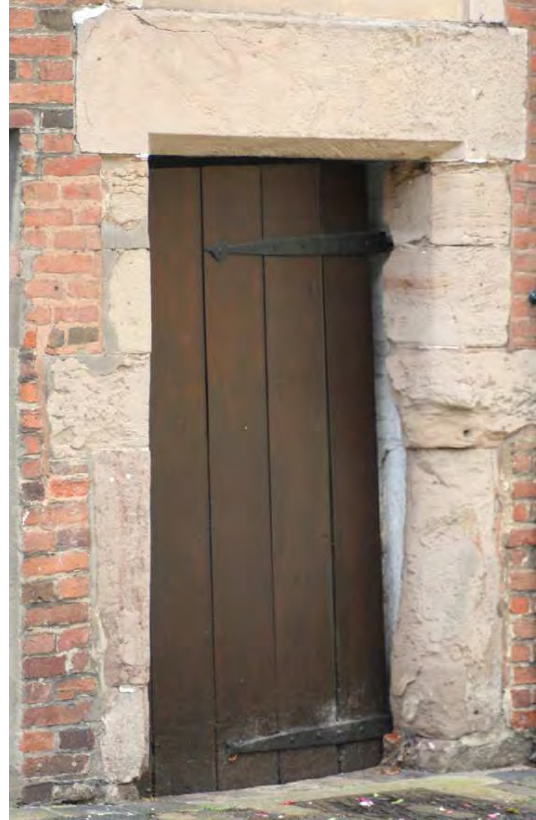
Above - boarded door with wrought iron strap hinges at the Almshouses. This simple pattern, is found on the passage doorway.

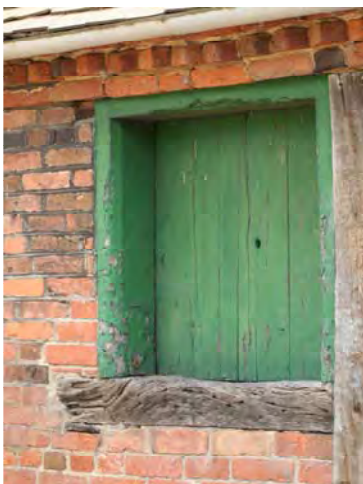
Left - simple boarded shutter and taking-in door to the outbuilding behind The Old Hall.

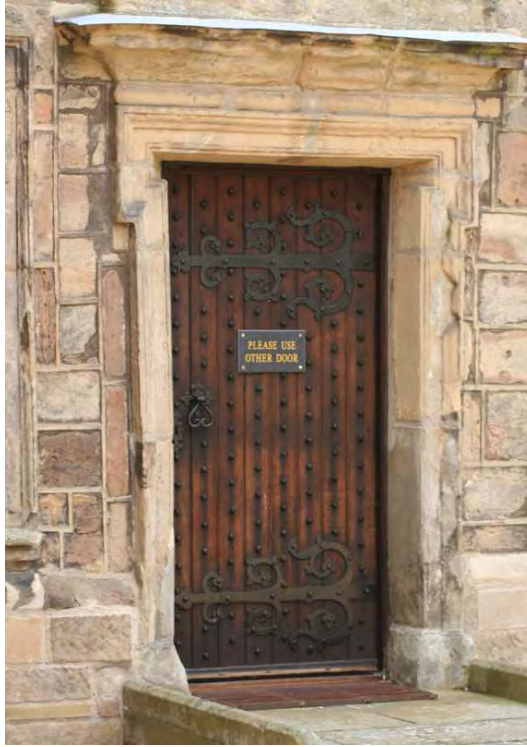
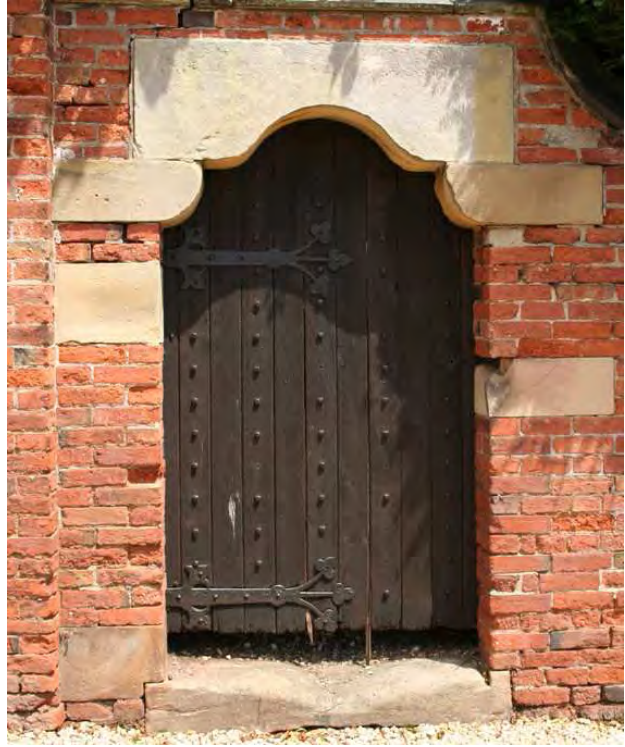
At The Old Hall (above left and right), many of the doors were restored in the 19th century. The styles reflect the high status of the house. They were old, simple styles of boarded door but embellished with ornate ironwork, studded with nails and decorative, flamboyant strap hinges.

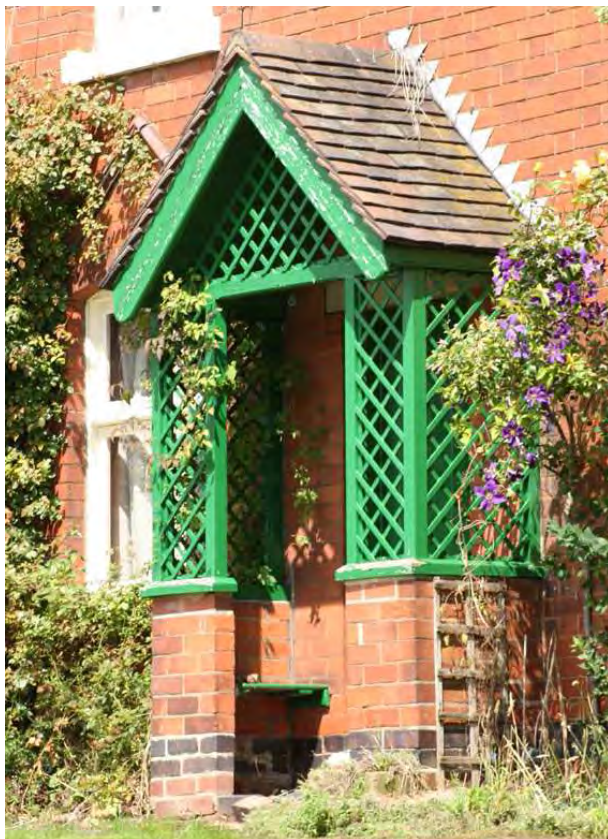
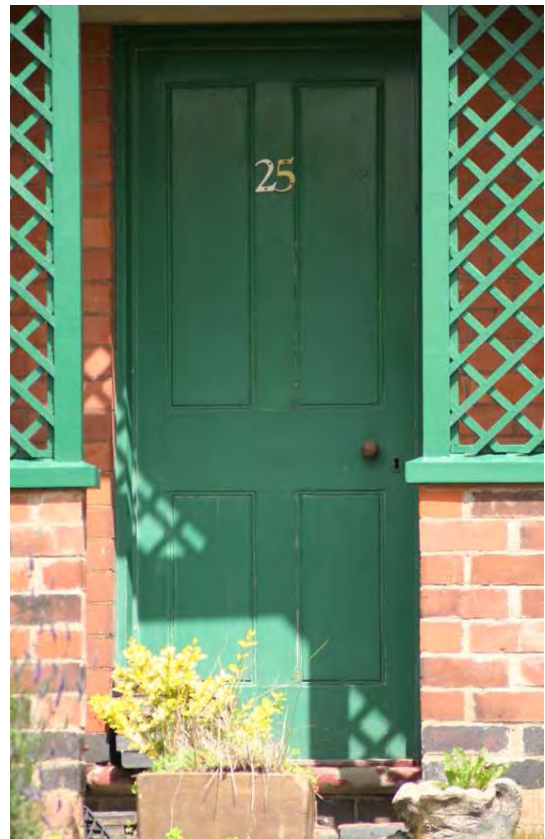
Below left and right - 23-27 Church Street; simple panelled doors and a timber trellis porch were adopted for these workers cottages of c1890. Door of four flush panels with bead mouldings.

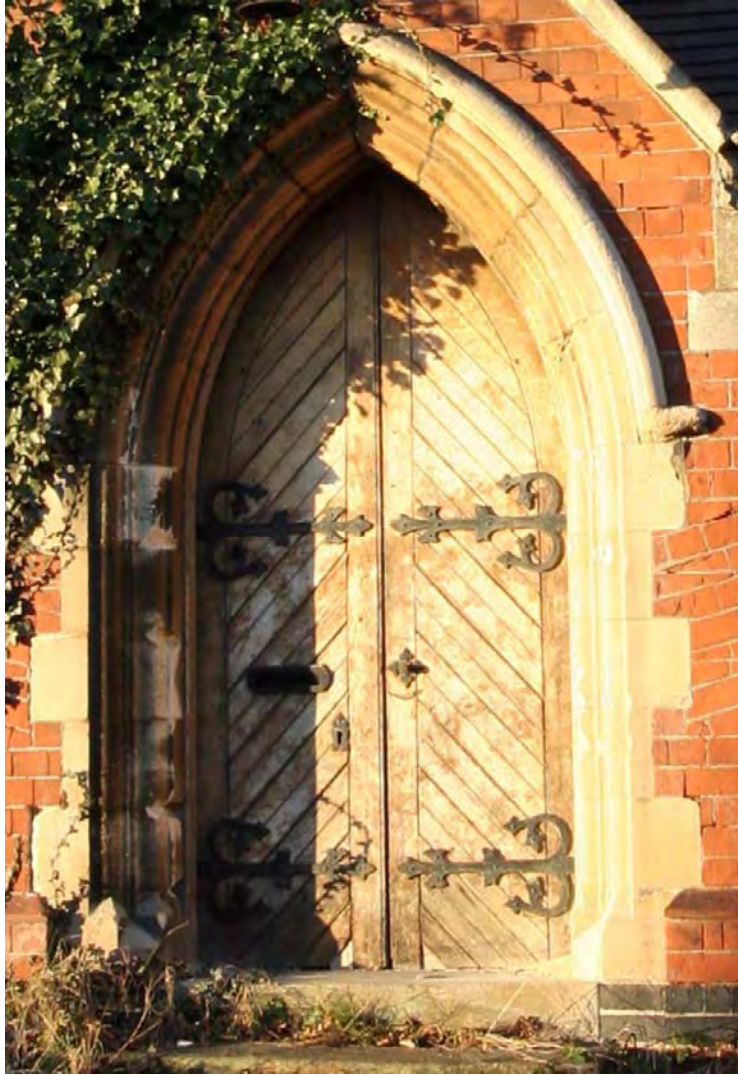
The former Wesleyan Chapel on Clifton Road was built c 1890. It has boarded doors, laid diagonally to the frame, and ornate strap hinges. The heavily modelled, "decorated" stone surround is typical of the Gothic Revival style of this late Victorian architecture.

Clifton Road has a number of buildings of individual architectural and historic interest, in particular The Wesleyan Methodist Chapel and its smaller “daughter” building, the Wesleyan School (pictured right) and the terrace of cottages opposite this pair, Clifton Road Villas. The north side of Clifton Road is dominated by the paired red brick gable frontages of the Wesleyan Methodist Chapel and its off-spring, the Wesleyan School, both built as pieces of street architecture, punctuating the street. These were built in a Gothic Revival style of architecture, using English

bond brickwork, the former using stone for the decorated windows and trefoil panels and the latter using simplified lancet windows made with moulded bricks. There is a series of engraved foundation stones in the front gable.

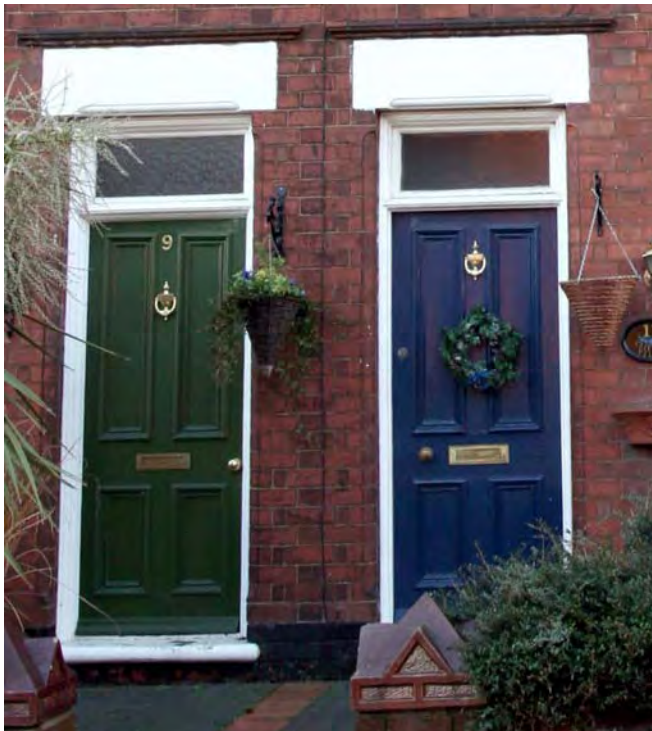
Along Main Street, during the 19th century, most of the new detached and terraced houses were built with panelled doors. Those at 9 and 11 Clifton Road (left) have four panels with heavily modelled, applied, bolection mouldings, and a plain fanlight.

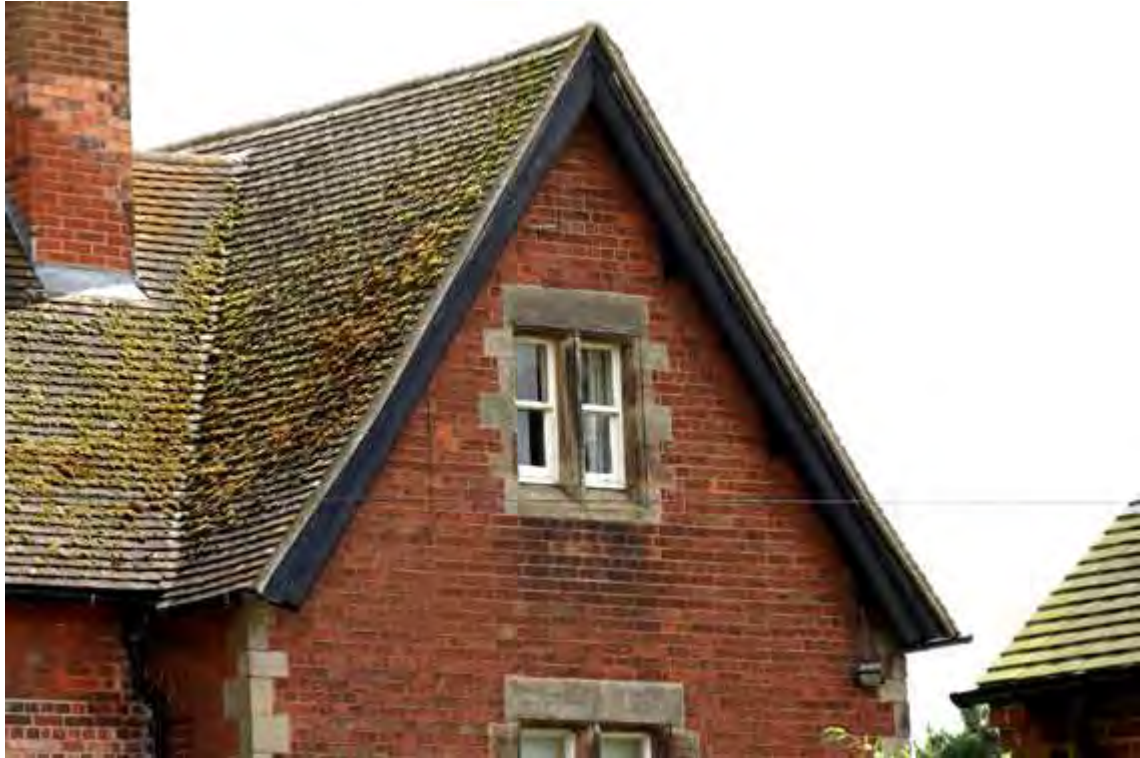
Above - steep pitched roof with timber bargeboards at The Old Rectory (1863).

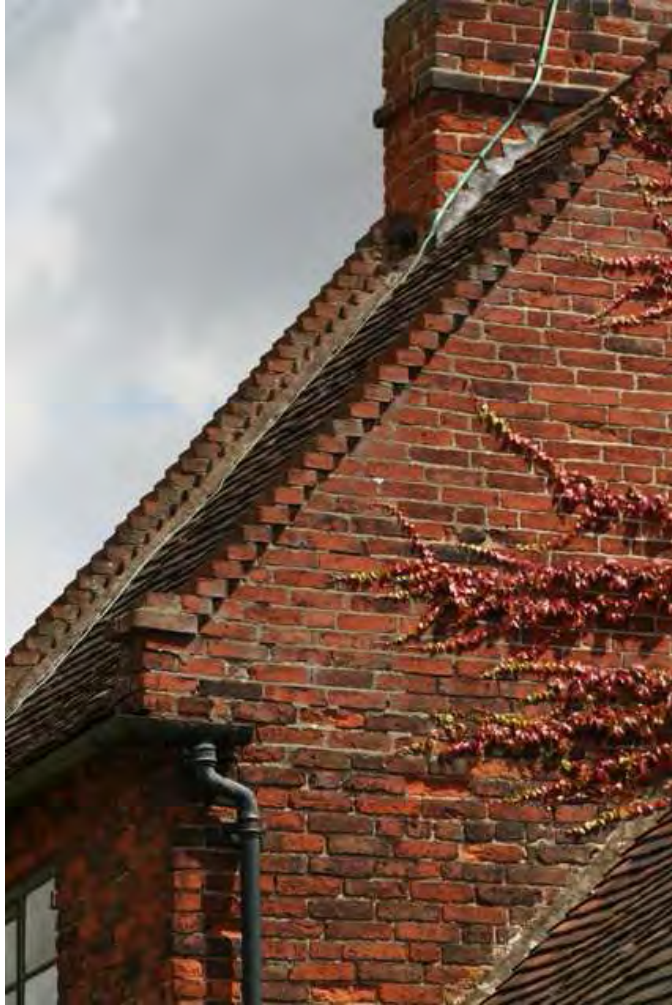
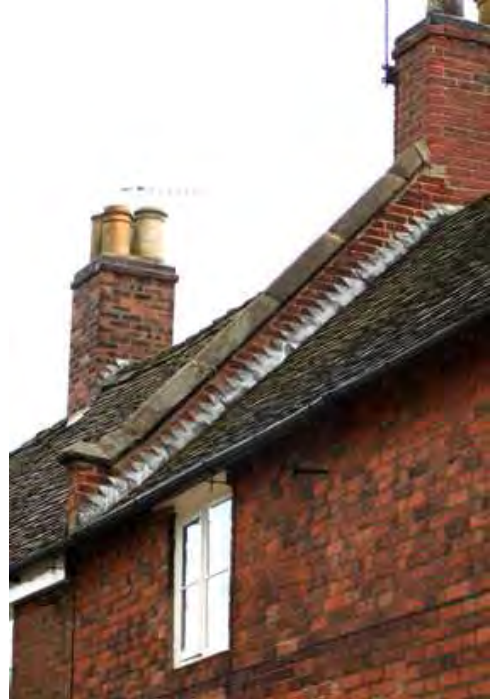
Bottom left and right - hipped tiled roofs at Netherseal Old Hall and The Stable Yard. These hips have rolled lead flashings.

Above and below - steep pitched roofs with raised, moulded, stone-coped gables (The Old Hall and the Village School).

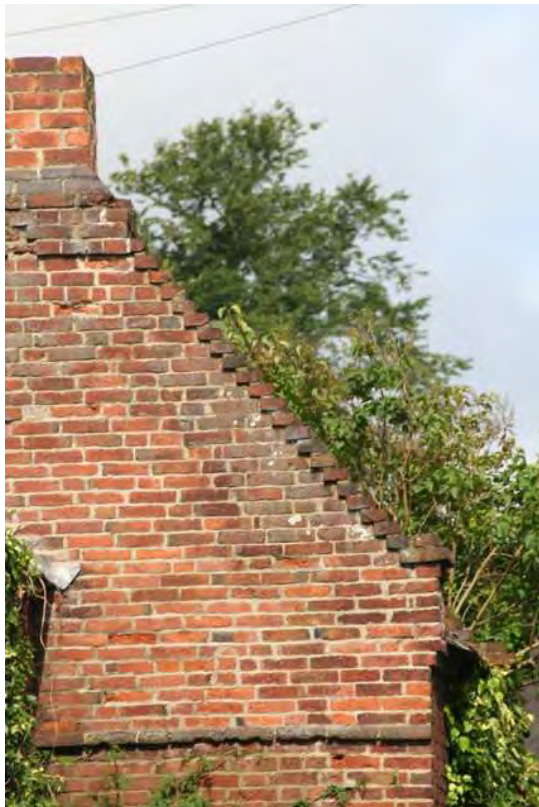
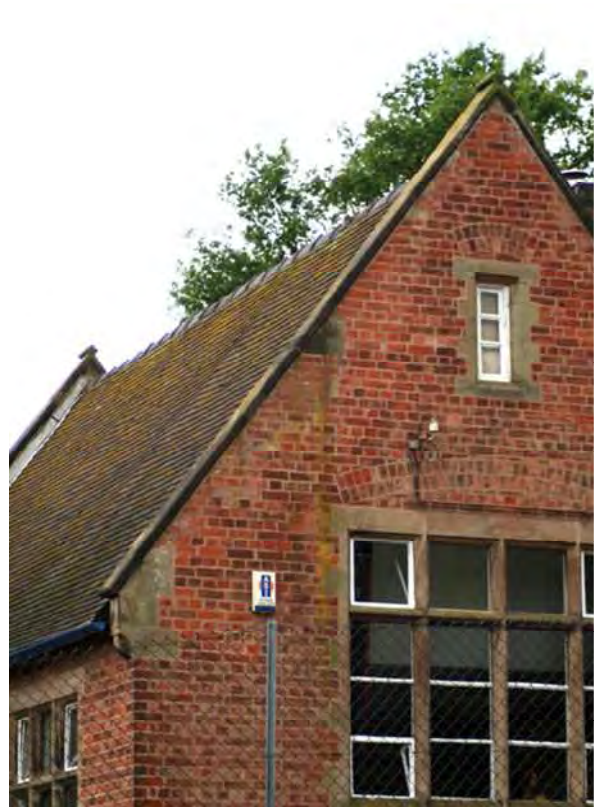
Left and bottom left - stepped and raised brick parapet gables (The Old Hall and The Old Stableyard).

Left - a complex roof detail combining a corbelled and dentilled verge with a raised gable with stone coped parapet (The Old Stableyard).

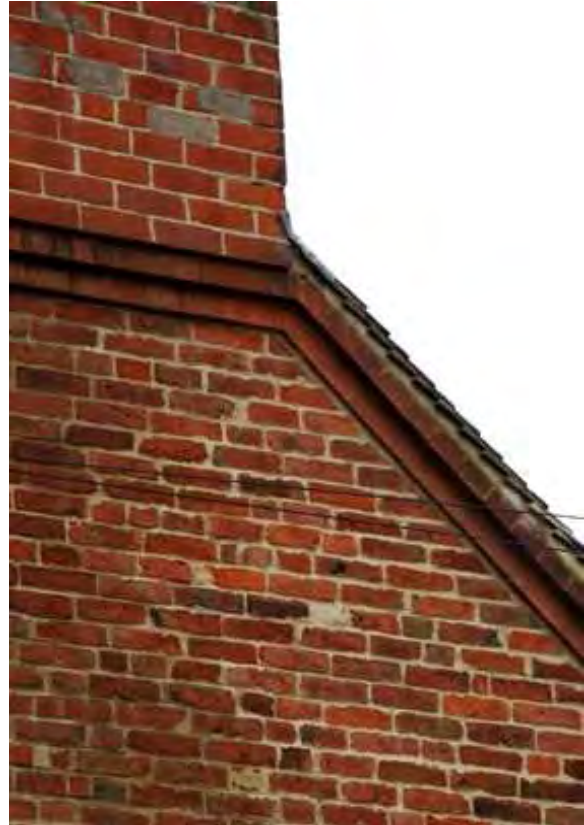
Above left - stepped corbelled verge (21 Church Street). Above right - plain corbelled verge (6 Old School House).

Below - a rebuilt C19 chimney of multiple engaged flues, broad oversailing cornice and moulded blue brick weatherings (The Old Hall).

Another decorative brick detail is the use of a raised brick band on the gable end of brick houses. This follows the verge, to provide a drip moulding (e.g. No. 6 Church Street), and is occasionally stepped, as can be found at 21 Church Street.

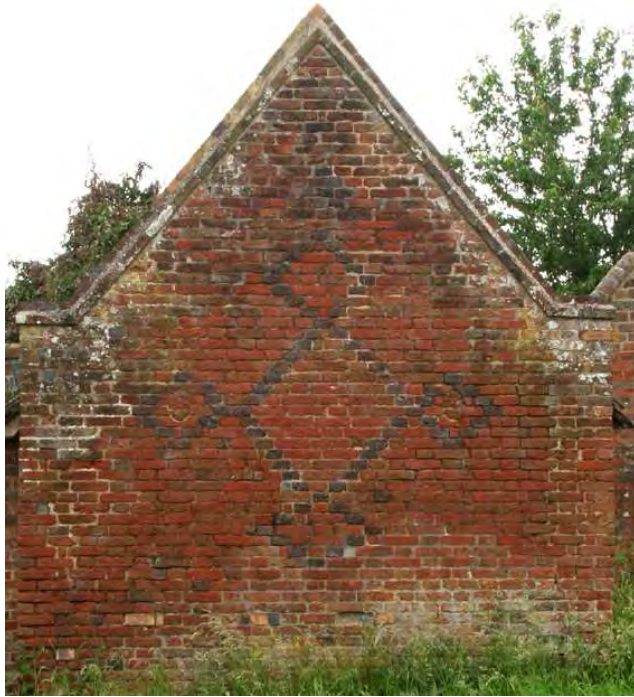
Decorative Flemish bond brickwork - blue brick lozenge pattern at The Old Hall (above) and detail of blue headers in the garden wall (top right). Buff headers were adopted during the mid C19 for a number of buildings (21 Church St - above right).

Right - Flemish bond brickwork with flared blue headers and moulded brickwork at the old dovecote.

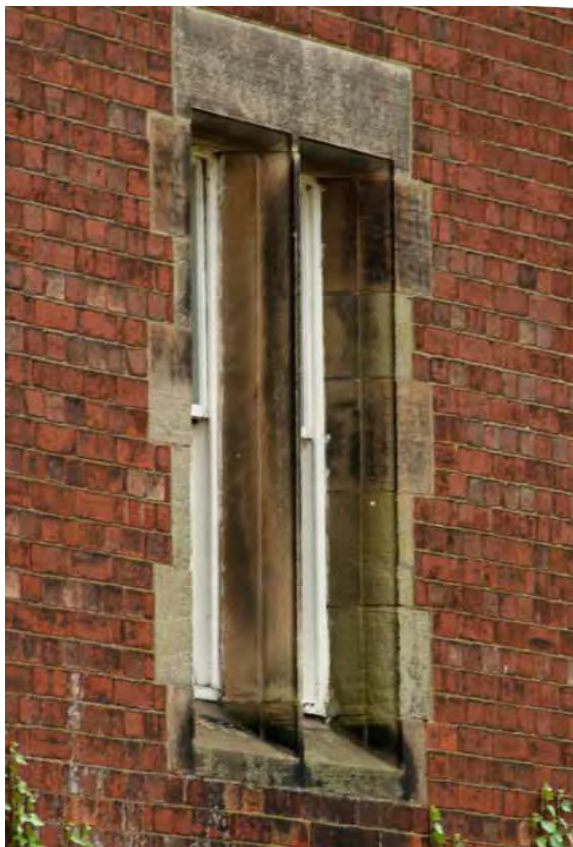
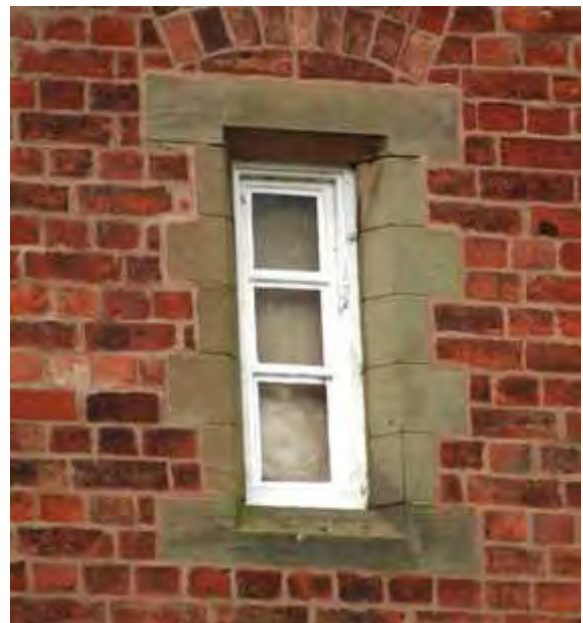
Many of the brick buildings have stone details, such as the moulded stone window surrounds at The Old Rectory (below) and the village school (bottom right).

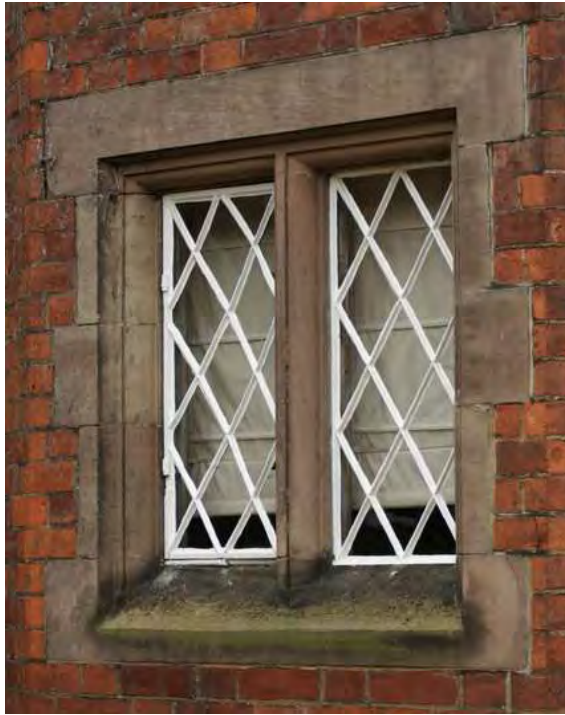
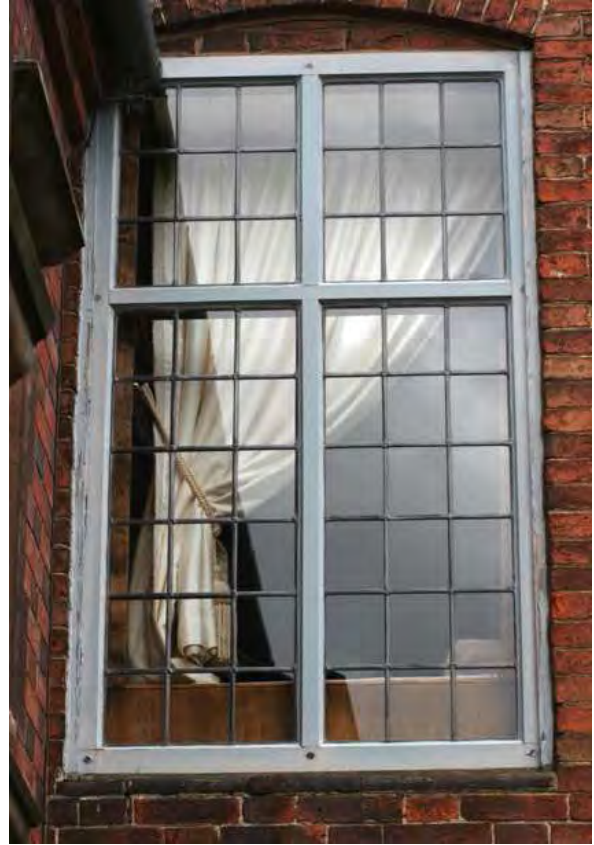
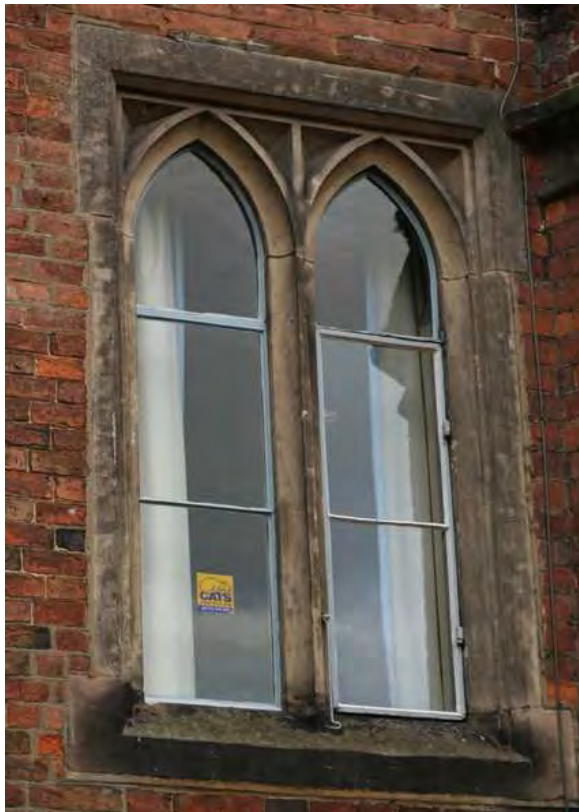
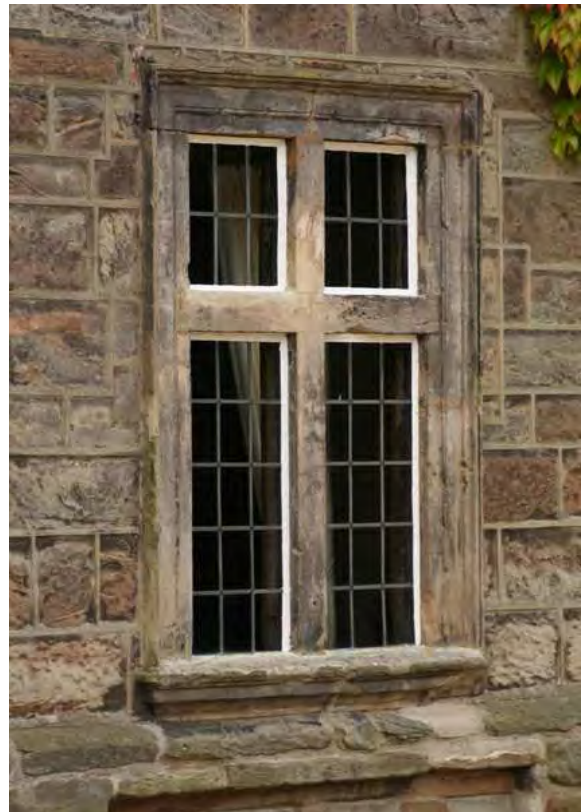
The Old Hall exhibits the widest range of window patterns, reflecting its long history. Above right - reproduction timber mullioned and transomed window with rectangular leaded-lights (an early C18 pattern). Below right - rectangular leaded-lights within original late C17 stone mullions and transom. Above and below left - diamond lattice and plain cast iron Victorian casements.

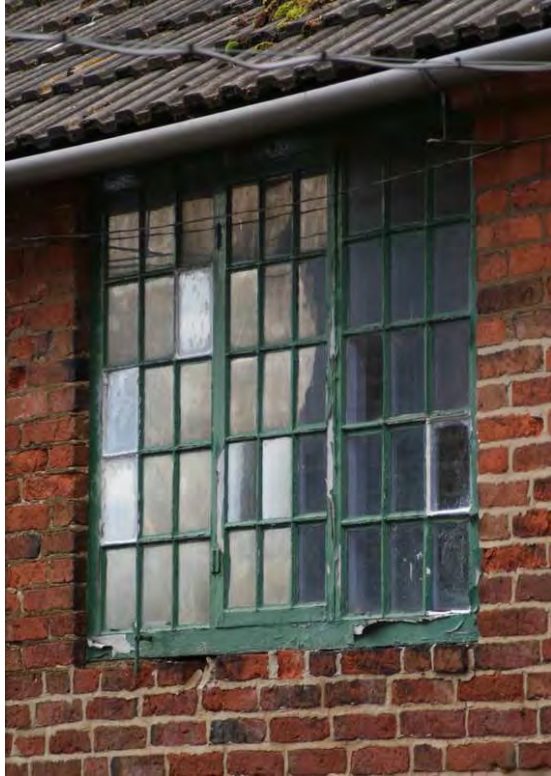
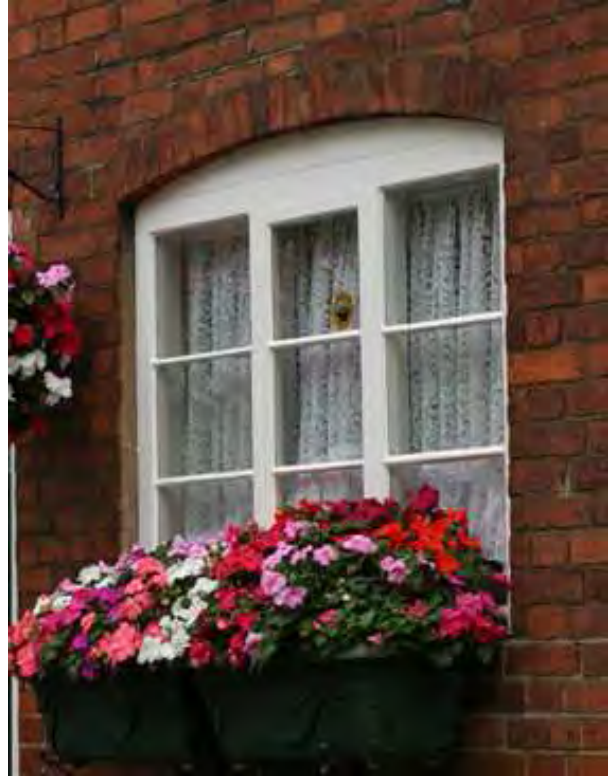
Casement windows are prevalent within the village. There are a few patterns evident. The most common is the simple two or three-light casement found at the Almshouses (top right and right) and Nos. 23-27 Church Street (bottom right).

The multi-paned casement window found at 21 Church Street (above left) is now a relatively rare survival of an old pattern.

The most common windows to survive were used in conjunction with brick segmental arches. These are the two-paned timber casements, a late 19th century window pattern that can be found at the Almshouses, Hall Farm and 21-27 Church Street. Small-paned timber casements survived at Mill Farm and have been preserved and restored.

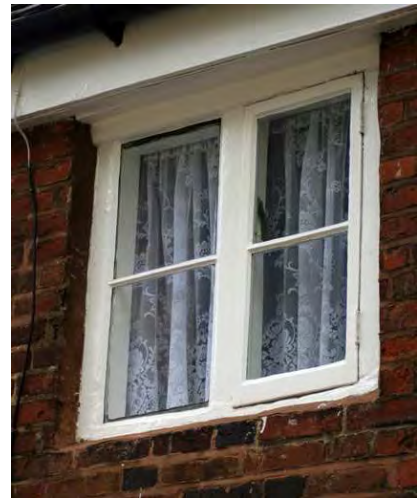
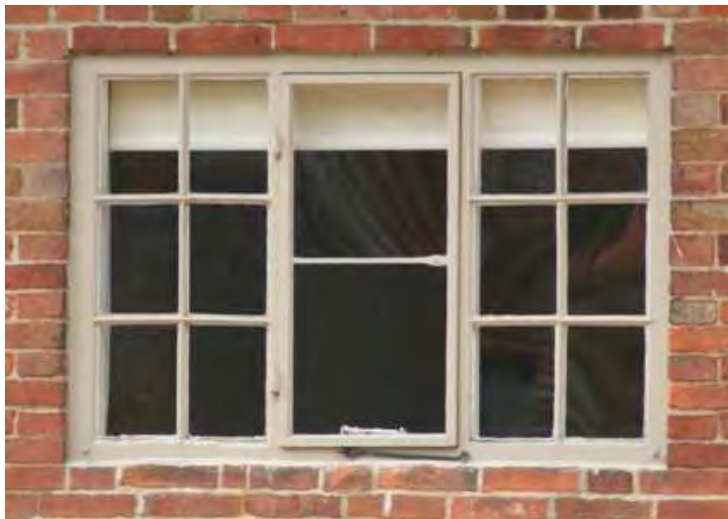
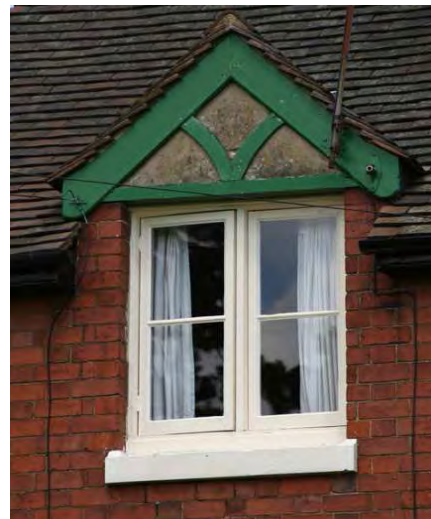
Below left - small-paned casement window at Mill Farm, formerly a leaded-light window with 12 panes in each of the three sections. The central opening light is made from iron and is original, with one of its original saddle bars surviving across the centre. The outer frame of the window is also original, but timber glazing bars have been inserted.

Right - 56 Main Street. The Victorian house has a bay window with vertical sliding sashes and moulded red terracotta details forming the acanthus-leaved capitals, moulded terracotta lintels and cornice.

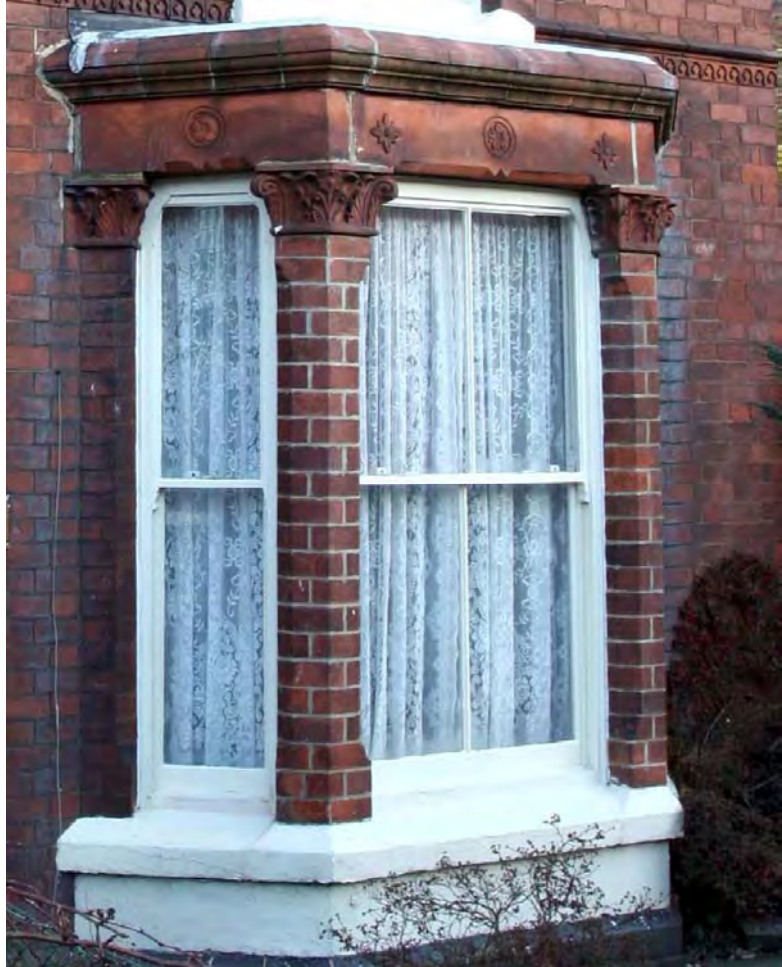
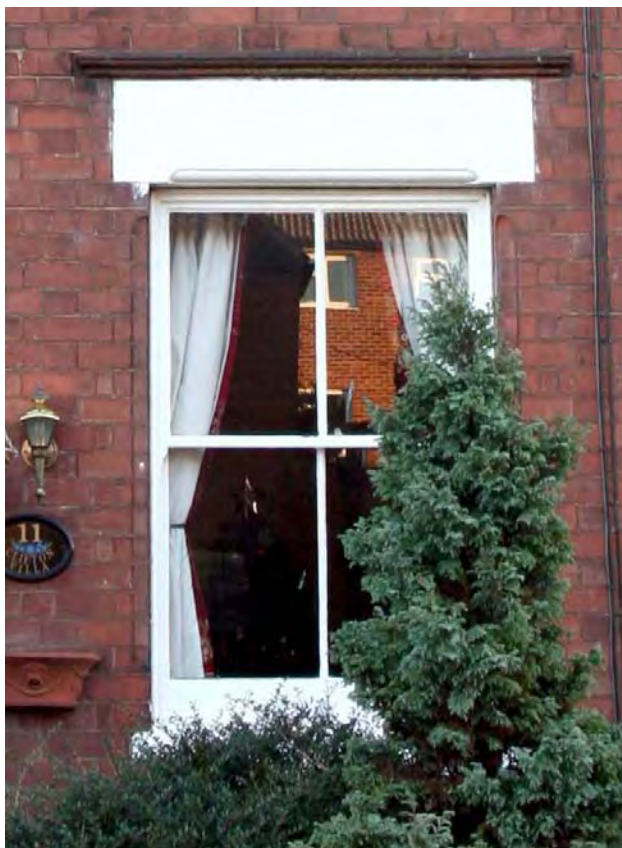
Left - 11 Clifton Road. The moulded details in the stone lintel are replicated in the terracotta window jambs.
