Netherseal *Conservation Area* Character Statement

**SOUTH DERBYSHIRE
DISTRICT COUNCIL**

Netherseal *Conservation Area*

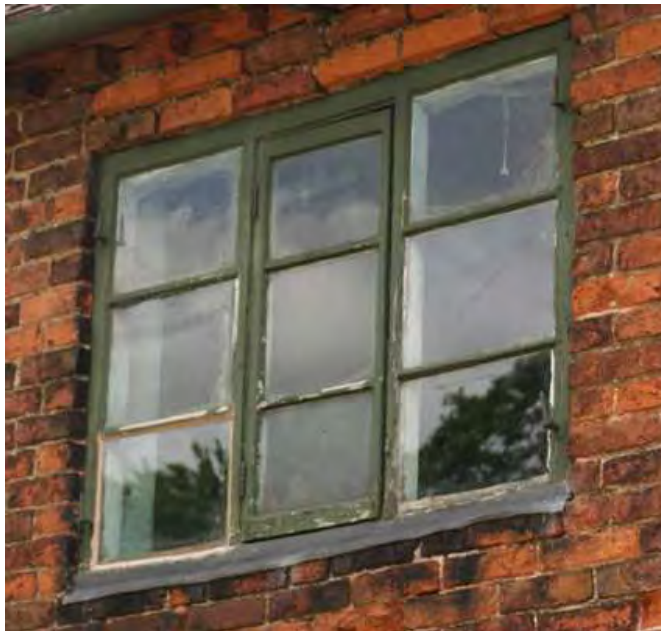
In association with casement windows, the most common pattern of lintel is the segmental brick arch. This was often used for economy. The example at The Almshouses (left) incorporates header and stretcher bricks, many of the headers have been fired at a higher temperature and so appear almost blue. The brick infill between the arch and the window, set back, is a typical early detail.

In many instances there is neither a lintel nor a cill, as in the outbuilding at the Old Hall (left). Instead the brickwork above the window is supported on the window frame. The cill has been simply protected here, at a later date, with a lead flashing.

- the segmental brick arch. This is found throughout the village on buildings such as the Almshouses, Mill Farm and the cornmill. It is generally found in the 18th and early 19th century on the smaller domestic buildings. This was the simplest and easiest lintel to construct as the taper was accommodated wholly in the mortar joints, without the need to cut the brick.
- the chamfered and moulded stone lintels. The earliest examples of moulded stone lintels can be seen at the Old Hall where they were part of a complete architrave, derived from classical architecture. In the 19th century moulded stone was often deeply chamfered to reflect Gothic styles of architecture, as in the windows surrounds at The Rectory and St. Peter’s School.

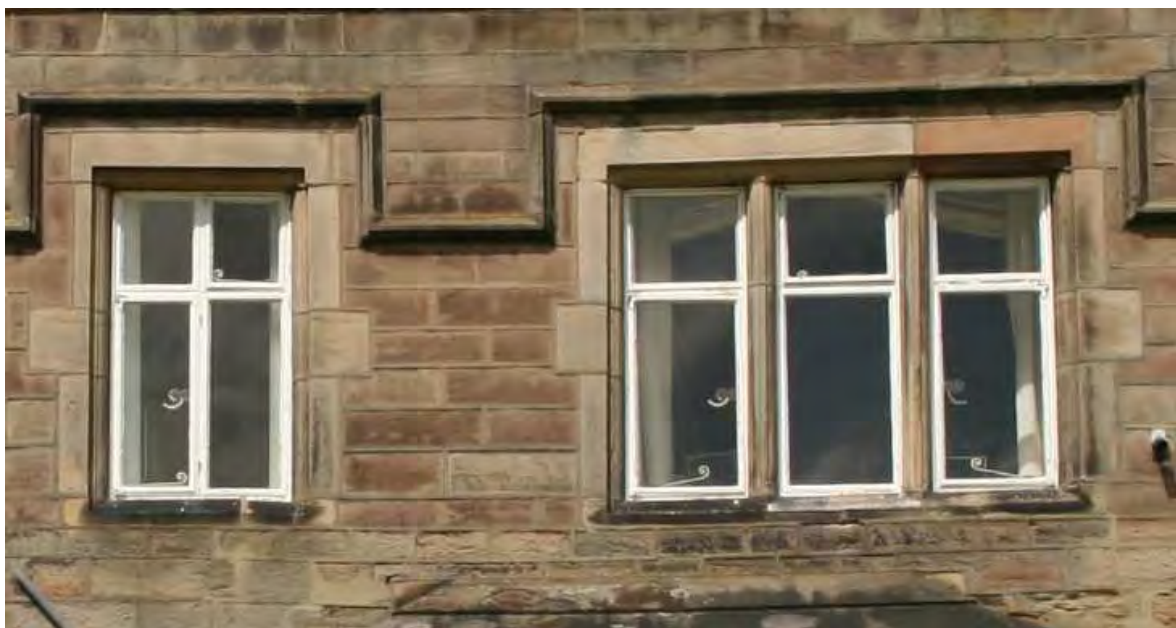
The lintels and cills of the larger buildings are treated as part of a complete window or door surround and are usually stone, carved and moulded, as in the example at the Old Hall (below).
